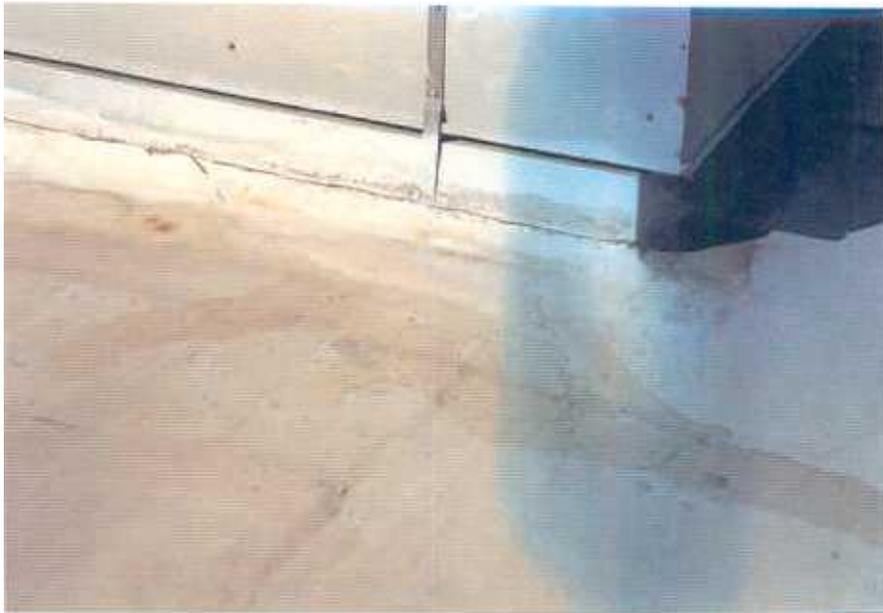
Figure 2.6-18 Water Accumulation at Base of Flashing
