FACILITY INSPECTION REPORT

Facility No:	K6-1145, K6-1145A		Fiscal Year:	2012
Facility Name:	Multi-Function Facility, Electrical Substation		Inspection Date:	12/11
Location:	Kennedy Space Center (KSC) VAB Area		Facility Owner:	NASA
RPI CRV:	\$3,439,185 and 58,442 as of 2010	Original Construction Date:	1985	
ISC Maintained Systems/Codes:	AC/FG/LU(ELV), AC(EHV), AI(MEC), FA/SC/SY(PHY), HV(HVC), PR/SR(STR), SS/WP(WWS)		FCA Type:	Refresh
Inspector(s):	Justin Gilman, Shannon Gordon

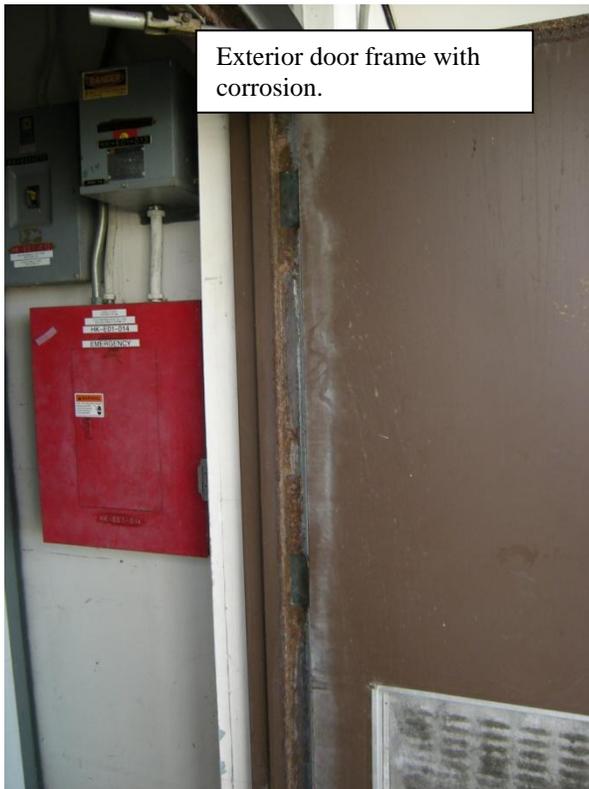
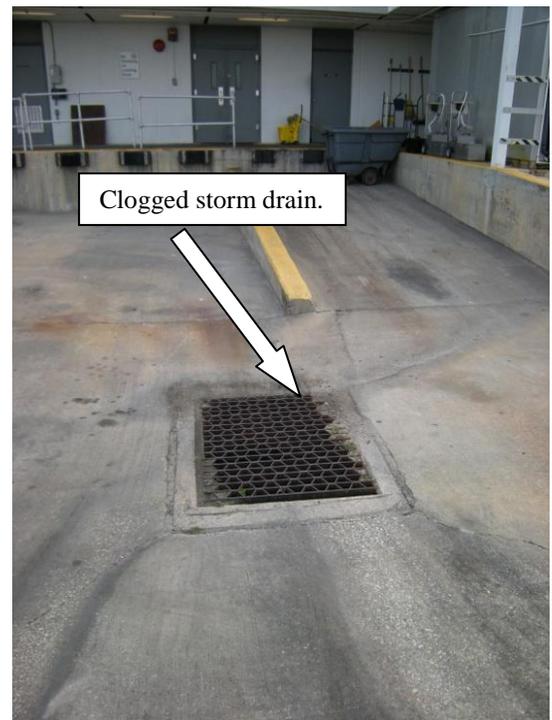
The exterior concrete and windows are in good condition. The exterior paint is in fair condition. The interior floor coverings and walls are in good condition. There are personnel doors at the rear of the facility that are experiencing some corrosion at the frames. There is also a storm drain in the loading dock area which is clogged and causing flooding. Work orders were submitted by the SME to correct these. See figures 4 and 5.

FCA Team initiated submission of a WON to clean out the storm drain.

- Replace the outdoor awning. (E1006461,existing)
- Repair rear kitchen personnel door frames. (10569074,existing)
- Clean out storm drain at rear of facility. (E1316988,added as a result of FCA)

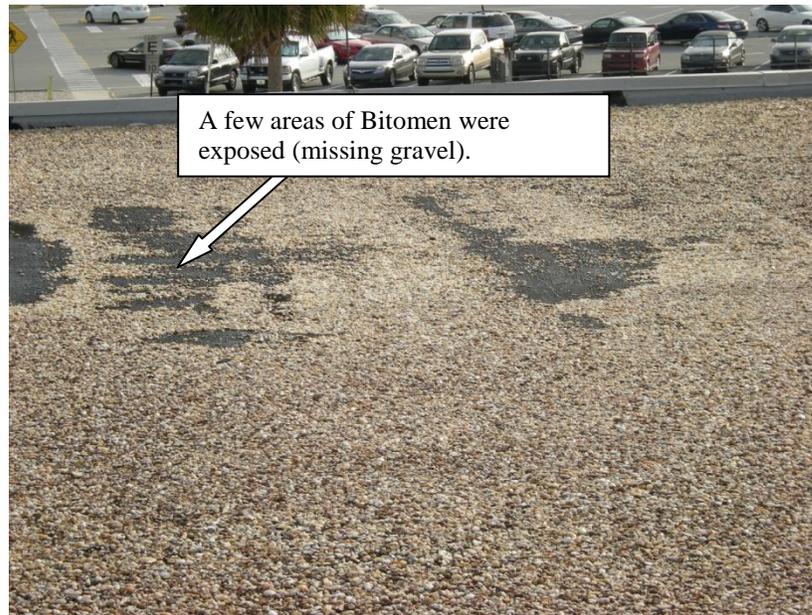
K6-1145-K6-1145A - Access to the roof top was available. The roof showed no signs of deterioration or fatigue. There were a couple of areas where the gravel was thin and this is being addressed by the SME. See Figure 6.

- Add gravel to thin areas. (E1316709, added as a result of FCA)

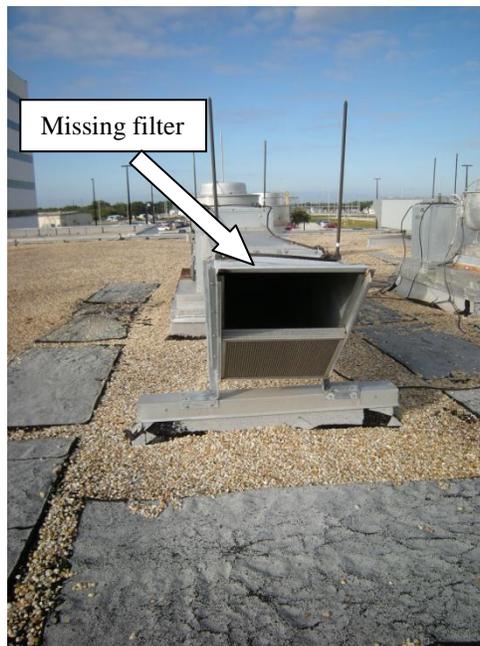
- Replace the missing filter on one of the roof-top exhaust fans. (E1317615, added as a result of FCA site assessment) see Figure 7.
- Replace fallen air handler access panel in north mechanical room. (E1317638, added as a result of FCA site assessment)
- The air handler in the medical facility appears to be operating as if the area was staffed at full occupancy. Because the area is unoccupied, the FCA Team will review with SME and Energy engineers to determine if the loads can be adjusted to reduce energy usage.

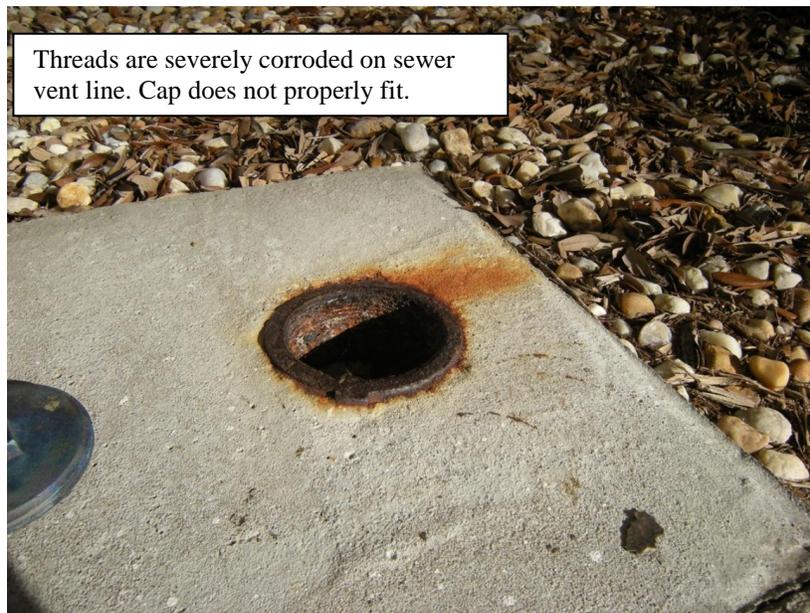
During the site visit, the FCA team found a sewer vent cap that was not properly sealed on the south side of the facility, adjacent to the credit union. Strong odors were noticeable. The ISC SME was notified and E1321234 Work Order was submitted. See WWS for more information on this deficiency.

- Adjacent to the Credit Union, a sewage cap was noted as not being secured properly. The cap had been replaced, but the threaded fitting was still rusted and beyond repair. The SME was notified and action is being taken. See Figure 8.
 - This is possibly the source to the odor complaint given during the interview of the Credit Union Manager.
 - (E1321234-D/O K6-1145 SW CORNER: Install temporary plug in clean-out, added as a result of FCA)
 - (ESR Submitted: ESR0000949-Replace Broken Clean-Out, added as a result of FCA)
