PURPOSE

On March 10, 2010, Consolidated Safety Services Inc. (CSS) industrial hygiene personnel conducted a limited bulk sampling of suspected asbestos containing materials in the Control Room of building N234A. The purpose of the task was to determine if the upcoming renovations in the Control Room will be impacting any asbestos containing materials. This report documents the findings and recommendations resulting from the industrial hygiene consulting services conducted in the Boiler House on insulation found on the piping and boiler stack of building N234A of the NASA Ames Research Center (ARC).

Table 1. Building N234A Control Room Bulk Samples for Asbestos Content – March 10, 2010

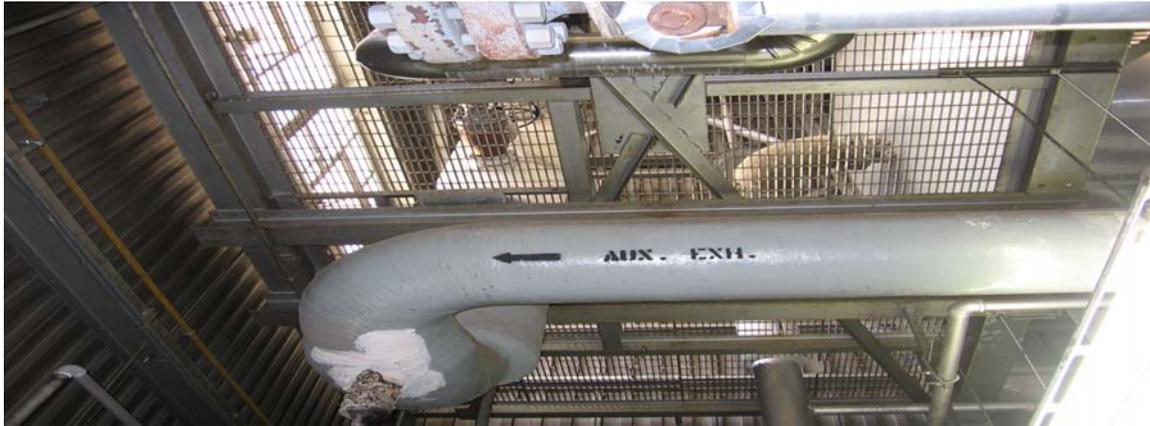
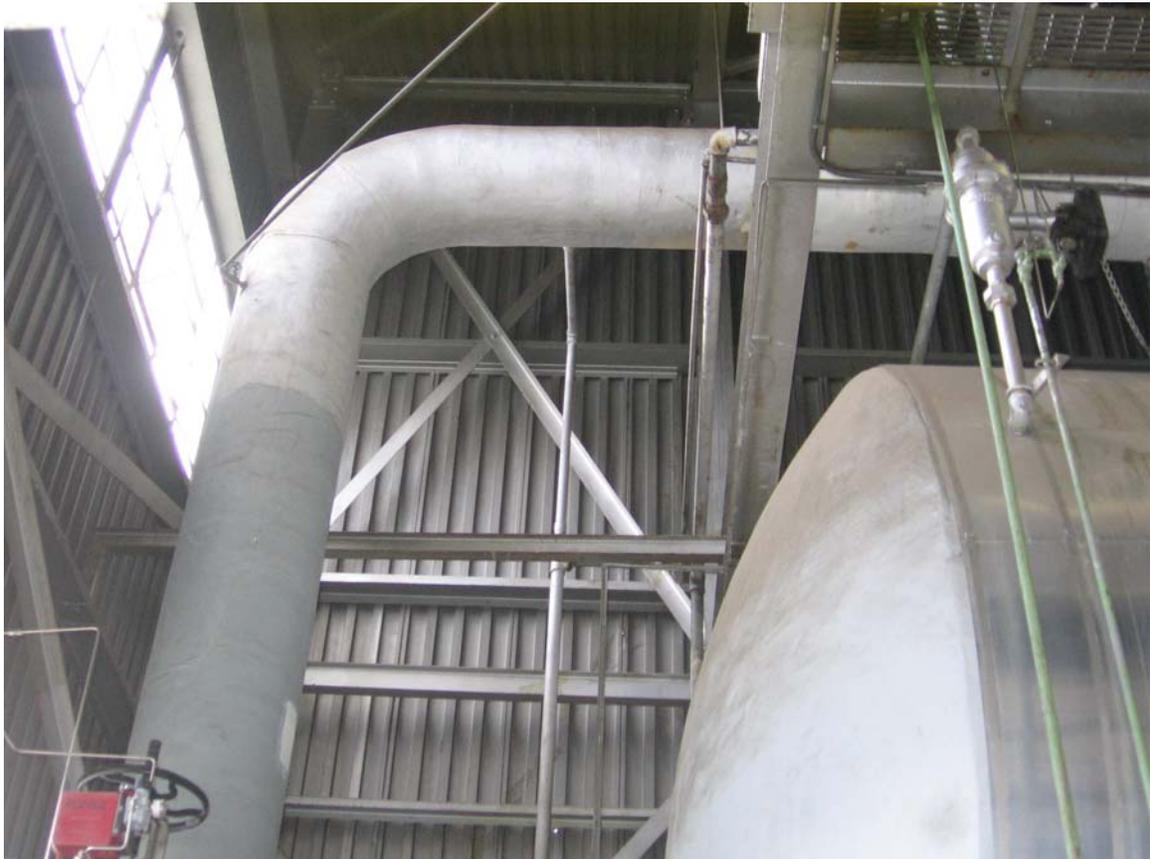
Pictures of: Sample Number N234-05TSI Description AUX EXH
Piping running from third floor tank to 1st floor tank.
