PURPOSE

On November 30, 2009 and December 10, 2009, Consolidated Safety Services Inc. (CSS) industrial hygiene personnel conducted a limited bulk sampling of suspected asbestos containing materials in the Boiler House of building N234A. The purpose of the task was to determine if the upcoming renovations in the Boiler House will be impacting any asbestos containing materials. This report documents the findings and recommendations resulting from the industrial hygiene consulting services conducted in the Boiler House on insulation found on the piping and boiler stack of building N234A of the NASA Ames Research Center (ARC).

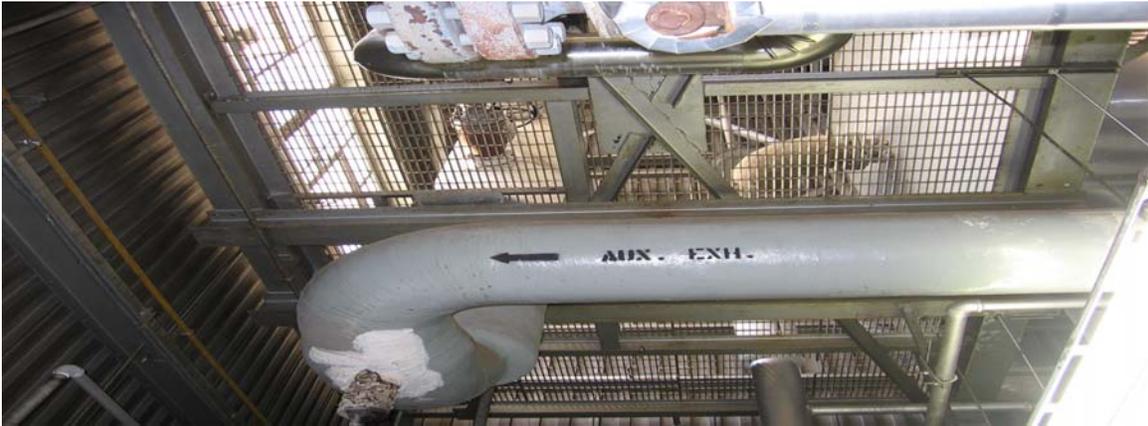
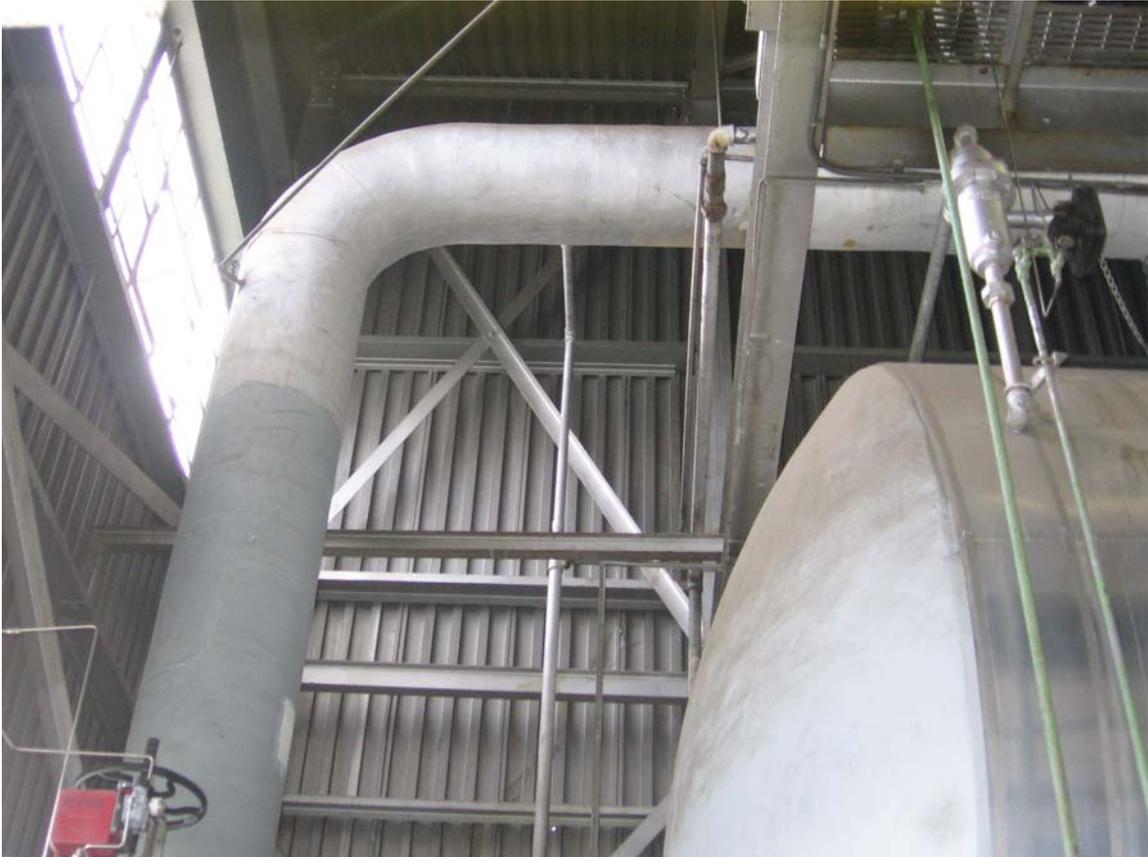
Pictures of: Sample Number N234-05TSI Description AUX EXH
Piping running from third floor tank to 1st floor tank.

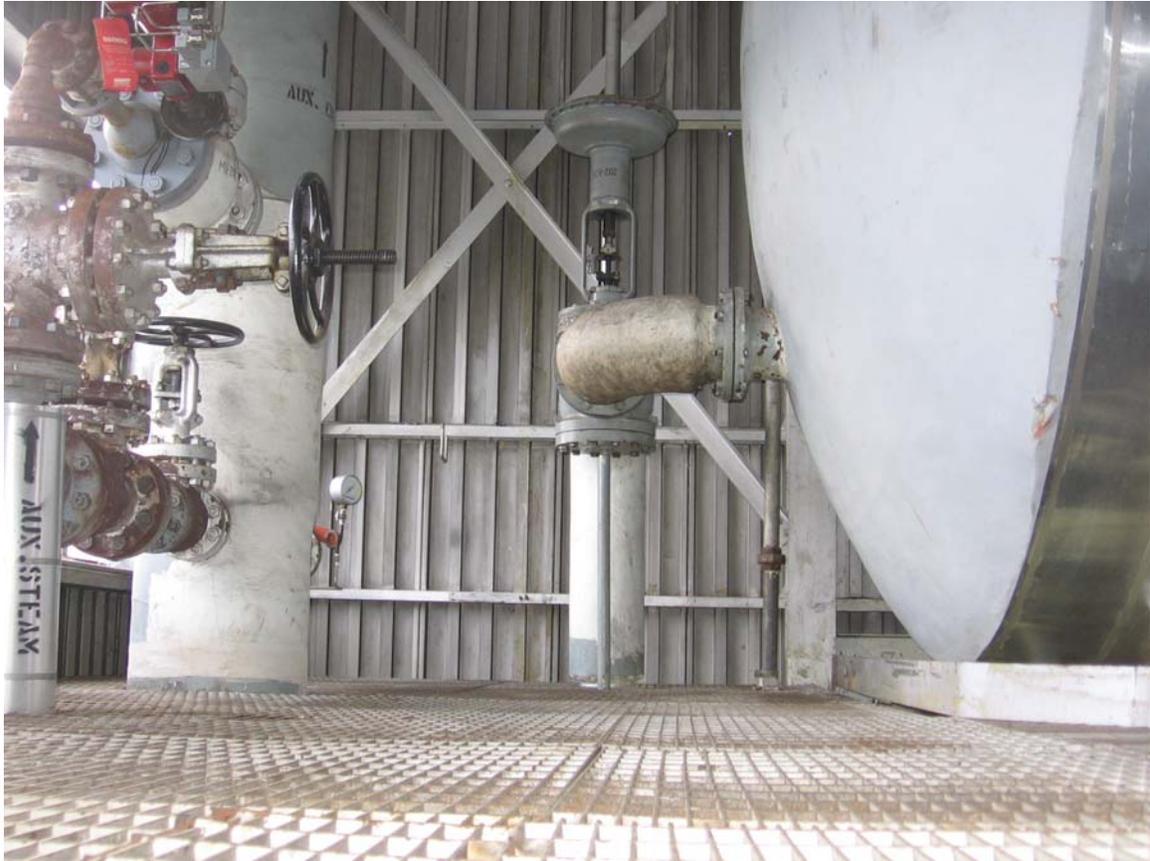
Picture of Sample Number N234-03TSI: Large piping going into tank on 2nd floor.

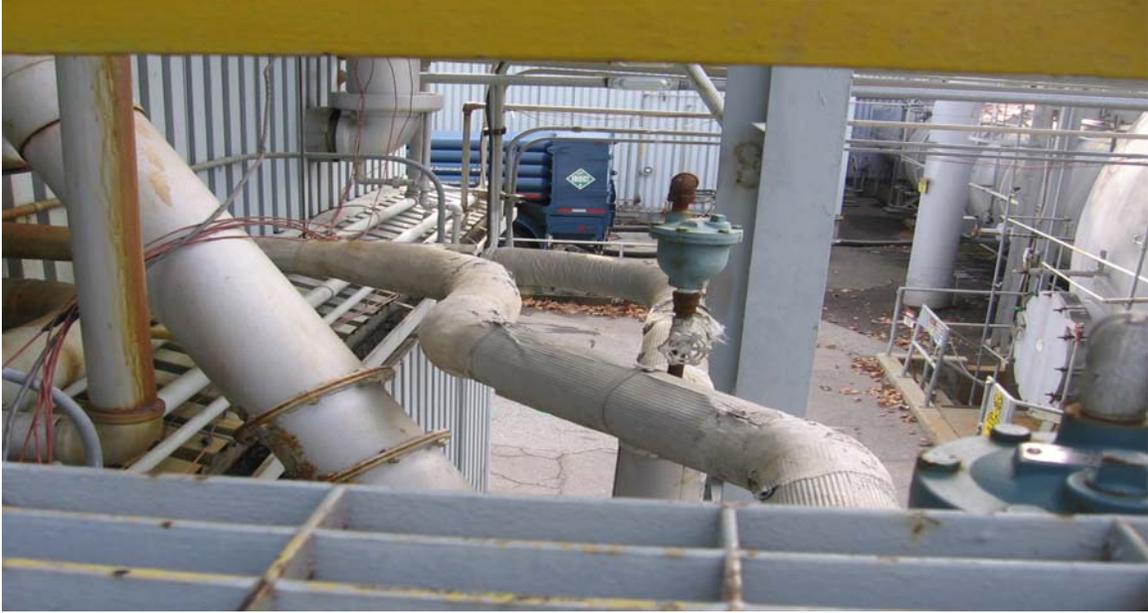
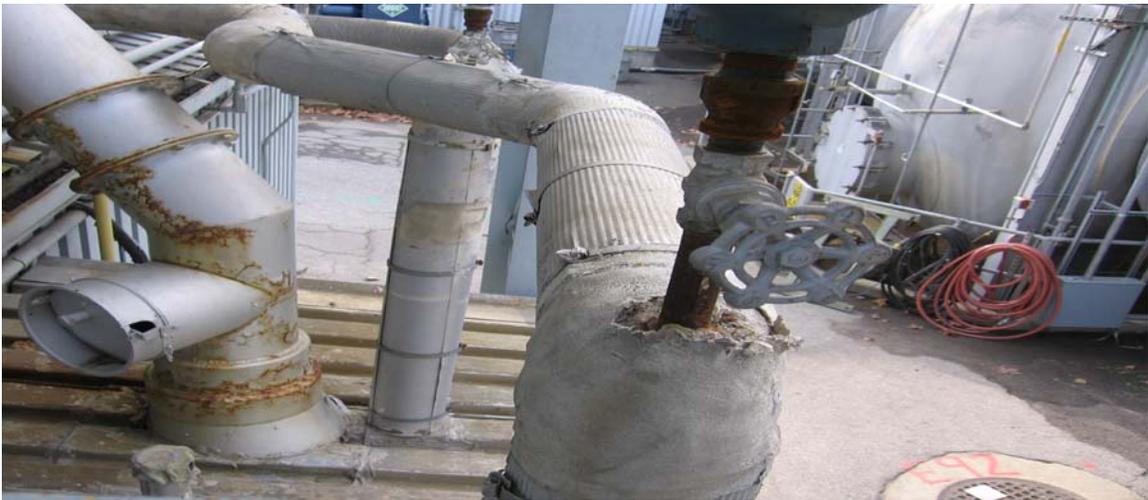
091209-N234-06Debris	Debris in pan below damaged pipes	8% Amosite	RACM	Class I
091209-N234-07	Vertical piping fiberglass	ND	N/A	N/A
091209-N234-08	Large water tank 2 nd floor	ND	N/A	N/A
091209-N234-09	Large water tank 2 nd floor	ND	N/A	N/A
091209-N234-10	Piping insulation outside under stairs (damaged)	15% Chrysotile	N/A	N/A

Asbestos Containing Damaged Piping outside under stairwell on west side of building: Sample number 091209-N234-10

Damaged TSI that is found in the boiler house and outside under the stairwell should be repaired and associated debris should be HEPA vacuumed by asbestos trained personnel.

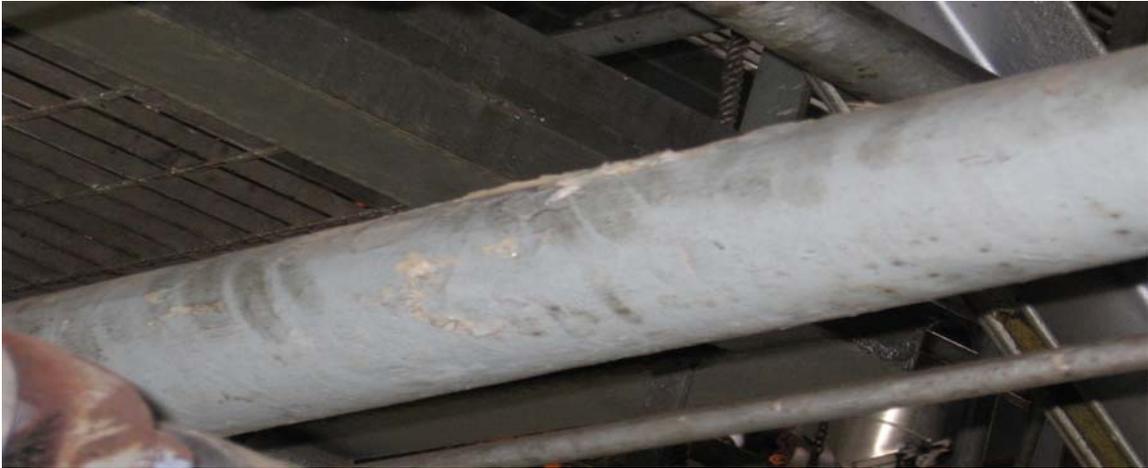
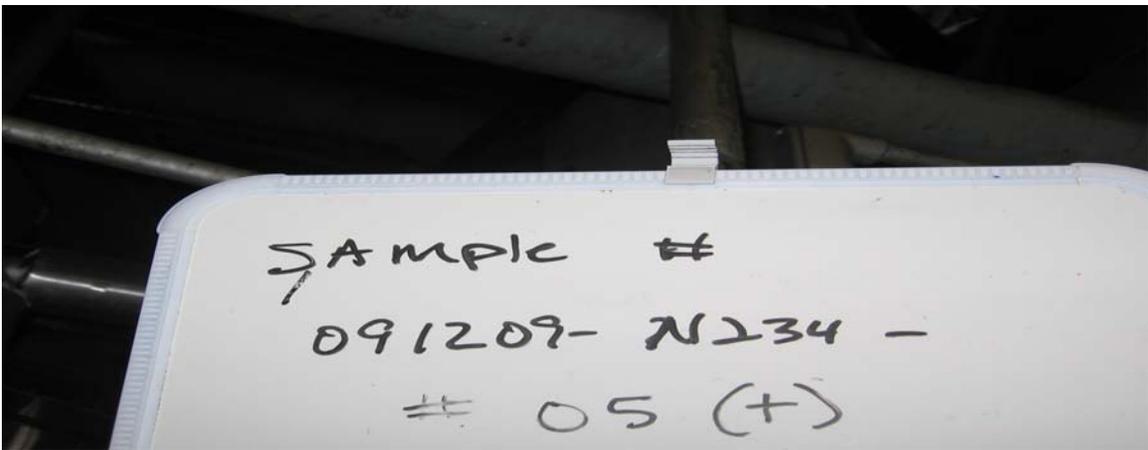
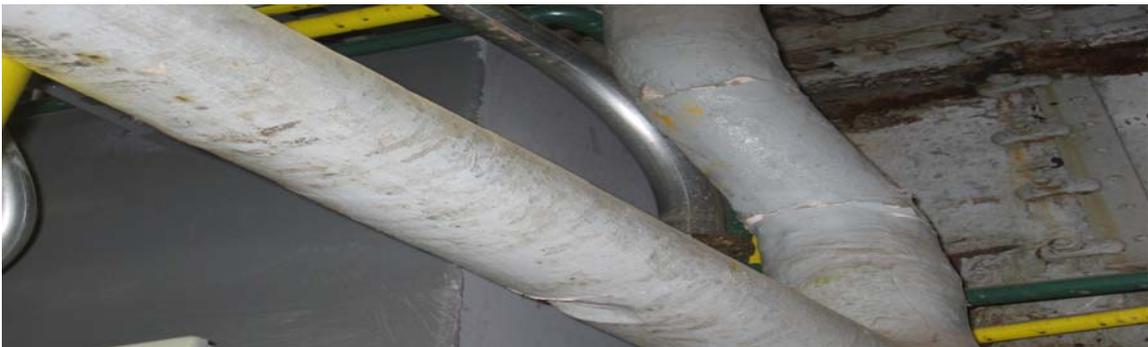
Pictures of sample 091209-N234A-05 Asbestos Containing Insulation of Horizontal Pipe running north and south across boiler house about 6" diameter and about 8 feet off the ground. Connects to the boiler and some damage was observed.

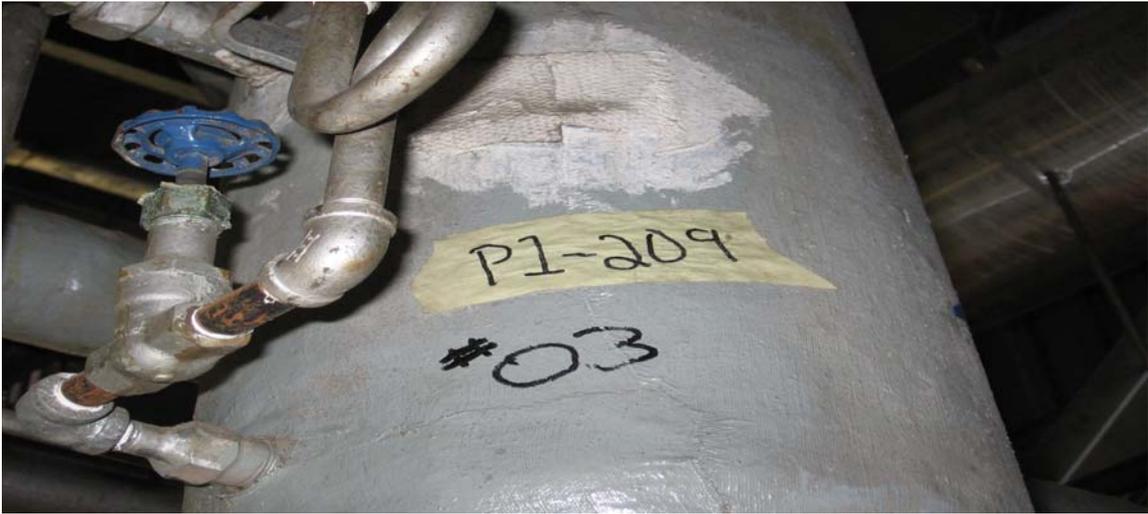
Sample Number 091209-N234-03 Asbestos Containing Insulation
1st Floor. Damaged jacket observed

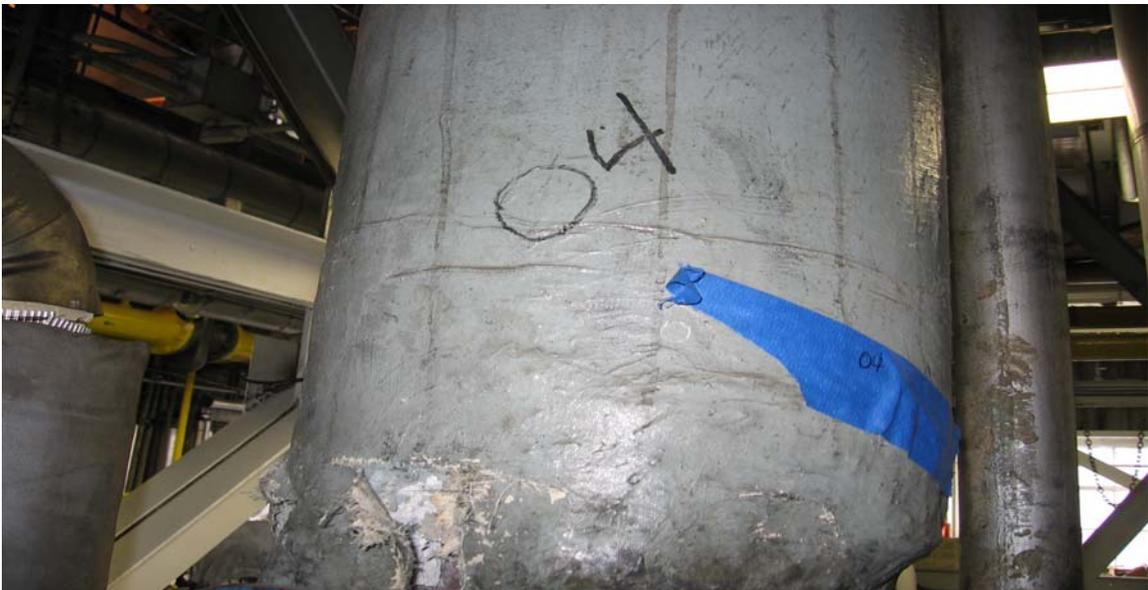
Sample Number 001209-N234-04: Damaged jacket observed

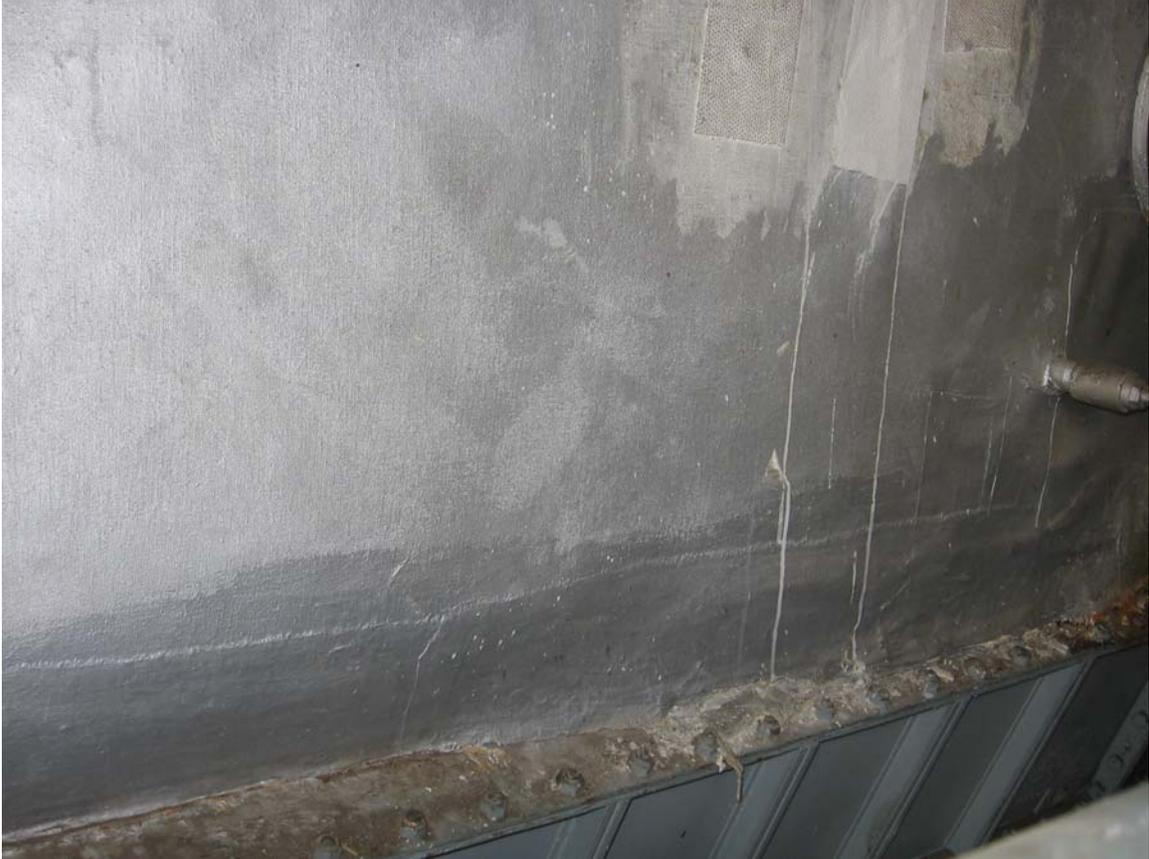
Sample Number N234-02TSI: boiler stack with some damaged jacket observed.
