DHC-6 (Twin Otter)
SERVICE BULLETIN 6/523

Flight Controls – Special Inspection of Control Cables for Wear and Corrosion (and Rectification)

ATA SYSTEM: 2700

NUMBER: 6/523

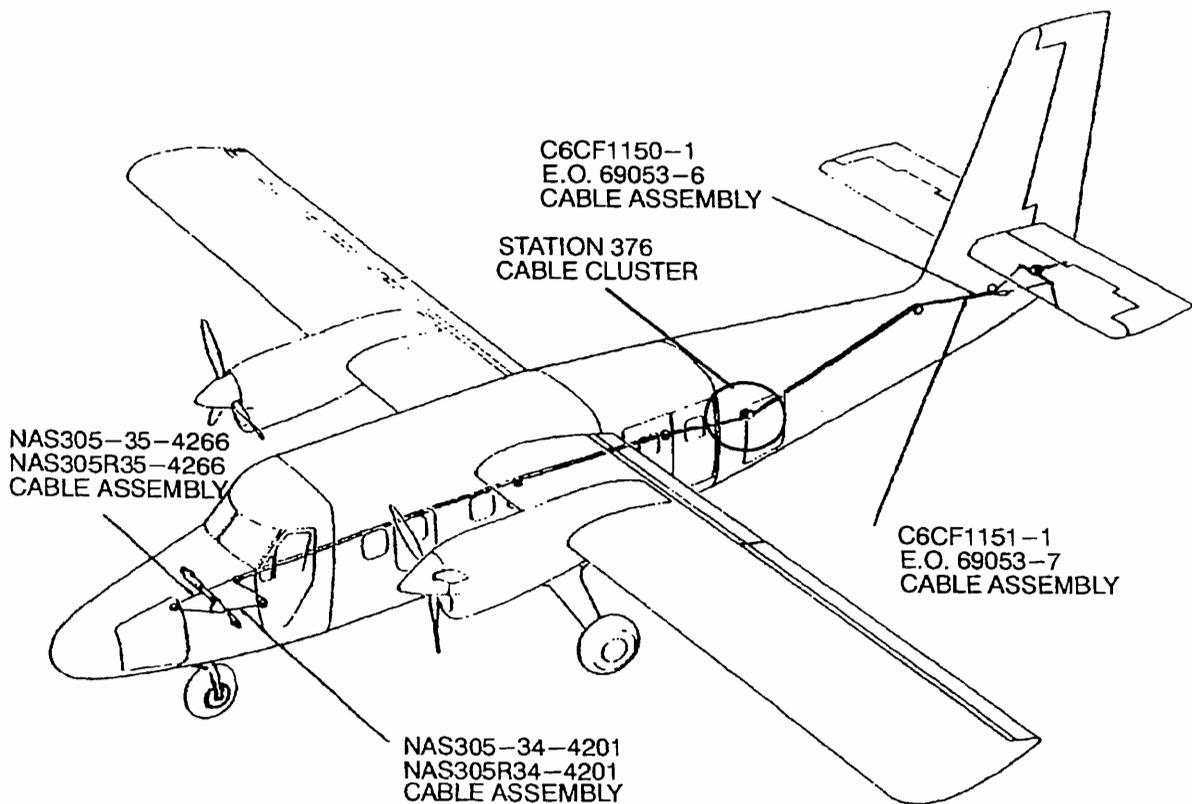
**Cable Assembly Locations – Rudder Control System (100/200/300 Series)
Figure 1**

Operators have found corrosion forming on control cables located in some areas of the aircraft (in particular, elevator/rudder cables under the rear baggage compartment floor at station 376). Excessive corrosion on the cables could result in breakage of the cables and a loss of flight control. This service bulletin contains a cable inspection procedure which includes application of a lubricant to non-stainless steel primary flight control cables.

1. Gain access to rudder and elevator cable assemblies in baggage compartment and rear fuselage.
2. Do a visual inspection of control cables (non-jacketed) visible at this section of fuselage per **Table 3**, Figures 1 and 2, and **Cable Inspection Procedure**. Observe carefully areas where cables pass over pulleys, quadrants, drums, or through fairleads. Place special emphasis on elevator and rudder cable inspection near cable cluster at Station 376 (refer to Figures 1 or 2).

3. Replace cables not acceptable to criteria in **Cable Inspection Procedure**. Make sure the new cable part numbers are identical to the discarded cable part numbers per **Table 3**.

4. Lubricate new or existing non-jacketed cables only as detailed in **Cable Inspection Procedure**. Do not lubricate stainless steel cables.
5. Install and rig replaced cable assemblies per Maintenance Manual PSM 1-6-2 or 1-63-2 Chapter 27.

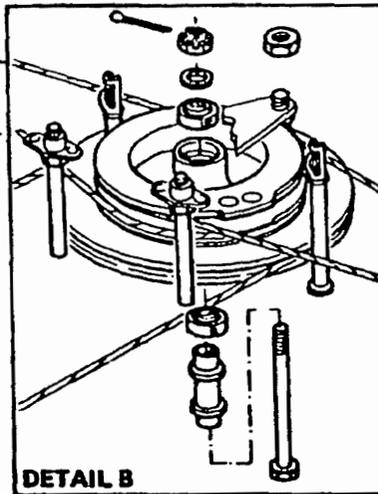
Cable Assembly Locations - Aileron Control System (100/200/300 Series)
Figure 3

1. Release, attach string and pull aileron cables out of wing box.
2. Do a visual inspection of control cables per **Table 4**, Figure 3, and **Cable Inspection Procedure**. Observe carefully areas where cables pass over pulleys, quadrants, drums, or through fairleads.
3. Lubricate new or existing non-jacketed cables as detailed in **Cable Inspection Procedure**. Do not lubricate stainless steel cables.
4. Replace cables not acceptable to criteria in **Cable Inspection Procedure**. Make sure the new cable part numbers are identical to the discarded cable part numbers per **Table 4**.
5. Install and rig cable assemblies per Maintenance Manual PSM 1-6-2 or 1-63-2 Chapter 27.
6. Install access panels.
