Date:	2/11/13	Time:	12:45 PM	Weather:	41F Windy
Outfall System:	06	Structure ID:	4100	Shape:	Round
Structure Type:	SCB	General Appraisal:	8	Diameter:	2.2'
Casting labeled "STORM":	NO	Invert:	10.5'	Water Depth:	1"
Housing Material:	CONC				
Location:	East side of Building 57, in grass.

**Storm Sewer Inspection Reports**

**BARR & PREVOST**

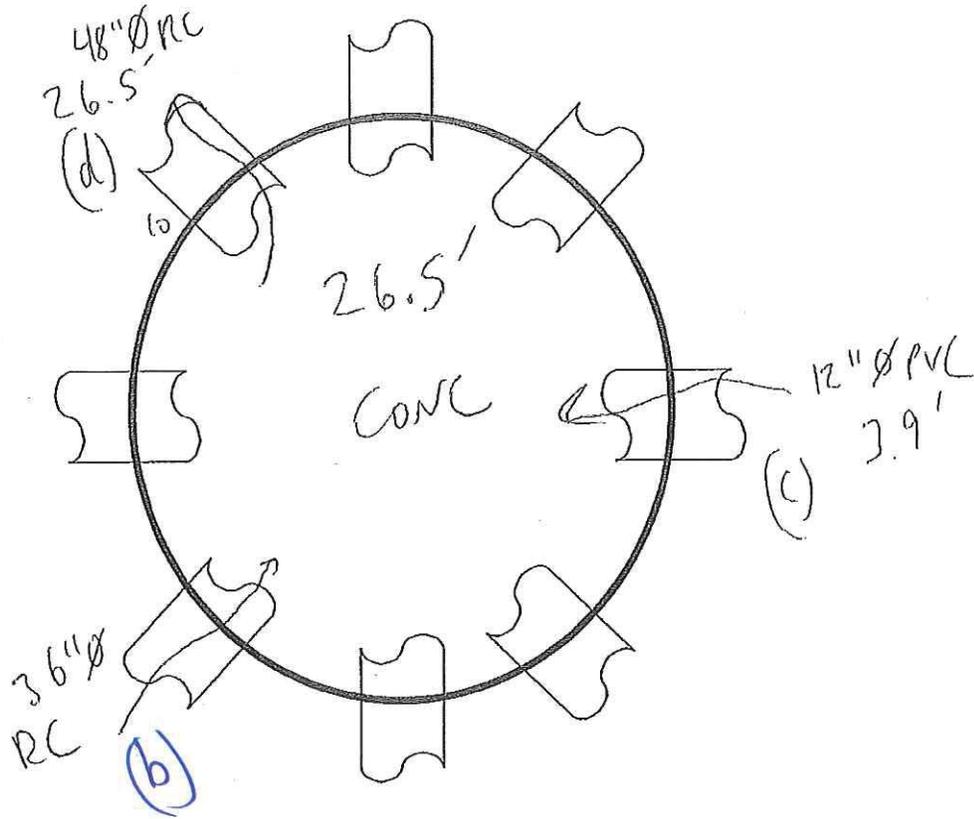
SMH 06-2100

The 12" PVC pipe appears to be misaligned or cracked, please refer to picture 2 in the photo reports.

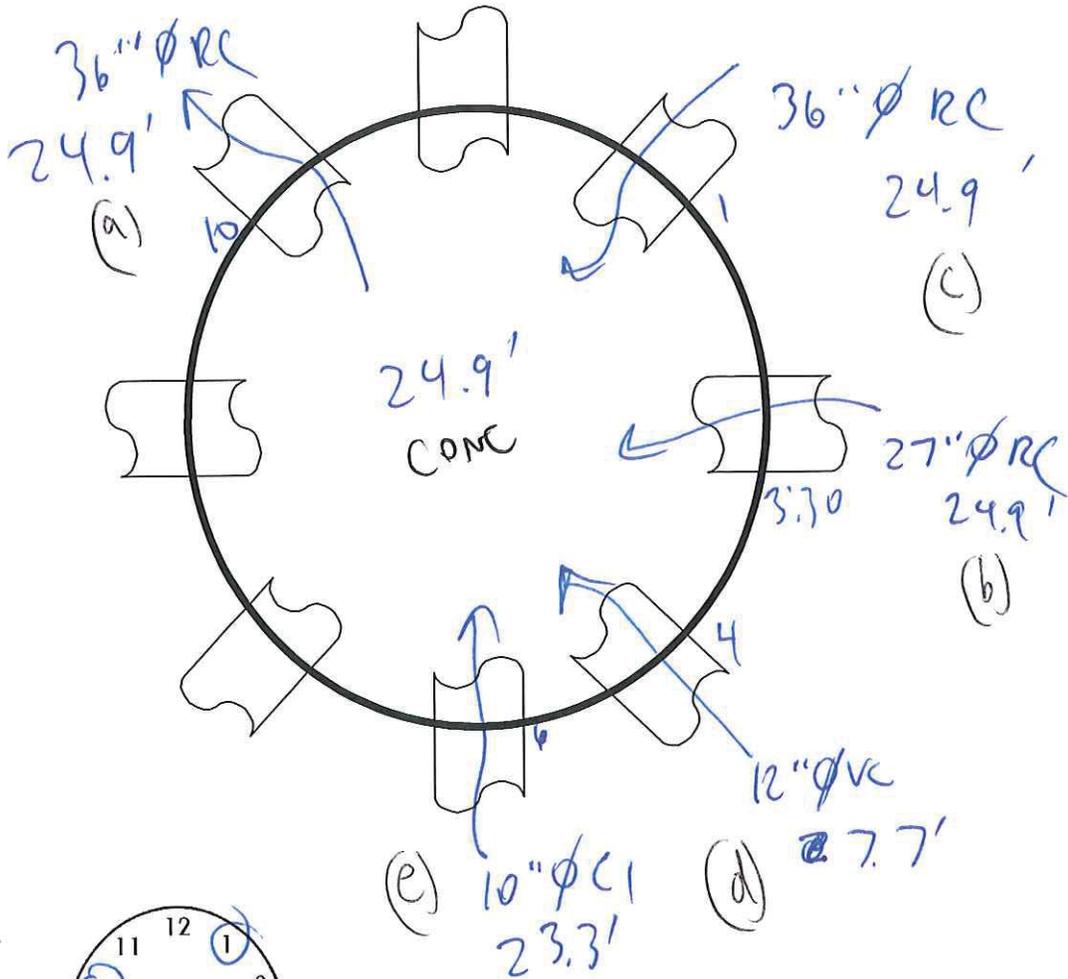
SMH 06-2200

All steps failed. Lid says :”SEWER”

There is a large amount of debris present near along the bottom of the manhole near the entrance of the 27" RC pipe. This debris might be blocking the flow of water through the structure. The amount of debris blocking the flow of water from the pipes is approximately 20%.

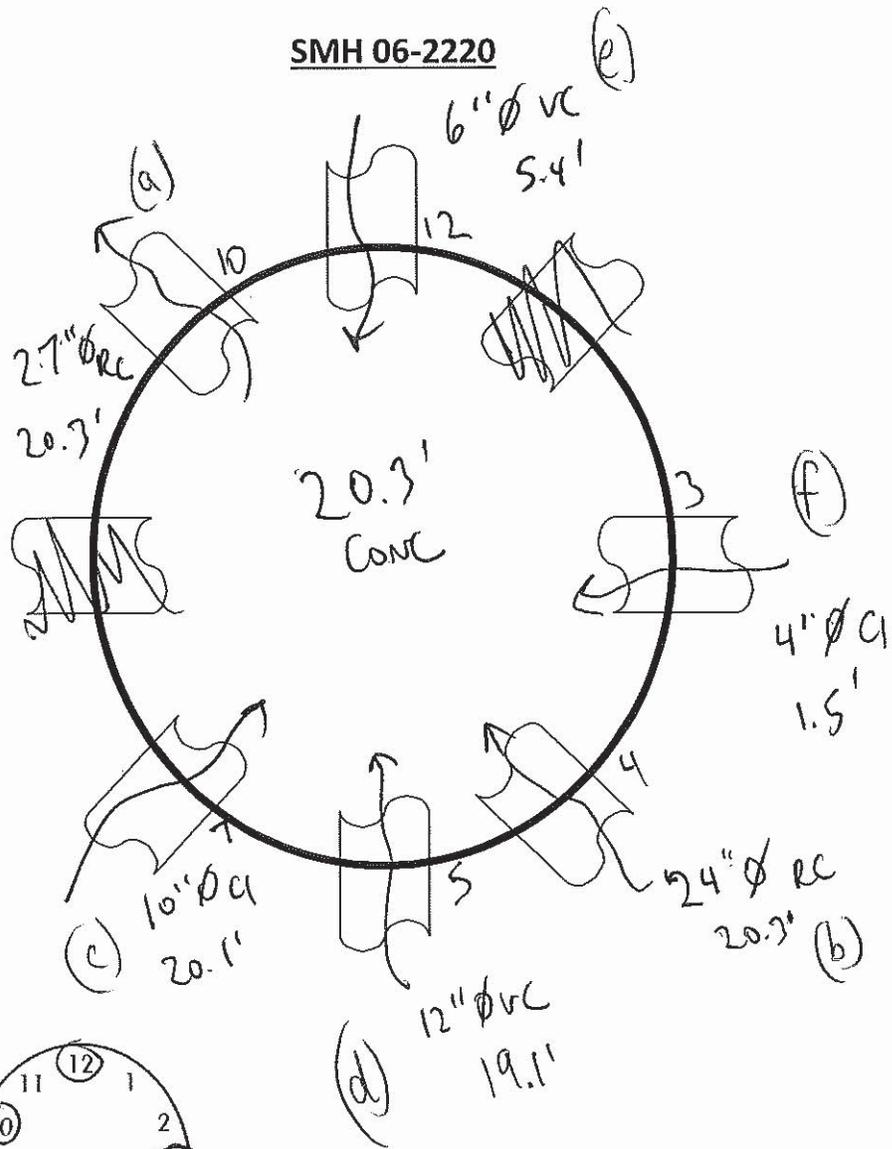
SMH 06-2220

Lid says "SEWER." Alignment off by 2" at 1 and 7 o'clock positions.

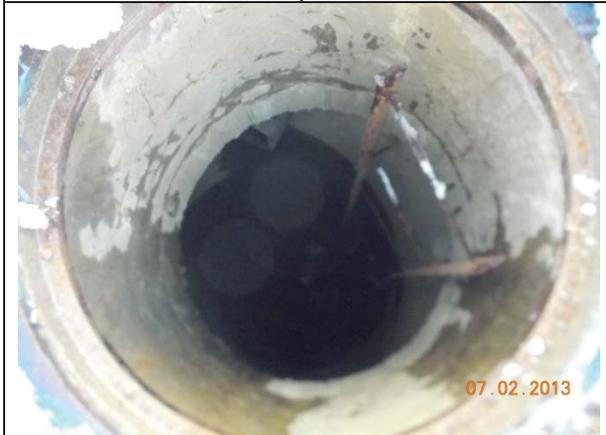
Map cracking on chimney. The map cracking has not appeared to affect the pipes coming into and out of the structure.

4: Map Cracking

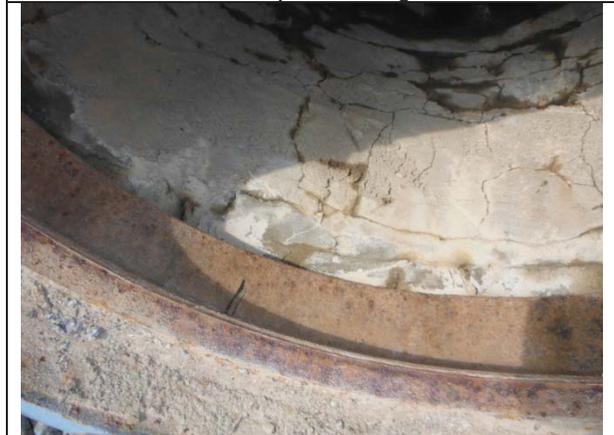
5: Map Cracking

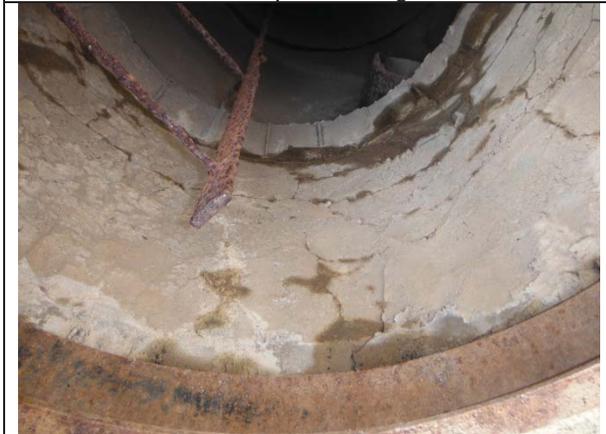
6: Map Cracking

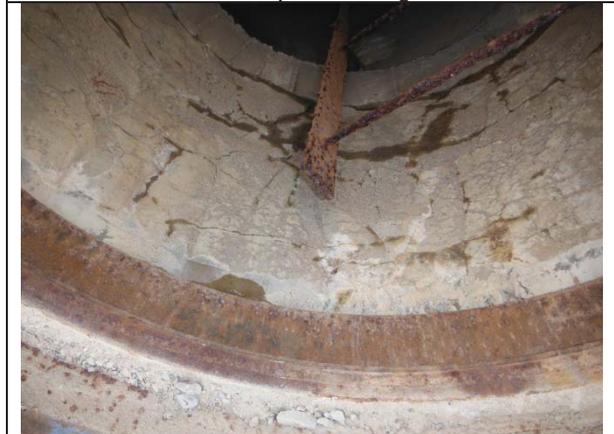
7: Map Cracking

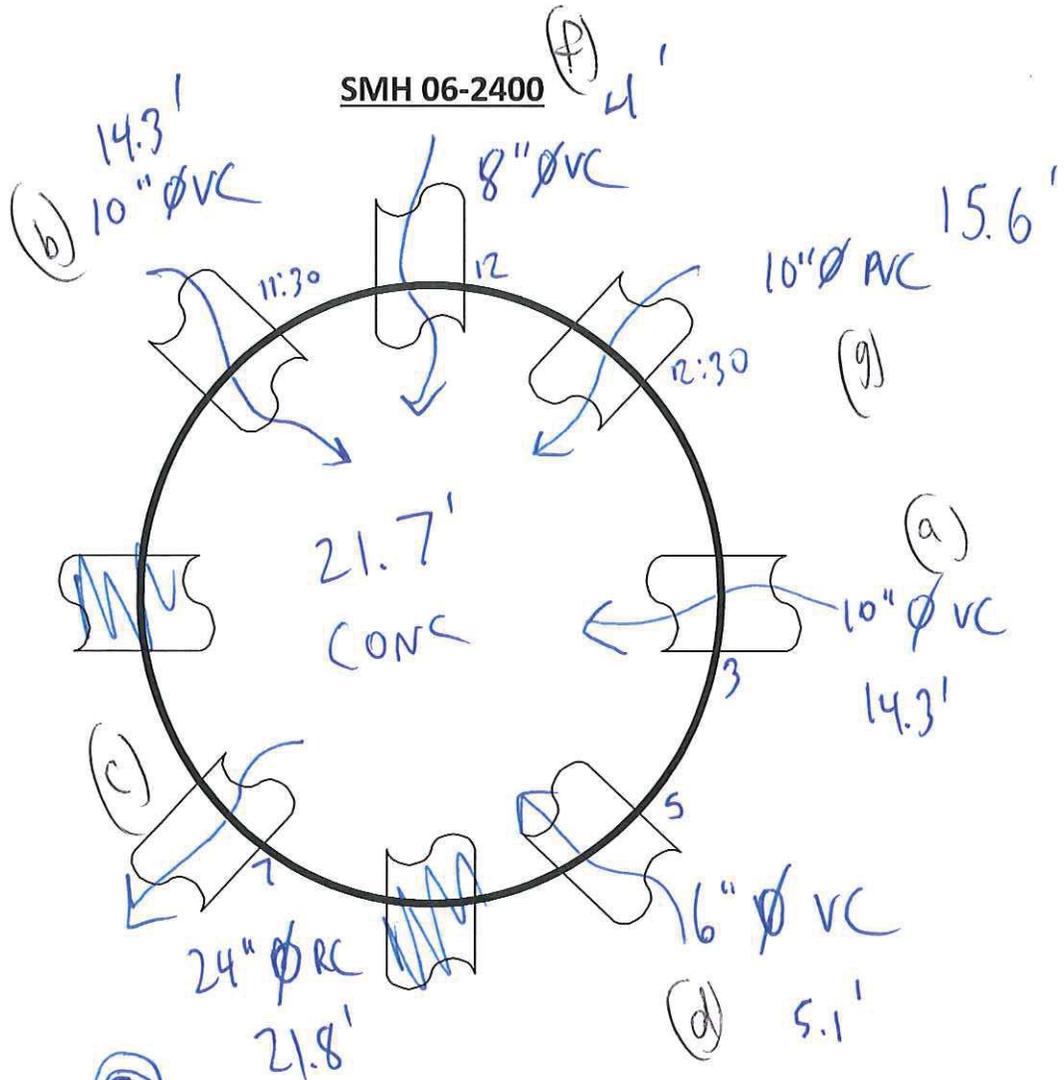
Top step delaminated 10%. At 1 o'clock position, concrete is "crumbled away." 1" high x 6" deep x 1'-0" around circumference.

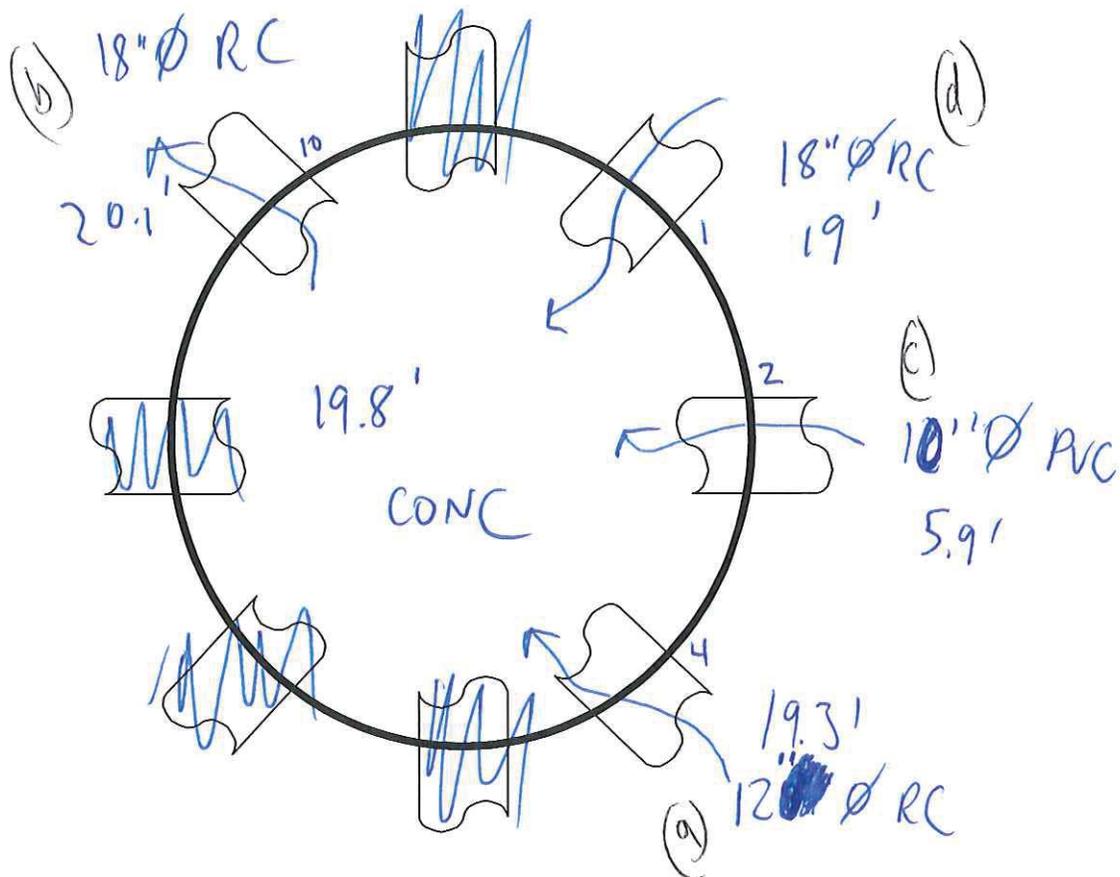
**SMH 06-2600**

There is a lot of sediment present in picture 7 of the photo report. Approximately, 25% of the pipe is filled with sediment and debris. Please refer to the picture report for details.

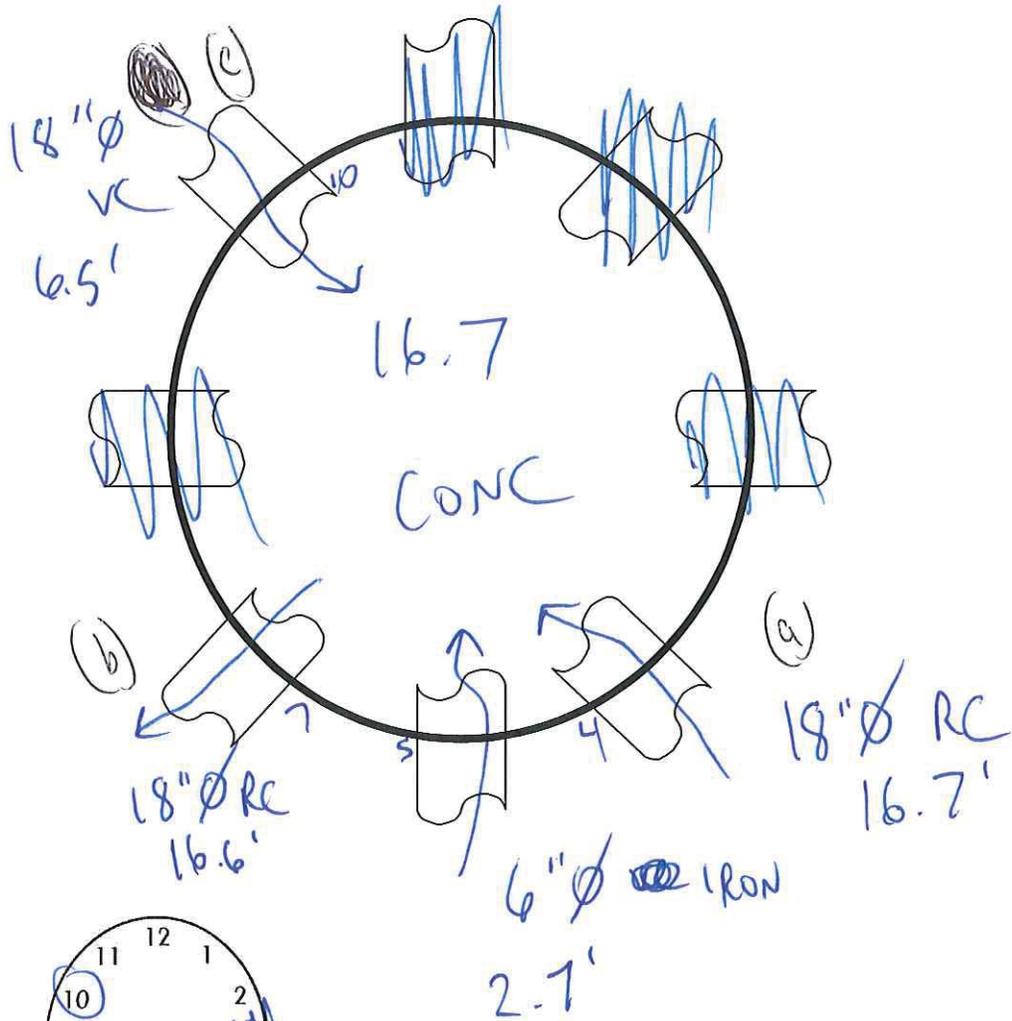
SMH 06-2700

Evidence of vertical separation is present in the 6" iron pipe located 2.7 feet below grade and at the 5 o'clock position.

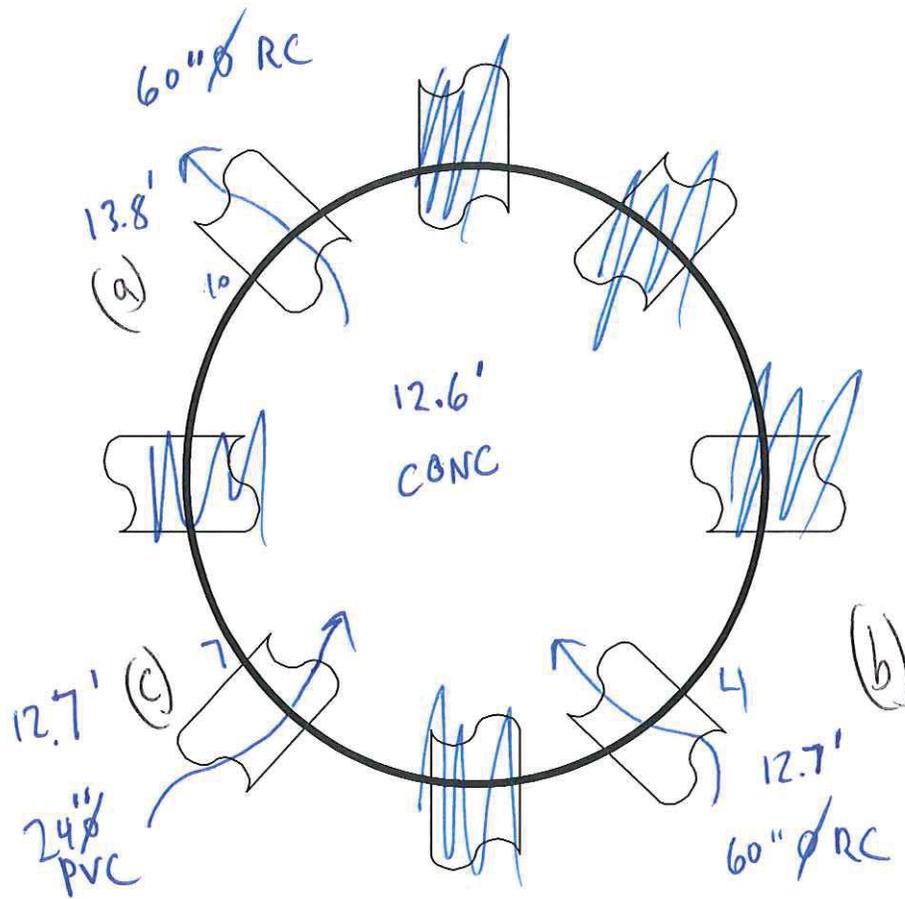
**SMH 08-1230**

Lid is solid (not grate). Casting is off alignment by 2" at 10 and 4 o'clock positions.

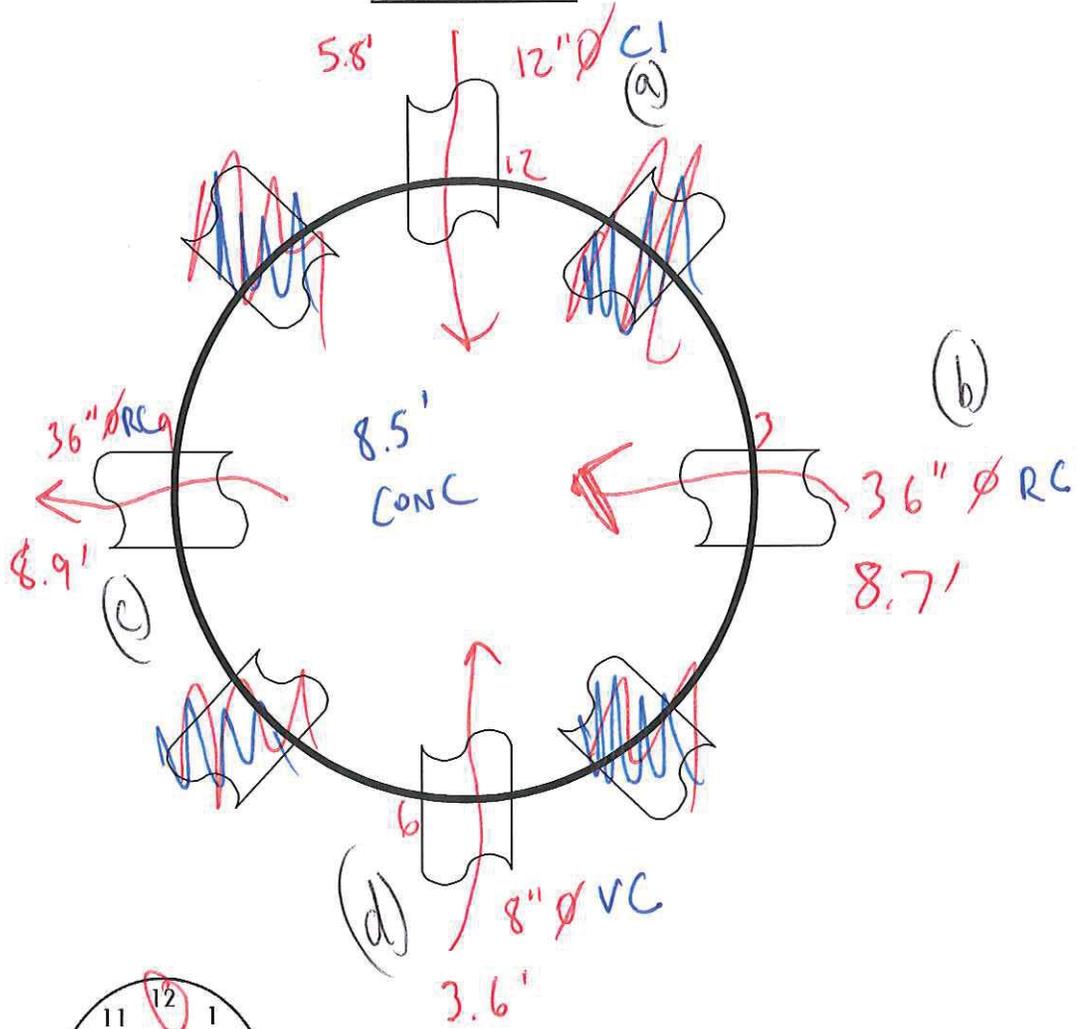
**SMH 08-3000**

Lid is solid, reads "THE MADISON FDRY CO, CLEVELAND O".  
 Steps have failed- 90% section loss.  
 The 8" VC pipe located 3.6 feet down and at 6 O'clock position appears to be 70% blocked with sediment.  
 Inverts b and c are shown as 120" on basemap but were found to be 36" diameter in field.

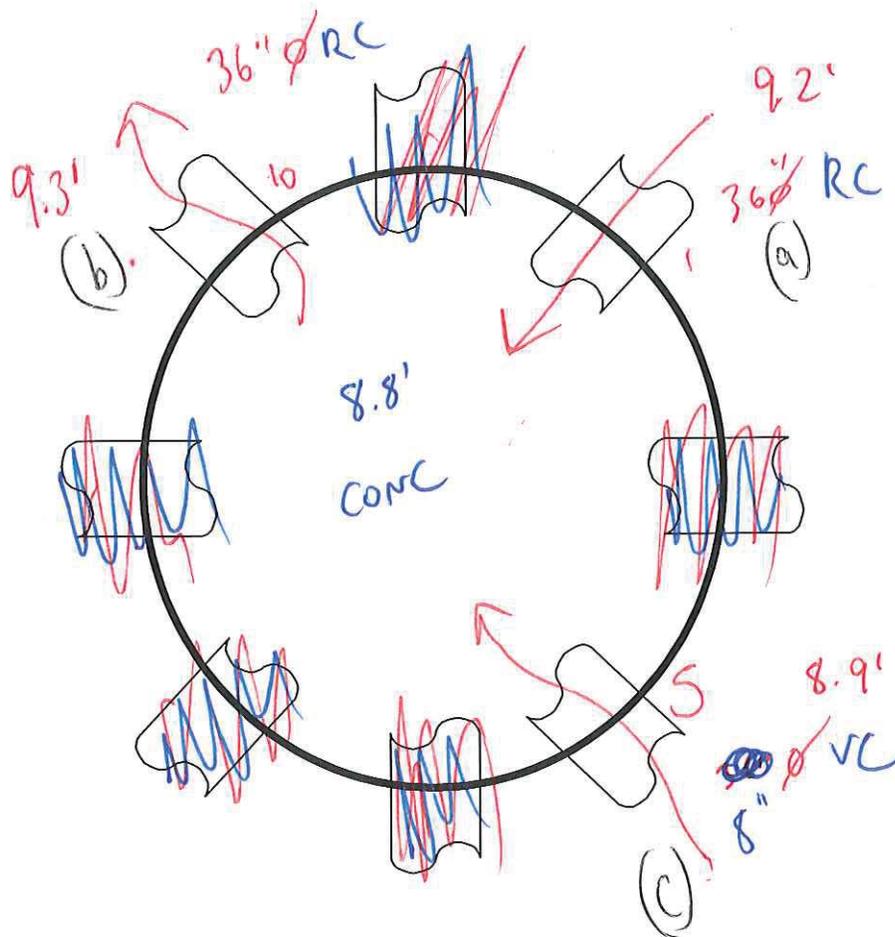
**SMH 08-3100**

Lid is a solid manhole lid. Lid reads "THE MADISON FDRY CO, CLEVELAND O". Steps are rusted and delaminating. Inverts a and b are shown as 120" on basemap but were found to be 36" diameter in field.

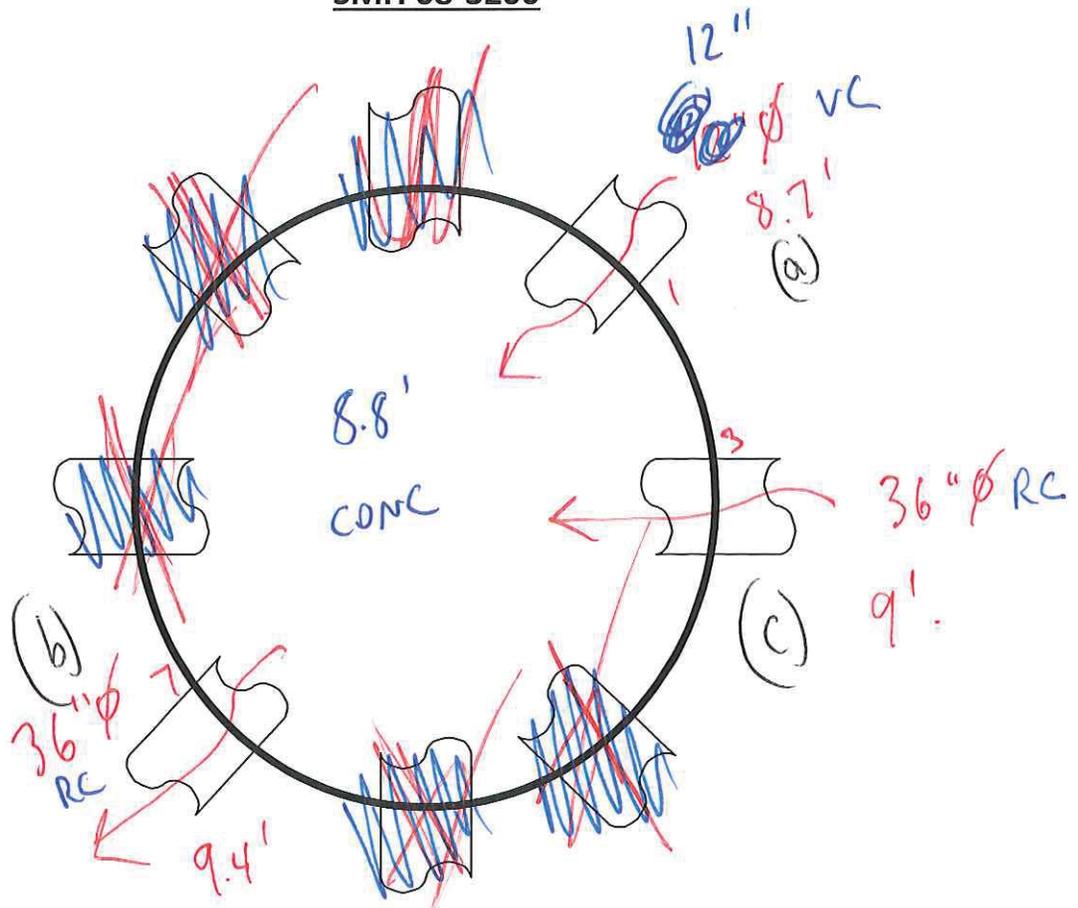
SMH 08-3200

Near wind tunnel networks around BLDG 114  
 Lid is a solid manhole cover.  
 Steps are rusting – metal is delaminating.  
 Invert b is shown as 120" on basemap but was found to be 36" diameter in field.

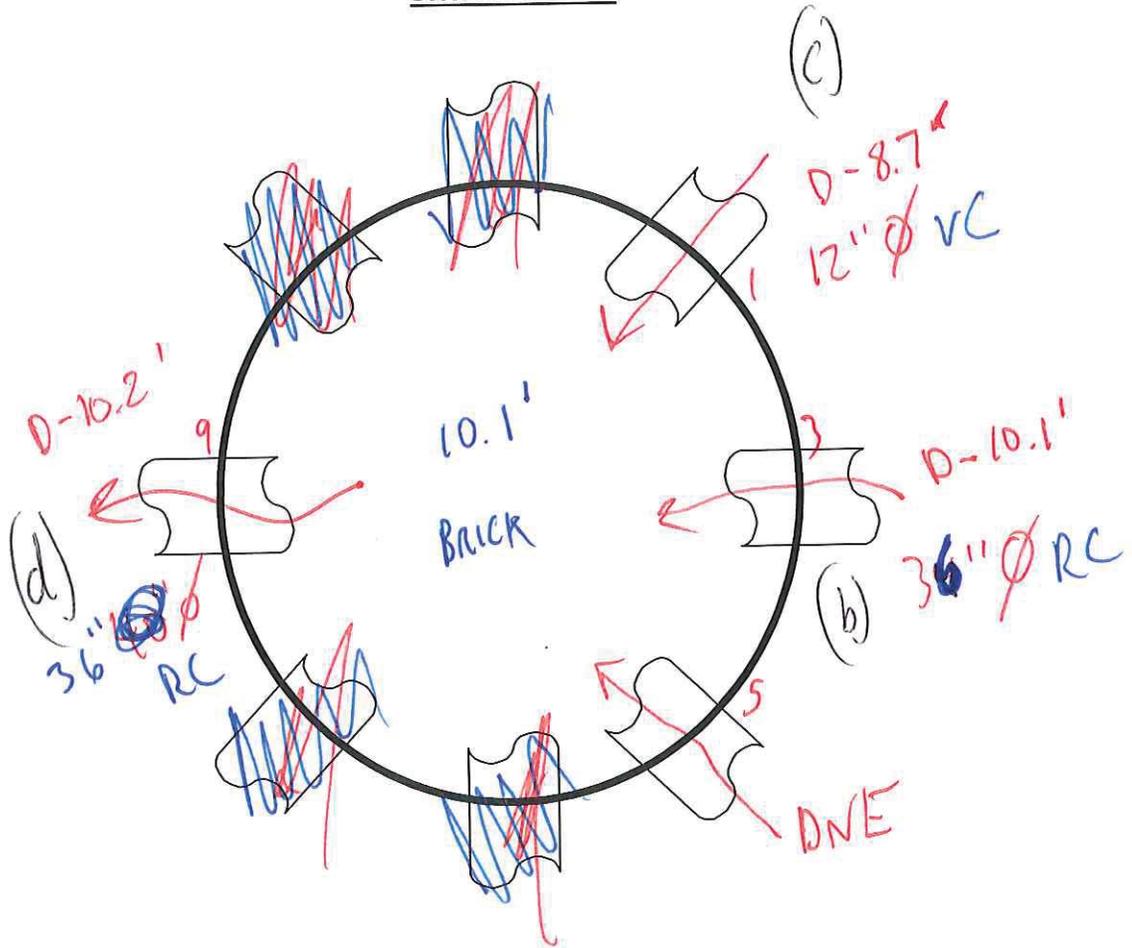
SMH 08-3400

The 34" RC pipe located at an invert of 10.1 feet and at the 3 O'clock position appears to be 90% blocked by sediment.

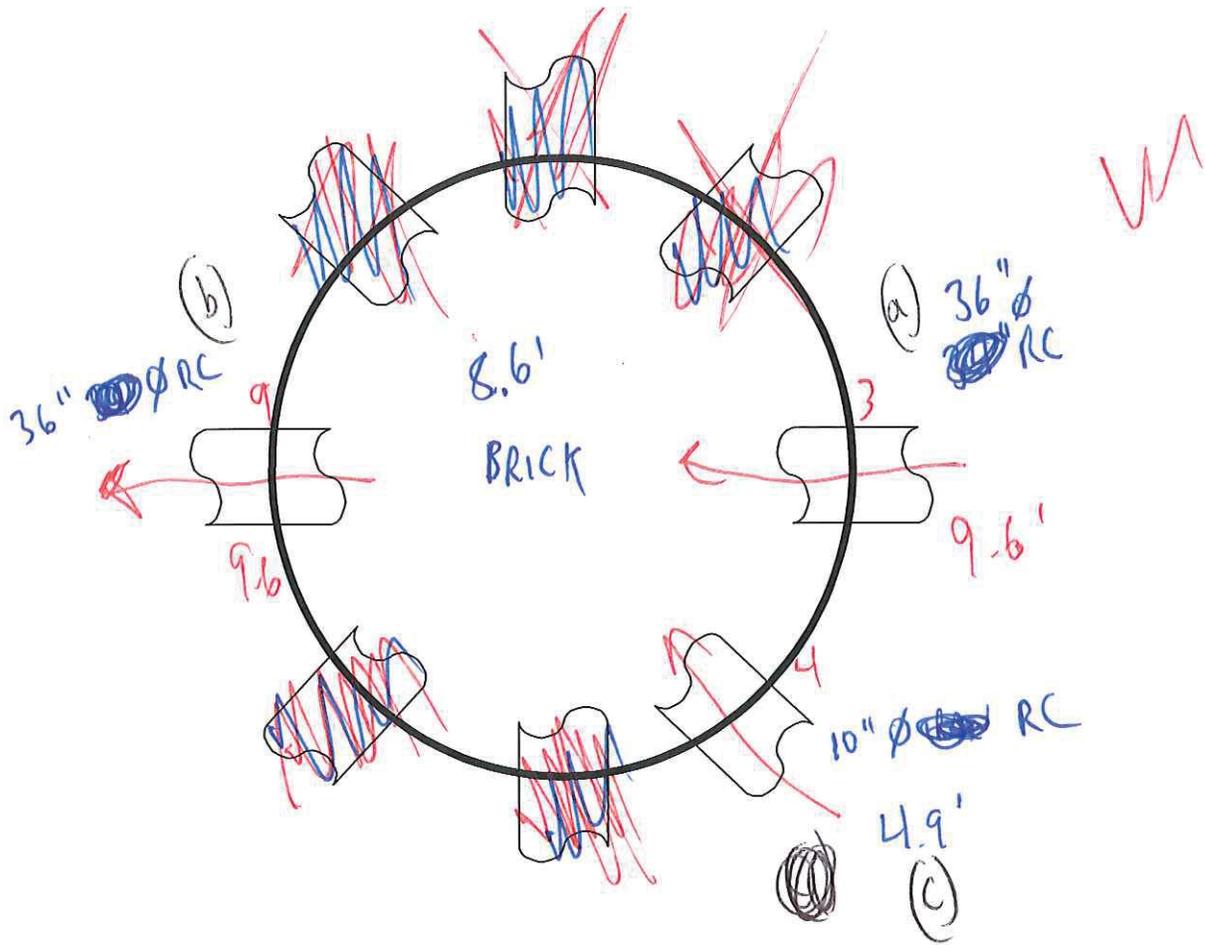
**SMH 08-3500**

Casting is labeled "THE MADISON FDRY CO CLEVELAND O".  
 Grout is delaminated at all joints on highest ring of brick chimney.

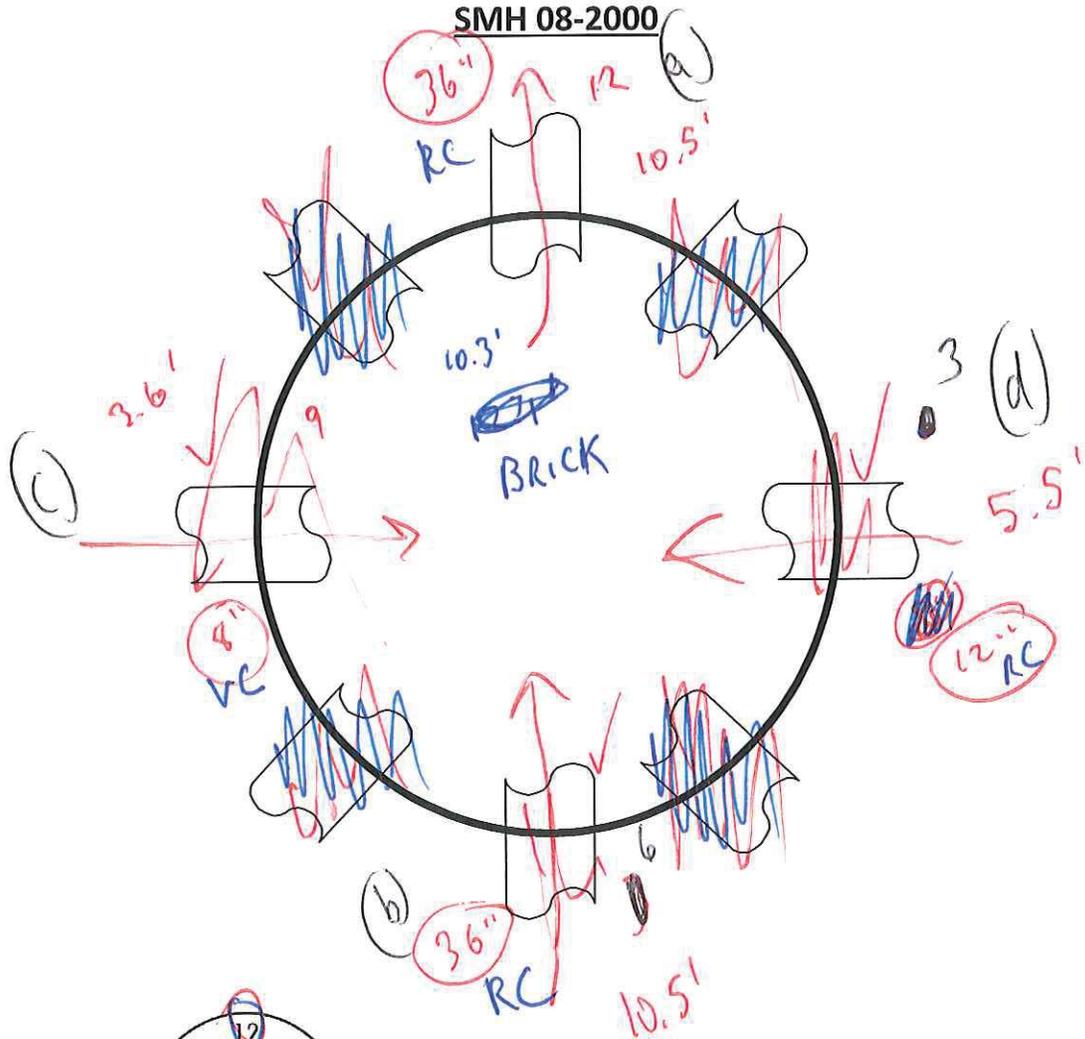
SMH 08-2000

Brick wall is showing section loss on 3 o'clock wall. Approximately 18" X 18" of brick is missing, centered around the 12" pipe. Section loss is approximately 1" deep into the wall.

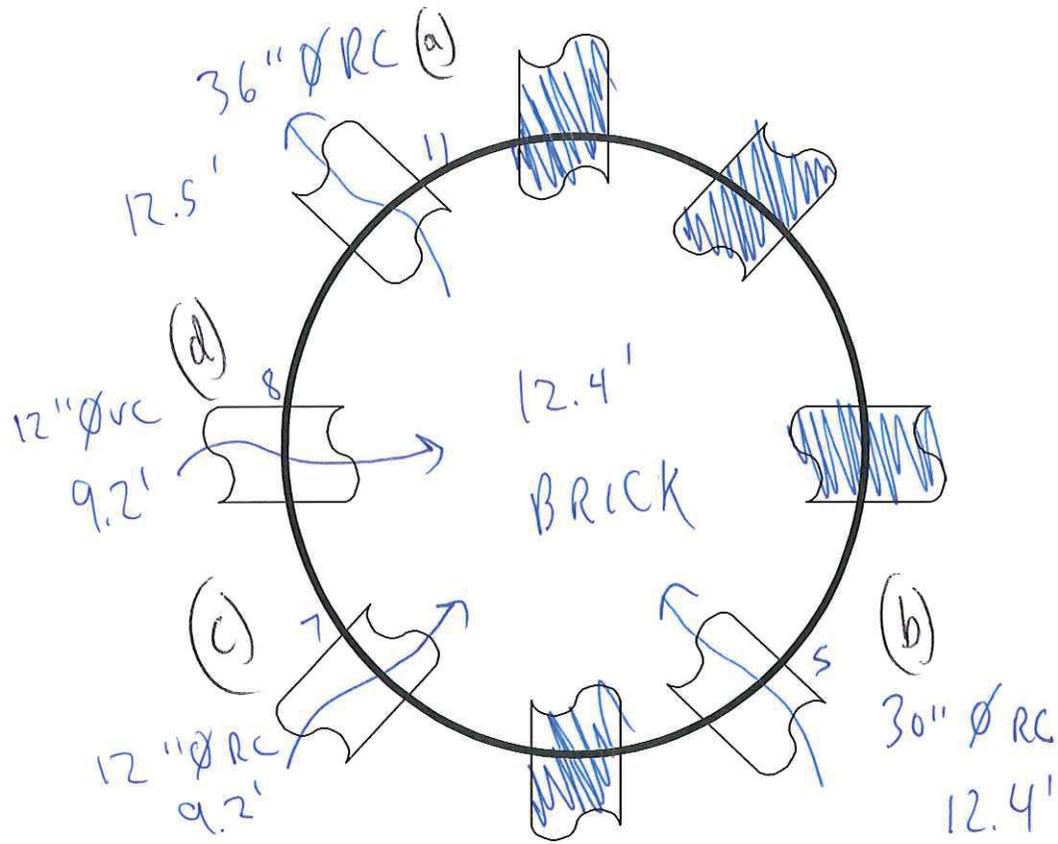
SMH 08-2100

Steps: top 3 delamination, bottom 3 90% section loss  
 4" below grade. Was buried, found with metal detector and dug using shovel.  
 Lid says "MADISON FDRY CO, CLEVELAND, O"

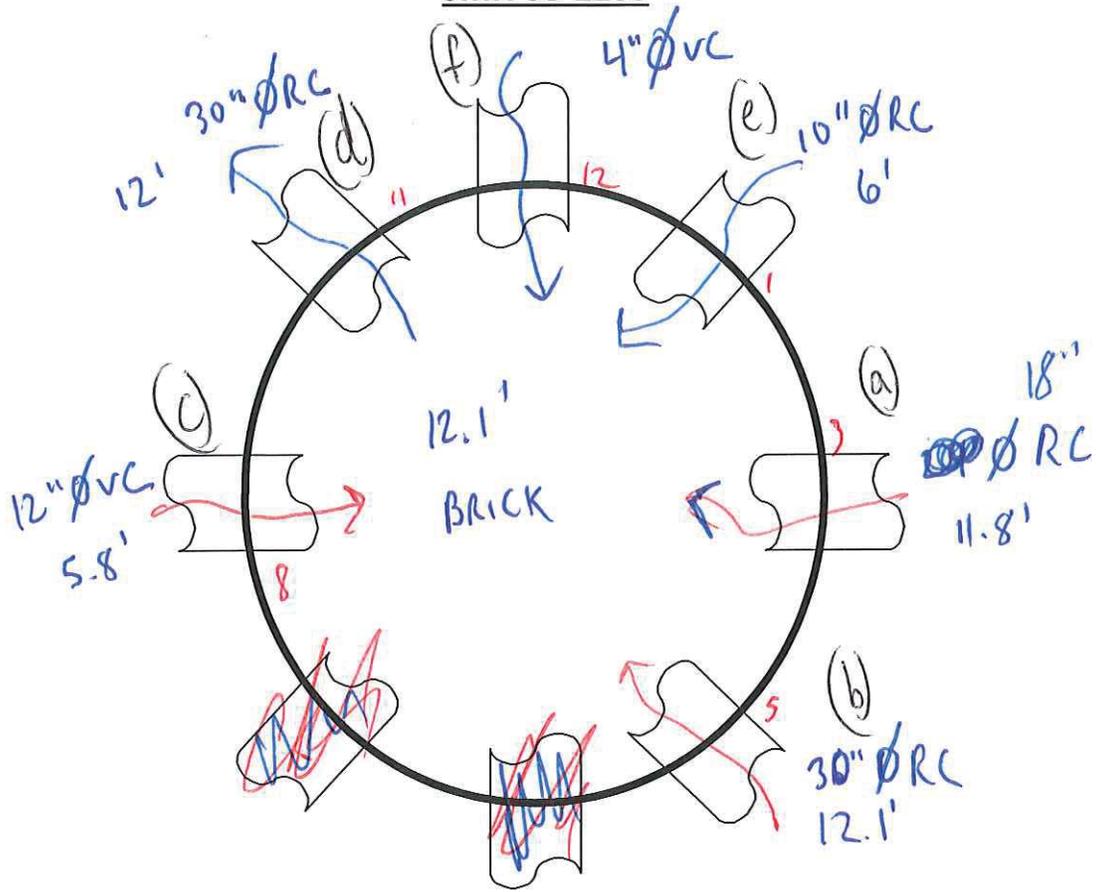
**SMH 08-2200**

No major defects in housing.  
 Casting is 2" off alignment at 12 o'clock and 6 o'clock positions.  
 Casting is a flat grate.

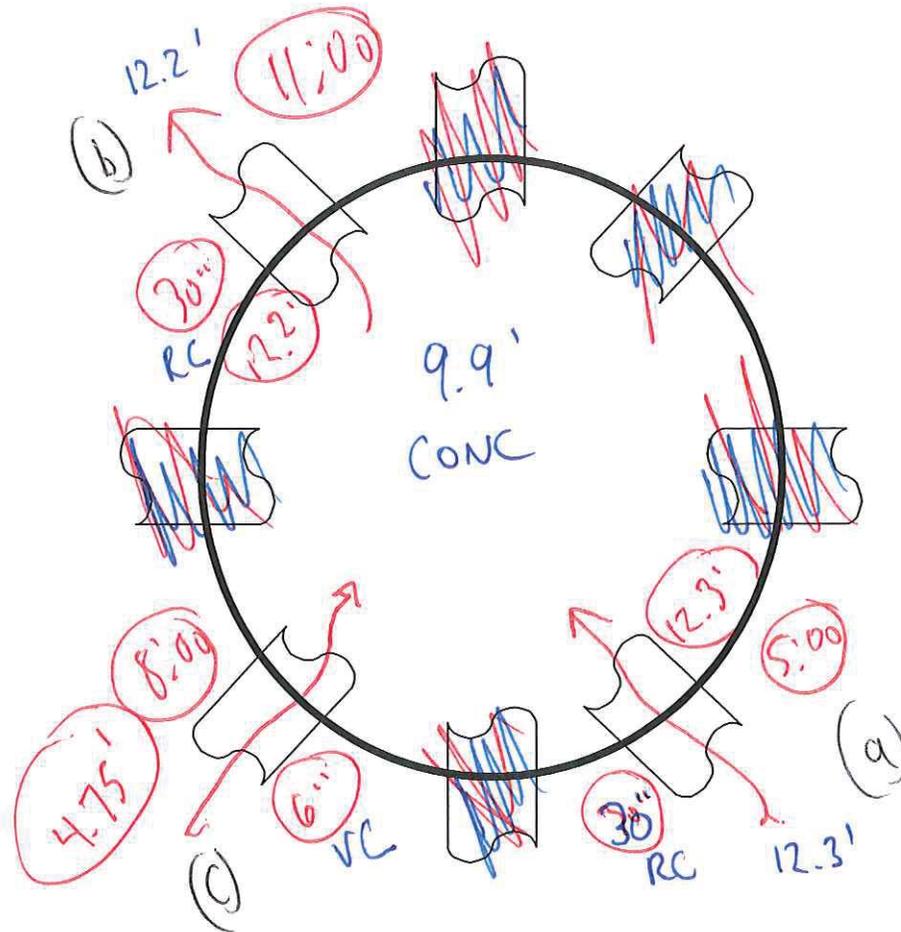
**SMH 08-4000**

Manhole lid reads: "THE MADISON FDRY CO" "CLEVELAND O"  
 Vertical separation in 6" diameter VC  
 Casting is a flat grate.

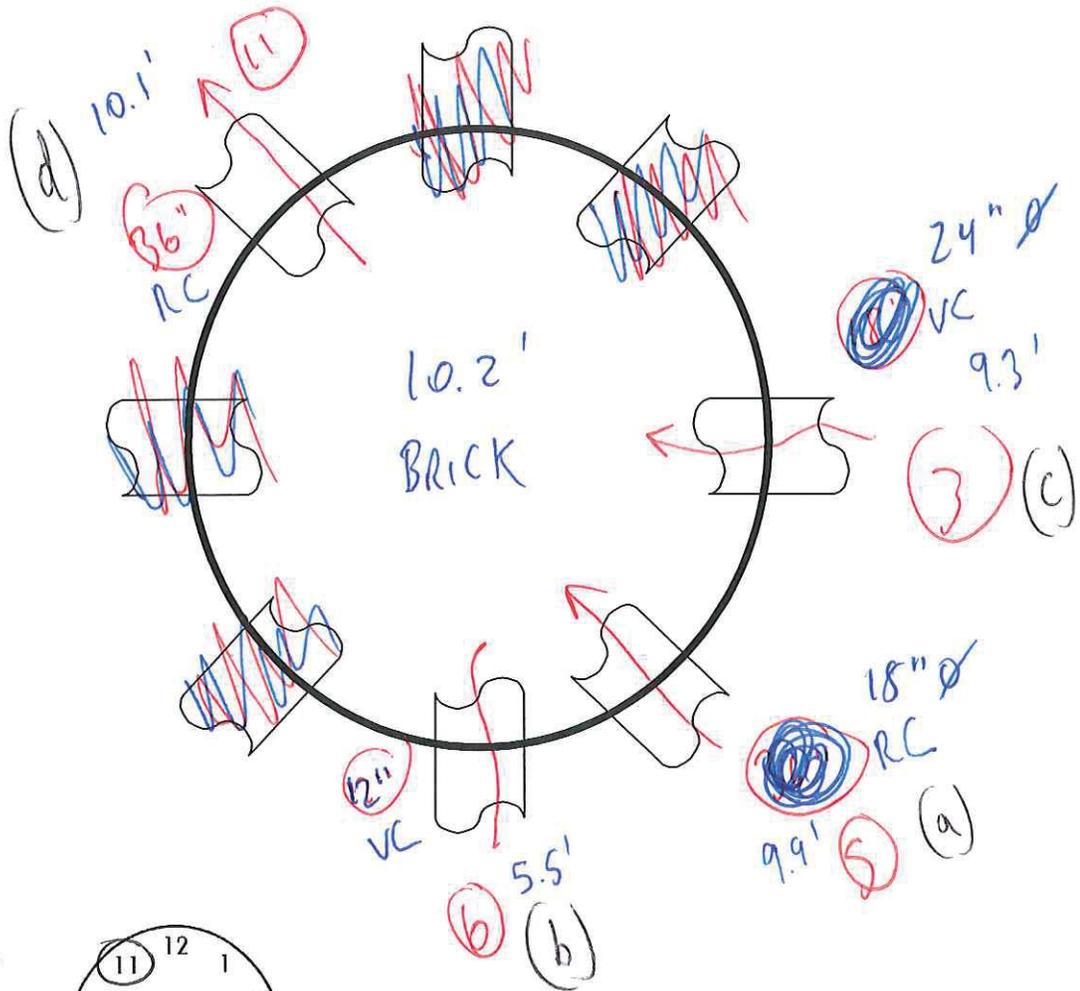
**SMH 08-4300**

Housing – no major defects, 8

Casting – no major defects, 8. Casting seems to be too small for manhole. Casting is flush at 10:00 position, but 4" off alignment at 4:00 position. Casting is a flat grate.

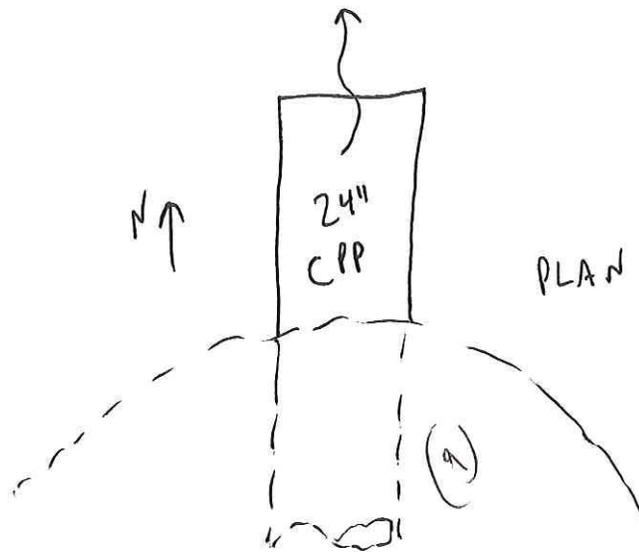
HW 25-0000

No headwall, pipe is direct buried.  
 This outfall will be removed and replaced.

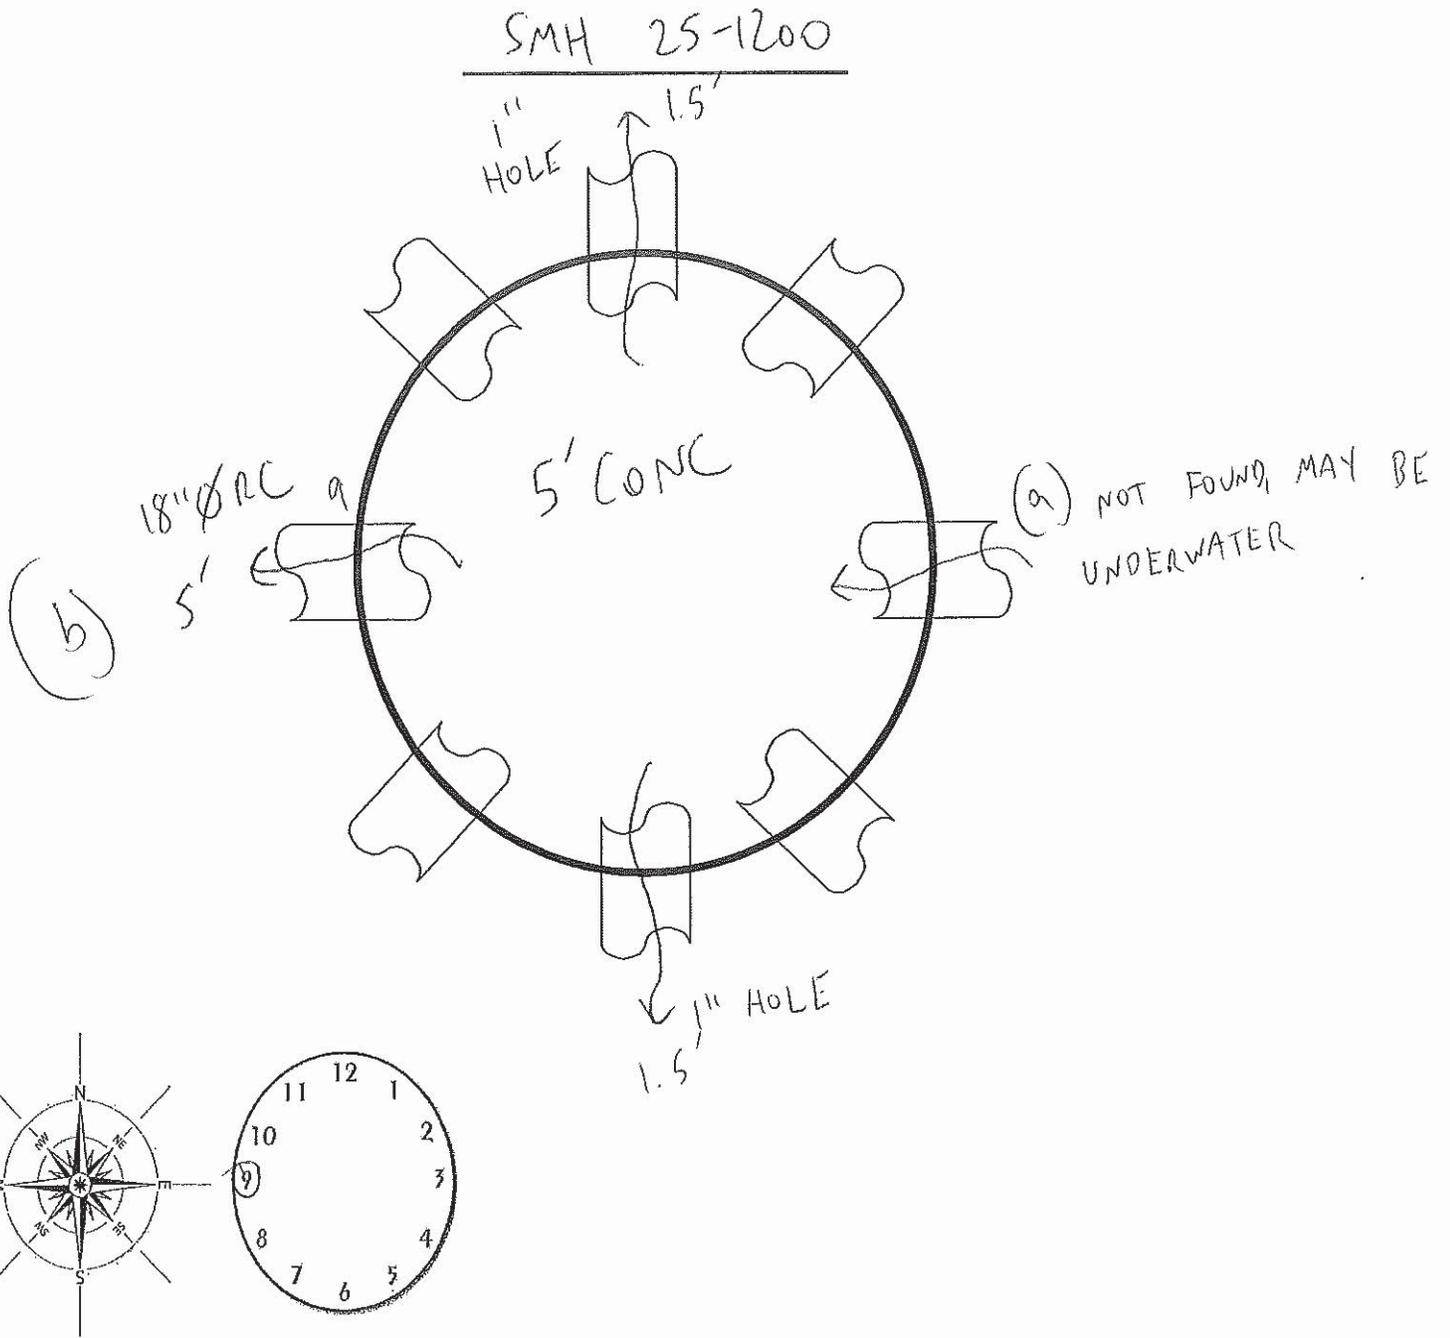
Invert was measured as 5.0'. Manhole protrudes 2.5' above ground. Water is leaking out of structure 1.0' feet above ground through holes drilled through the sides of the manhole. This manhole possibly was plugged with concrete because according to the basemap this structure has a 15 foot invert. See pictures 5 through 10.

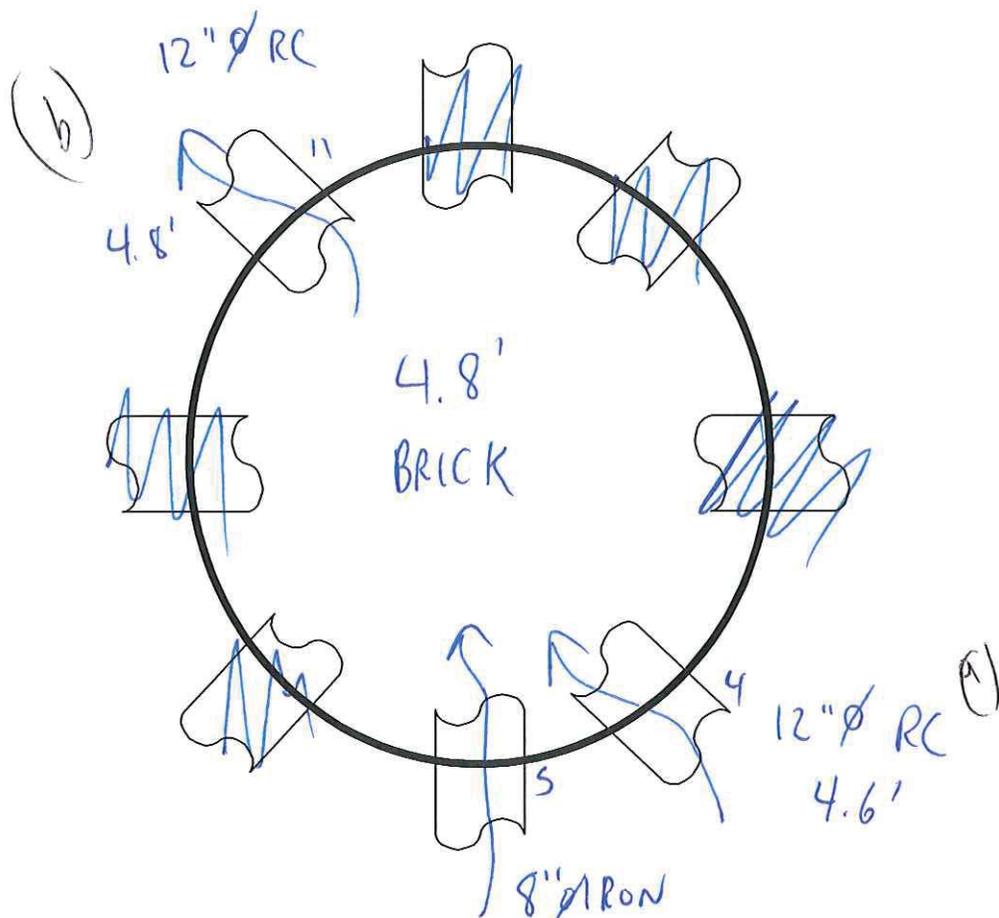
**SCB 25-1220**

Lid has 10% section loss – see field sketch. Lid has a pattern, could not detect any text.

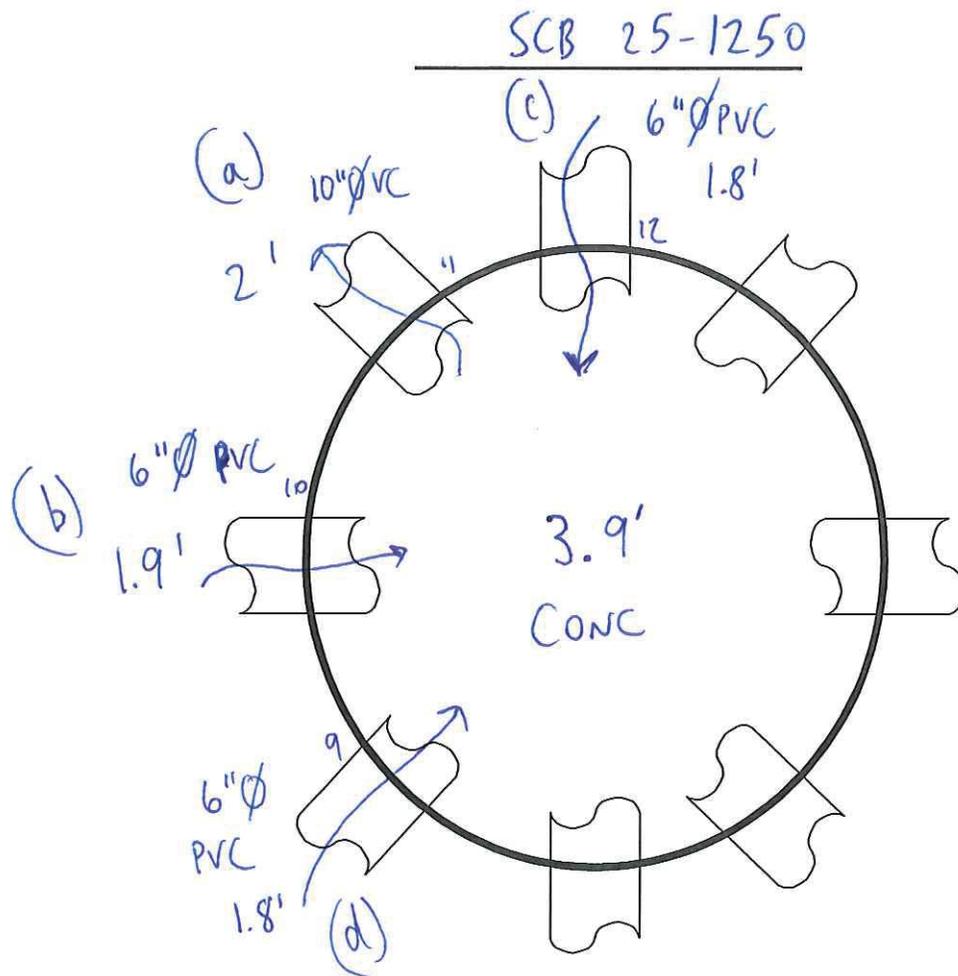
Water is 1.8' deep, therefore cannot see bottom. Sediment on bottom of unknown depth. Casting is 3" off alignment at 1 and 7 o'clock positions. Lid is a grate and has no text.
