Date:	2/11/13	Time:	12:45 PM	Weather:	41F Windy
Outfall System:	06	Structure ID:	4100	Shape:	Round
Structure Type:	SCB	General Appraisal:	8	Diameter:	2.2'
Casting labeled "STORM":	NO	Invert:	10.5'	Water Depth:	1"
Housing Material:	CONC				
Location:	East side of Building 57, in grass.

**Storm Sewer Inspection Reports**

**BARR & PREVOST**

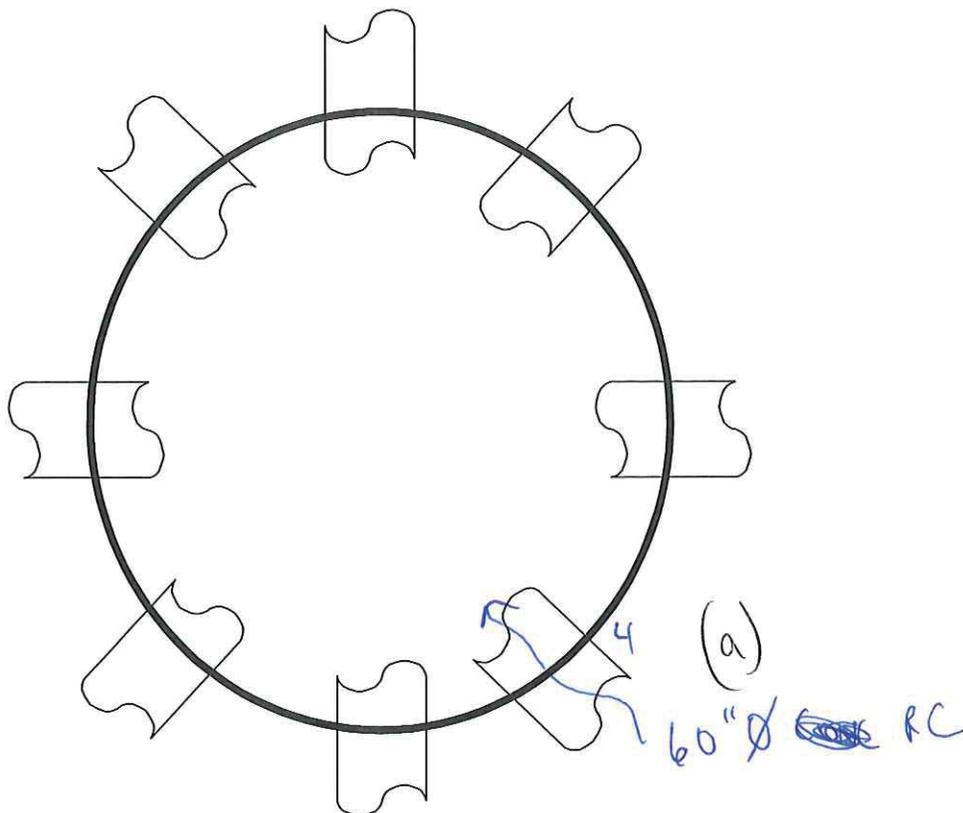
HW 17-0000

Downed branches from trees are surrounding the headwall on this outfall but do not appear to be blocking the flow of storm water out the outfall.
