EXHIBIT B - SOLICITATION NNL14504840E HAZARDOUS  
MATERIALS SURVEY, BUILDINGS 1192 C, D & E

## HAZARDOUS MATERIALS STUDY

Building 1192 Complex  
NASA Langley Research Center  
Hampton, Virginia

EXHIBIT B - SOLICITATION NNL14504840E HAZARDOUS  
MATERIALS SURVEY, BUILDING 1213

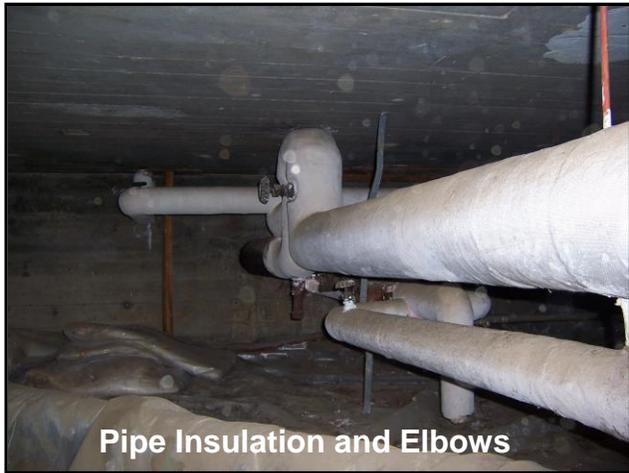
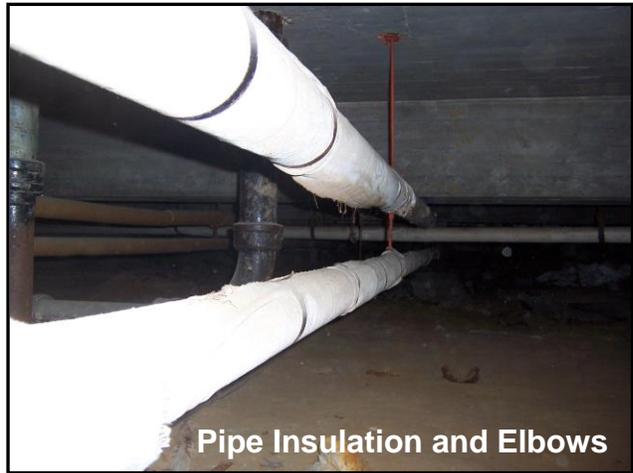
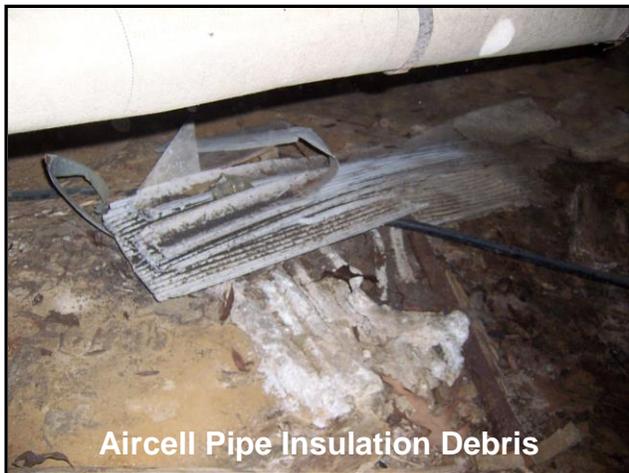
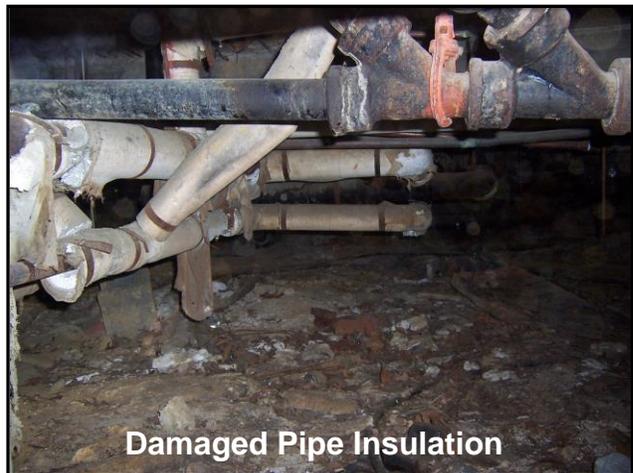
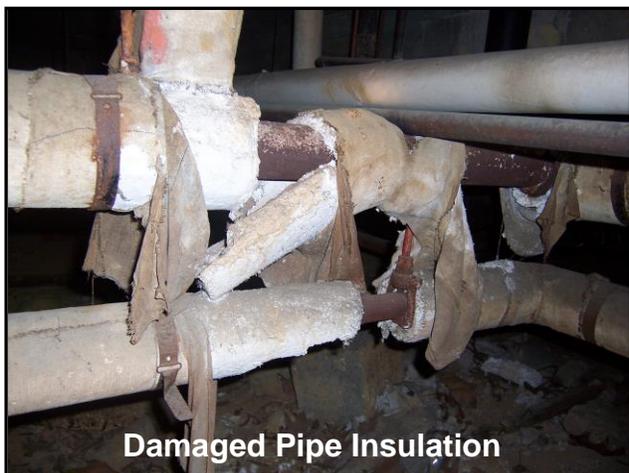
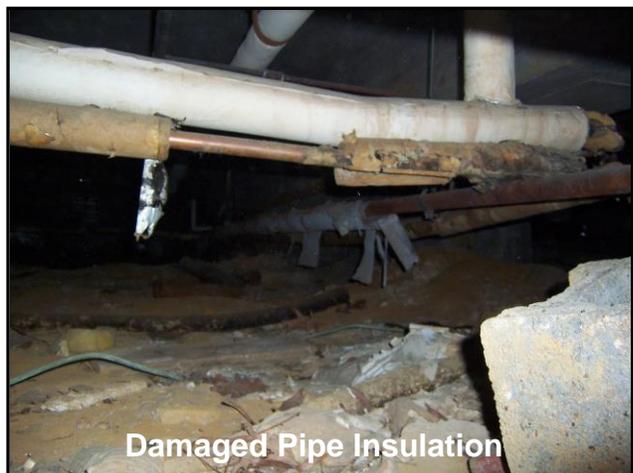
BUILDING 1192 CRAWLSPACE

BUILDING 1192			
Material	Location	Condition	Friability
Transite Panels	Above Front Entry Awning, Above All Windows	Good	Non-Friable
Pipe Insulation	Crawlspace (see photos in Appendix C)	Damaged	Friable
Fire Doors	Top and Bottom of Stairwells	Good	Non-Friable
White Caulking	Exterior Perimeter of Doors	Good	Non-Friable
White Caulking	Exterior Perimeter of Windows	Good	Non-Friable
Joint Compound*	Associated with Drywall on the Dividing Walls of the Original Structure	Good	Non-Friable
9" x 9" Green Floor Tile and Associated Black Mastic	Throughout First Floor Original Structure. Mostly Under Carpet.	Good	Non-Friable
Floor Tile and Associated Black Mastic	Under White 12" x 12" Floor Tile in S1A and S2A.	Good	Non-Friable
Floor Tile and Associated Black Mastic	Under Carpet in Room 210, in Room 200, and on Stair Landing Between Floors in Center of Structure.	Good	Non-Friable

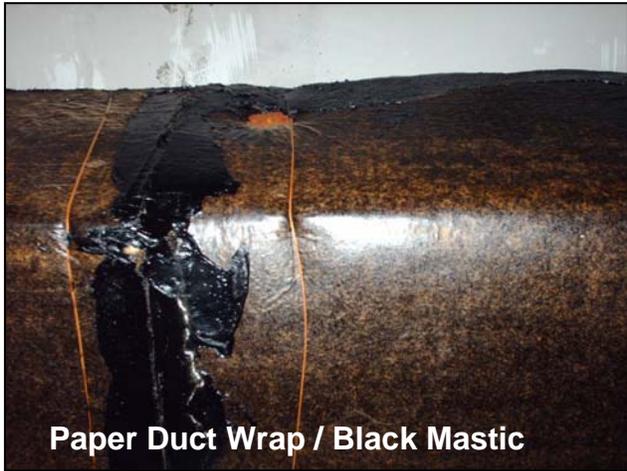
Material	Location	Quantity	Condition	Friability
Paper Duct Wrap with Black Mastic	128, 131		Good	Non-Friable
Black Mastic Under Carpet	144, 131, 139		Good	Non-Friable
9" x 9" Gray Floor Tile & Associated Mastic	133, 133A, 133B, H1D		Good	Non-Friable
9" x 9" Red Floor Tile & Associated Mastic	H1D, 133B		Good	Non-Friable
Transite Wall Panels	H1D, 133, 133A		Good	Non-Friable
9" x 9" Beige Floor Tile & Associated Mastic	133B		Good	Non-Friable
9" x 9" Brown Floor Tile & Associated Mastic	129A, H1A, 142, 144B		Good	Non-Friable
18" x 18" Black Floor Border Tile & Associated Mastic	144A, 144B		Good	Non-Friable
Mastic Associated with 6" Dark Brown Cove Base Molding	142A, 143, 144A, 142, 144, H1A, 144B		Good	Non-Friable
Preformed Pipe Insulation	126, 127 Crawlspace Under Restrooms		Damaged Damaged	Friable Friable
Mudded Pipe Fitting Insulation	126, 118, 117, 127, 109 Crawlspace Under Restrooms		Damaged Damaged	Friable Friable

**Paper Duct Wrap / Black Mastic**

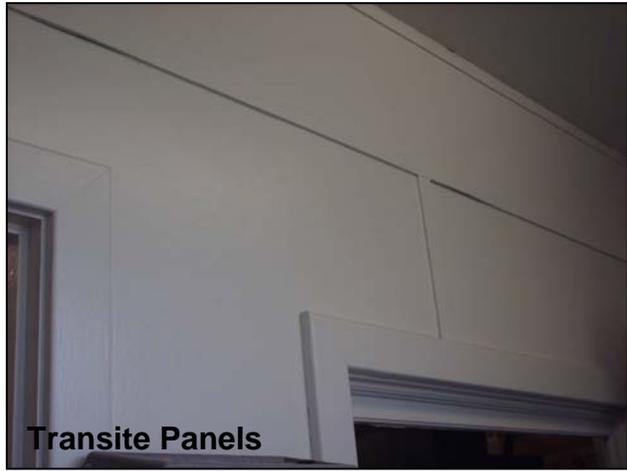
**Transite Panels**

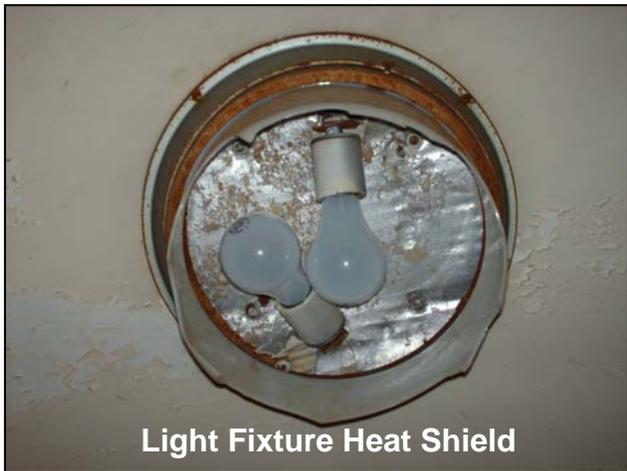
12" x 12" Orange Floor Tile & Associated Mastic	109		Good	Non-Friable
Light Fixture Heat Shield	Hall 1		Damaged	Non-Friable
Sink Mastic	117		Good	Non-Friable
Canvas Vibration Damper	118		Good	Non-Friable
Fire Doors	139		Good	Non-Friable
12" x 12" Cream/Green Streaked Floor Tile and Associated Mastic	140, 141		Good	Non-Friable

**Light Fixture Heat Shield**

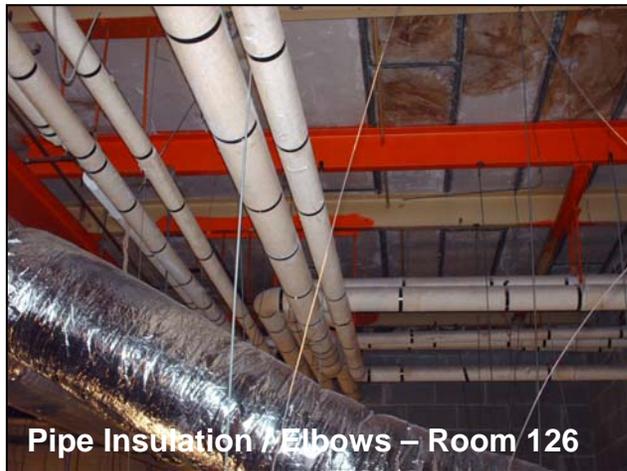
**Pipe Insulation / Elbows – Room 126**

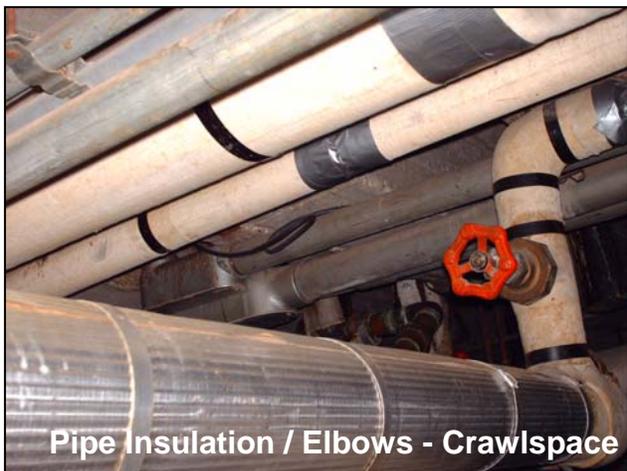
**Pipe Insulation / Elbows - Crawlspace**

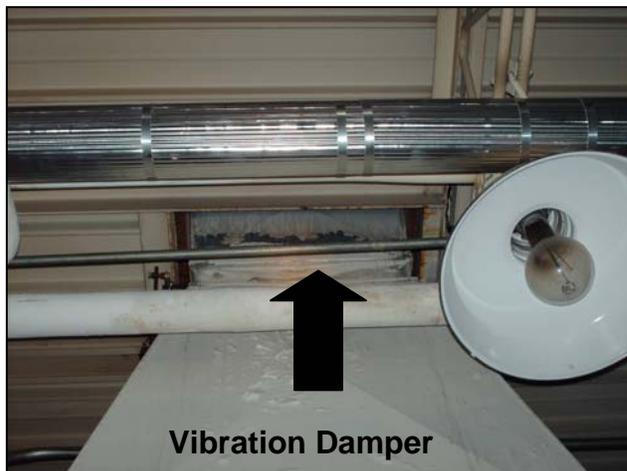
**Vibration Damper**
