Turnover Environmental Condition Assessment

(TECA)

MLP 2

August 20, 2012

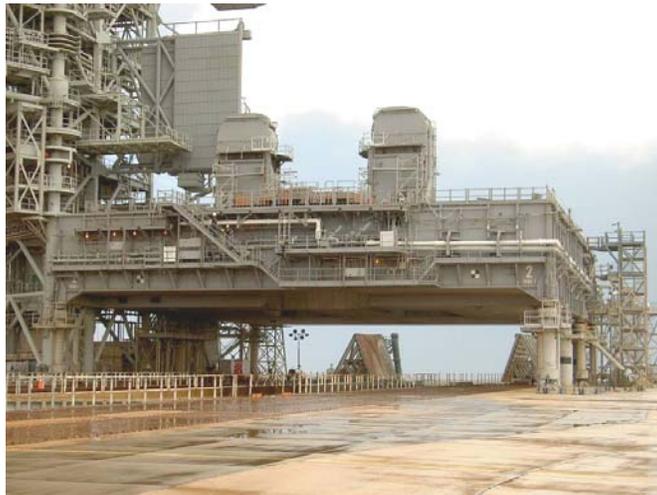
Built in 1967, the MLPs were designed for the Apollo/Saturn program and modified in the 1970's to support the Shuttle. There are three levels, constructed of steel, with a Tail Service Mast (TSM) on either side of the Main Engine exhaust vent. These 31-foot masts contain the feed lines through which liquid hydrogen (LH<sub>2</sub>) and liquid oxygen (LOX) were loaded into the shuttle's external fuel tank, as well as electrical hookups and flares which eliminated free hydrogen present prior to main engine ignition. At launch, the umbilical was pulled away from the orbiter and retracted into the Masts, where protective hoods rotated closed to shield them from the exhaust flames. Each TSM assembly is 15 feet (4.6 meters) long, 9 feet (2.7 meters) wide, and rises 31 feet (9.4 meters) above the Platform deck. Other umbilical's carried helium and nitrogen, as well as ground electrical power and communications links. Each MLP, in total, weighs approximately 9.25 million pounds (4,2 Mkg) and measures 160 feet by 135 feet (49 meters by 41 meters), and is 25 feet (7.6 meters) high (Figure 1).

Figure 1. MLP 2 at Launch Pad (NASA Archive)

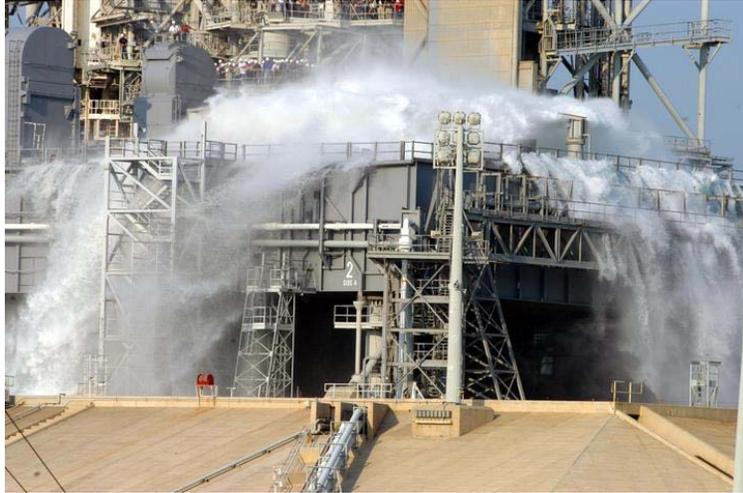
Eight attach posts, four on the aft skirt of each SRB, supported and held the Space Shuttle on the Mobile Launcher Platform. These posts fit on counterpart posts located in the Platform's two solid rocket booster support wells. The space vehicle disconnected from the Platform by explosive nuts. Sound suppression water was transmitted into the exhaust vents of the MLP (Figure 2).

Figure 2. Sound Suppression Test Pad 39A (NASA Archive)

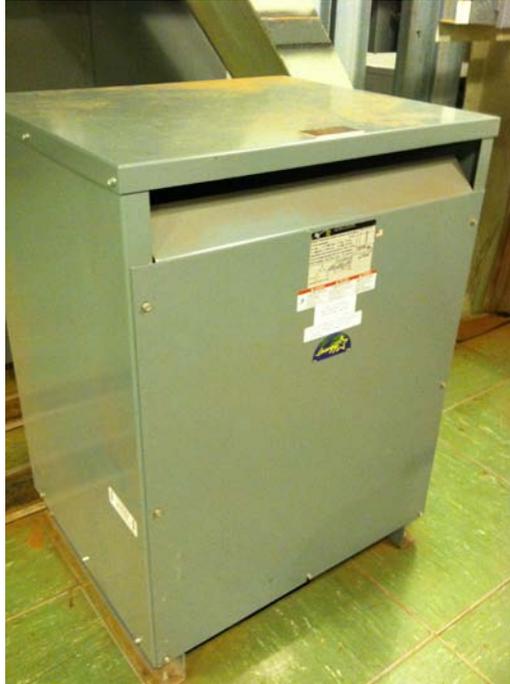
- The oxygen monitoring units has been removed.
- The following can be found in the numbered compartments of MLP 2:
  - 8B - a dry type transformer (see Figure 4), chilled water supply lines, a stainless steel sink which was hooked up to potable water but not used and oxygen analyzer supervisor panel and oxygen analyzer integration unit panel (see Figure 5).

Figure 4. 8B - Dry type transformer

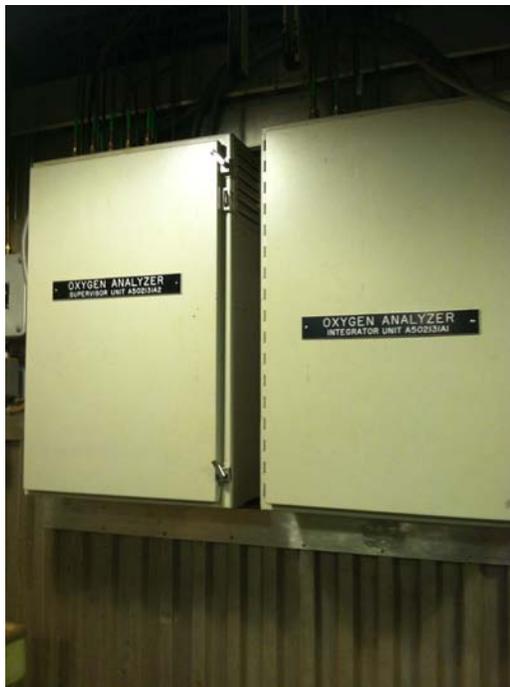
Figure 5. 8B - Oxygen analyzer panels

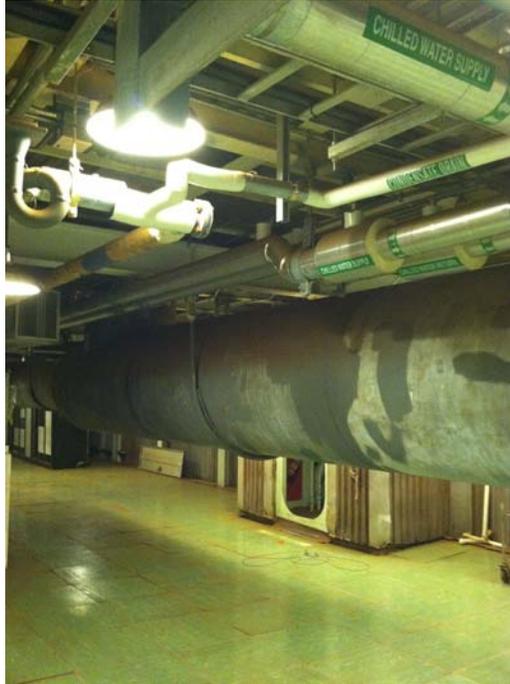
- 7B - sound suppressions lines and chilled water lines (see Figure 6), the hand- held fire extinguisher was removed on August 14, 2012 (see Figure 7), chilled water HVAC unit and an area of paint sampling for lead (see Figure 8).

Figure 6. 7B - Sound suppression

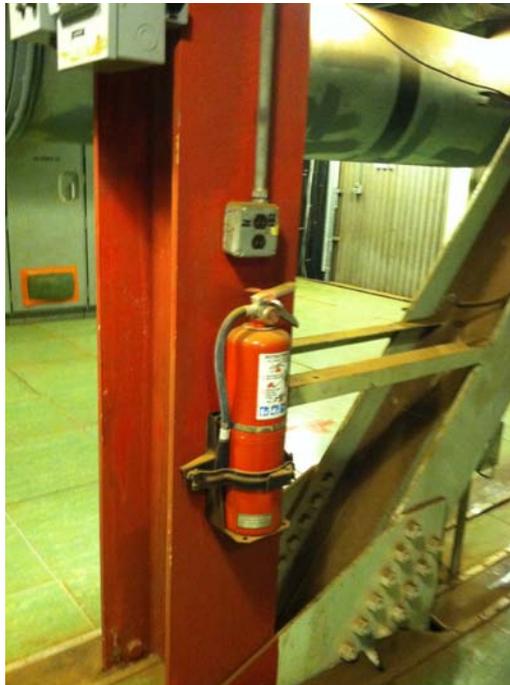
Figure 7. 7B - hand held fire extinguisher was removed August 14, 2012.

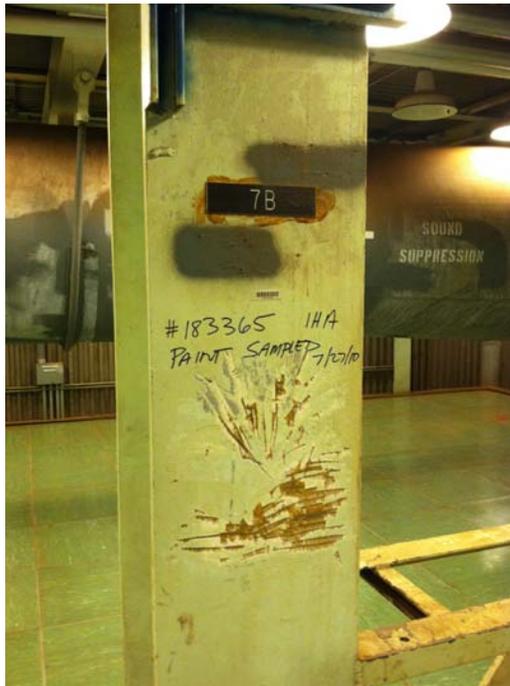
- Asbestos-Containing Building Materials (ACBM), lead paint and PCB-contaminated paints are known to be present in MLP 2. An Asbestos Containing Material (ACM) survey performed in May 1997 indicated friable ACM has been identified in MLP 2. Lead and PCB contaminated paints are indicated through interviews of key personnel. Information regarding the location and quantity of known ACBM as well as contaminated paints will be provided to any occupant of this facility through the MESC Environmental Health office.

Figure 8. 7B – Lead paint sampling area

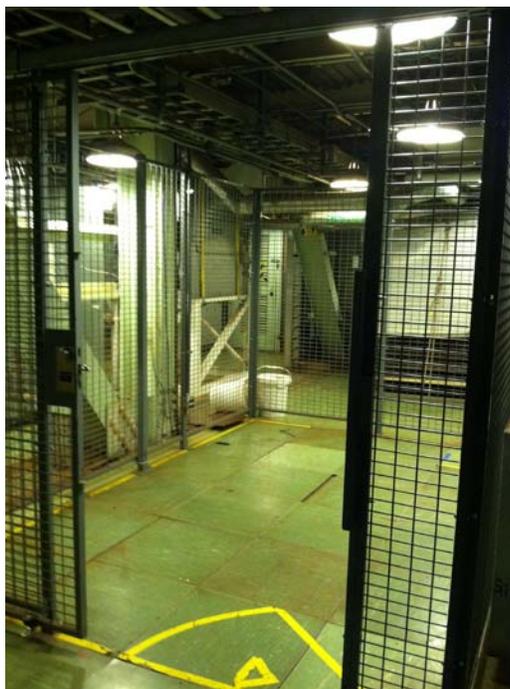
- 10B - sound suppression lines, HVAC lines, power panels and communications have been removed (Figure 15 background).
- 9B - empty cage that formally housed a Satellite Accumulation Area (SAA) when at the Launch Pads (see Figure 9), two dry type transformers (see Figure 10) and heater power switching panels (see Figure 11).

Figure 9. 9B - Empty caged area that formally housed a Satellite Accumulation Area

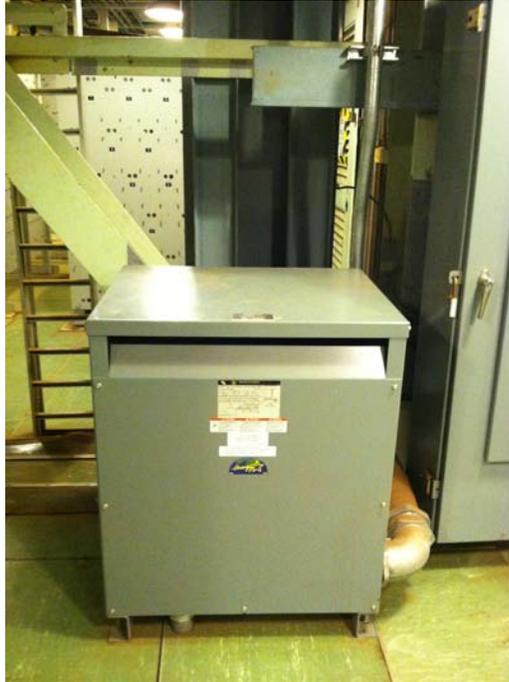
Figure 10. 9B – Dry type transformer

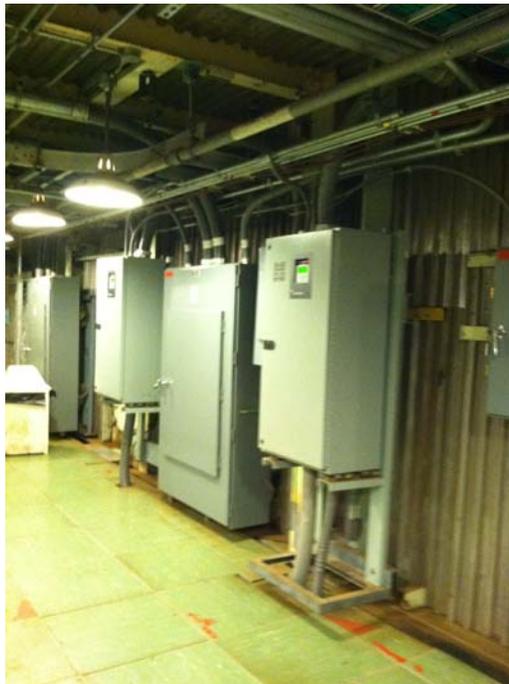
Figure 11. 9B - Heater power switching panels

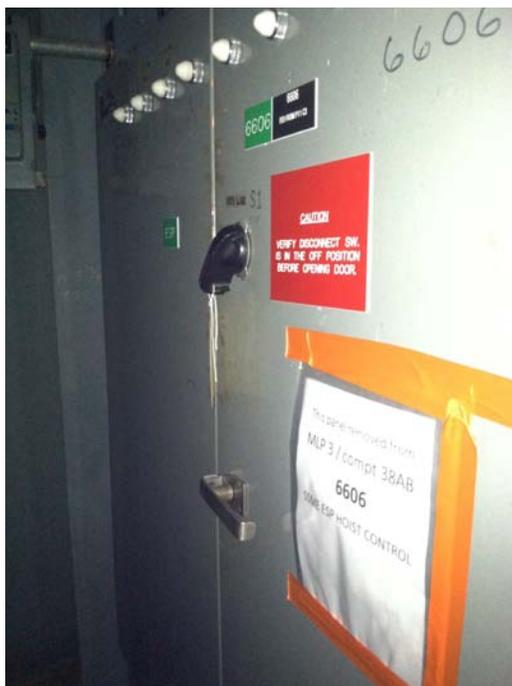
- 48B is an instrumentation room.
- 36AB has sound suppression and power panels.
- 37AB - power supply panel for the Solid Rocket Booster (SRB) winches (see Figure 12).

Figure 12. 37AB – Power supply panel

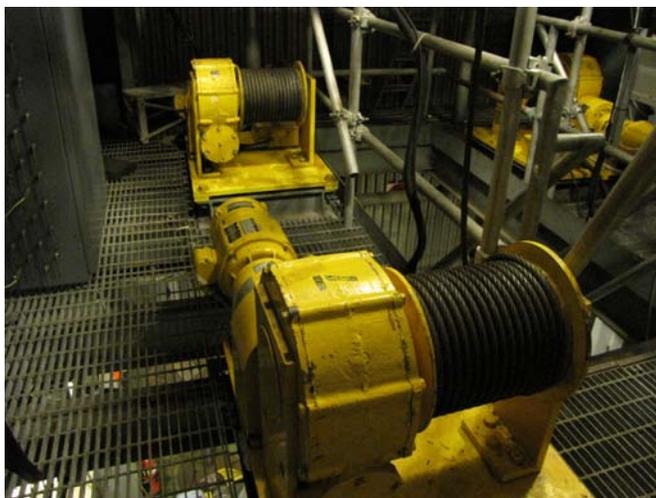
- Engine Platform Winches contain approximately 5 gallons of 90 weight gear oil. Eight winches are located on the SRB Platform (Compartments 37A, 41A, 31A). Four winches are located on the SSME Platform (Compartments 2B and 16B).

- 38AB - power panel for Space Shuttle Main Engine (SSME) winches.
- 37A - four SRB winches are in this compartment (see Figure 13) and four hold down posts.

Figure 13. 37A - SRB winches

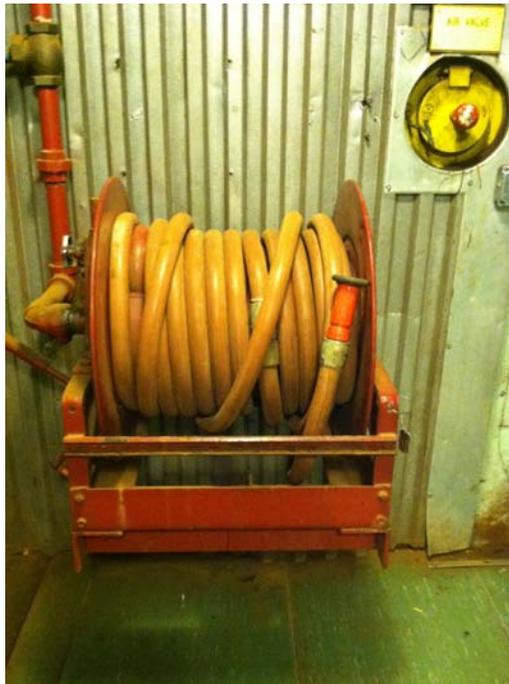
- 47AB - water lines for the sound suppression system.
- 15B - fire suppression hose (see Figure 14), Integrated Network Control System (INCS) panel has been removed (see Figure 15) and a dry type transformer.

Figure 14. 15B - Fire hose

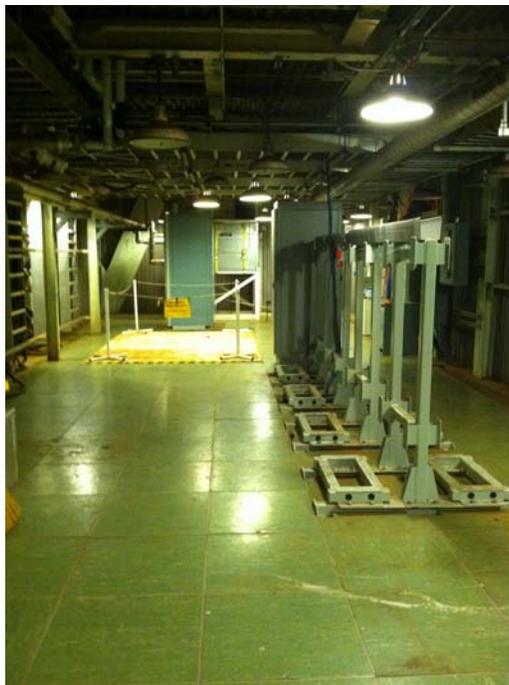
Figure 15. 15B – INCS panels removed (foreground) and communications removed from 10B (background)

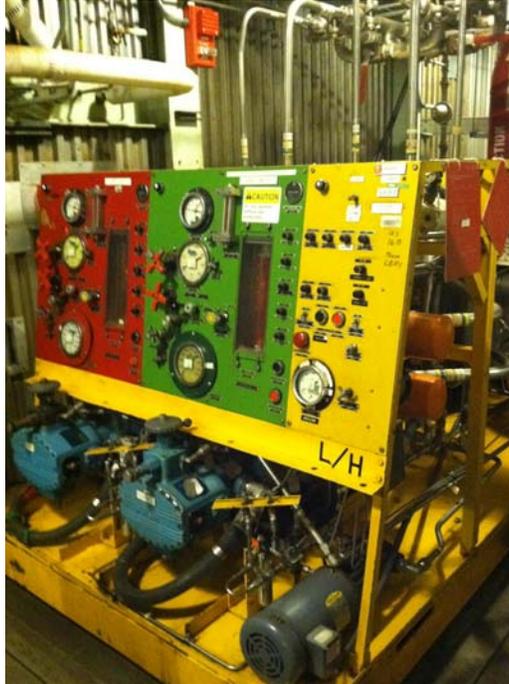
- 16B - chilled water lines, the drained SRB hydraulic pumper with 104 gallon hydraulic oil tank , S/N S72-0841-01-007, (see Figure 16) and SSME winch. The hydraulic pumper is labeled “Empty/Permanently Closed” and dated 4/2012 (see Figure 17). The 100 gallon contingency tank is labeled “Empty” (see Figure 18).

Figure 16. 16B – SRB hydraulic pumper unit

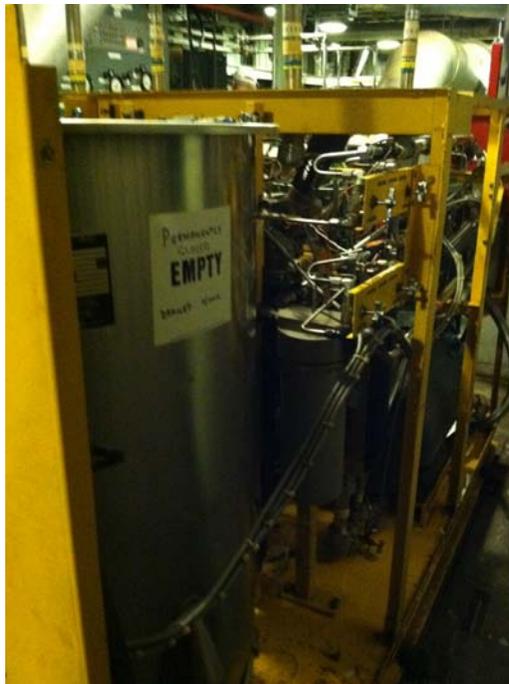
- The hydraulic pumping systems existed to supply the Space Shuttle's SRBs and Orbiter with hydraulics. The three 104 gallon capacity reservoirs, which were SPCC sites, are located in Compartments 2B (K6-0546MLP2-1), 16B (K6-0546MLP2-2), and 43B (K6-0546MLP203). There is secondary containment "coffins" surrounding each pumper. Stainless steel piping supplied hydraulic fluid to Zero-Level. These hydraulic pumpers units have been drained of hydraulic fluid, labeled "Permanently Closed and Empty" (4/2012) and removed from the KSC SPCC Site Specific Plan.

Figure 17. 16B – Hydraulic tank on pumper labeled “permanently closed/empty”

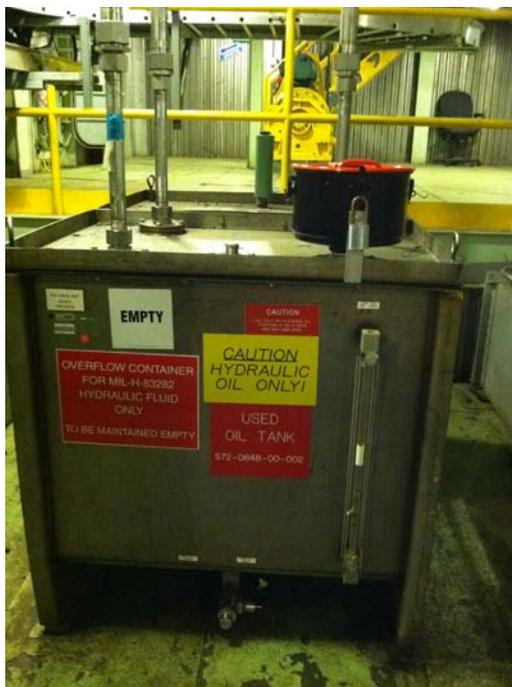
Figure 18. 16B – 100 gallon contingency tank

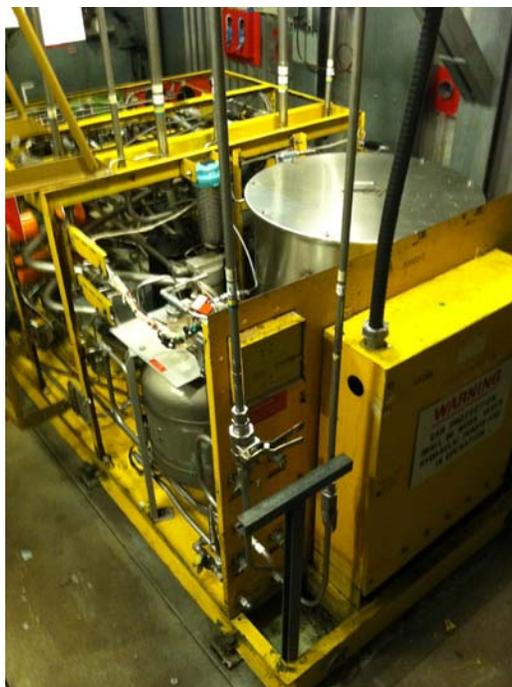
- 43B - Orbiter hydraulic pumper with 104 gallon hydraulic oil tank, S/N S72-0841-01-017 (see Figure 19). The hydraulic pumper is labeled with “Empty/ Permanently Closed” and dated 4/2012 (see Figure 20).

Figure 19. 43B – Orbiter hydraulic pumper unit

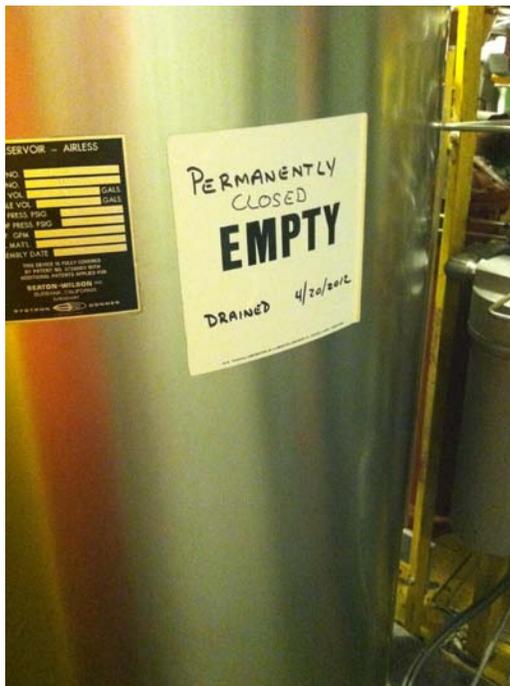
Figure 20. 43B – Hydraulic tank on pumper labeled “permanently closed/empty”

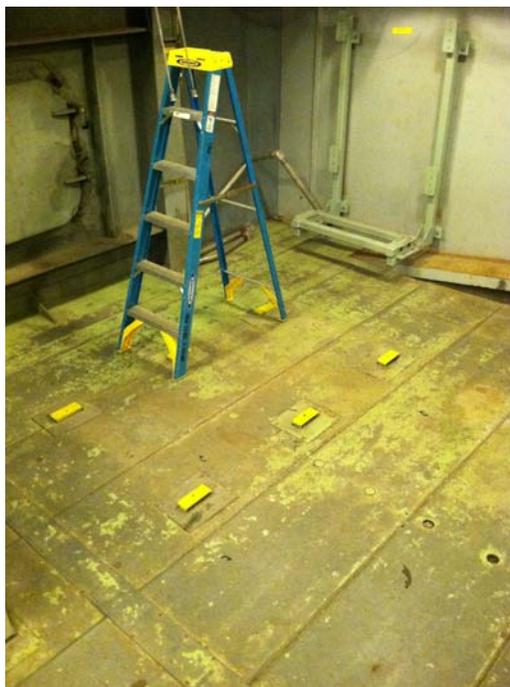
- 45AB - fire suppression pipes.
- 34B – INCS panel will remain. The helium panel and LH2 panel have been removed.
- 33B - SRB Aft Skirt Purge panels have been removed (see Figure 21), alarm distribution panel removed (see Figure 22).and the Orbiter Helium Anti/Ice panel has been disconnected.

Figure 21. 33B - SRB Aft Skirt Purge panels have been removed

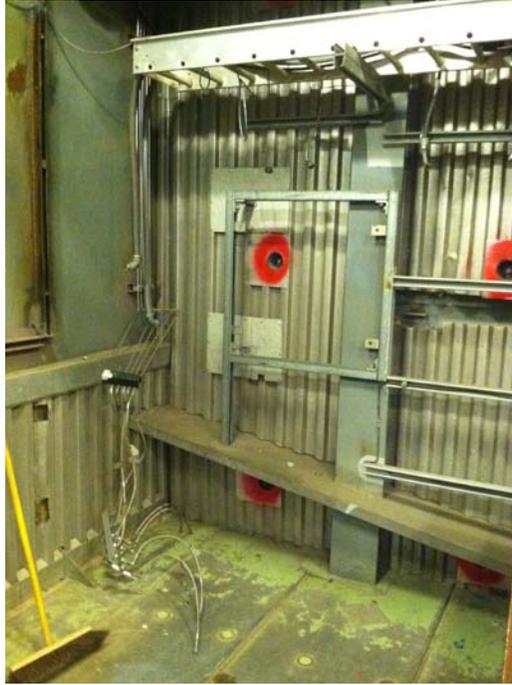
Figure 22. 33B – Fire alarm distribution panels removed

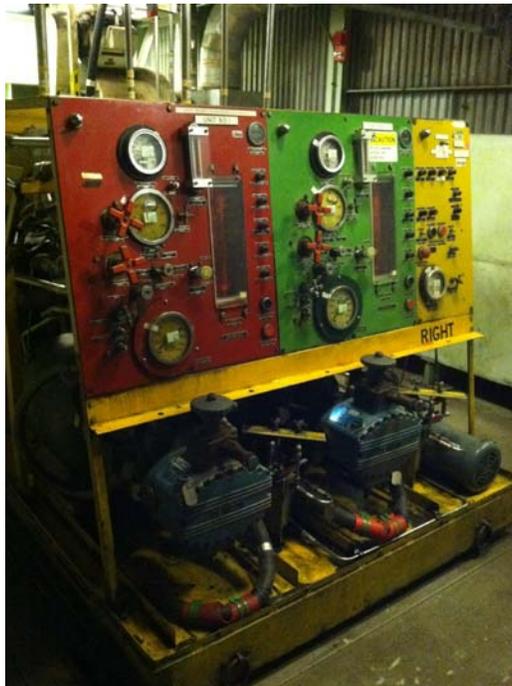
- 35AB, 32AB, 39AB and 42AB all contain sound suppression lines.
- 2B - two SSME winches, SRB hydraulic pumper unit, S/N S72-0841-01-018, (see Figure 23), Orbiter/SRB Control Panel and ventilation lines. The hydraulic pumper is labeled with “Empty/Permanently Closed” and dated 4/2012 (see Figure 24).

Figure 23. 2B – SRB hydraulic pumper unit

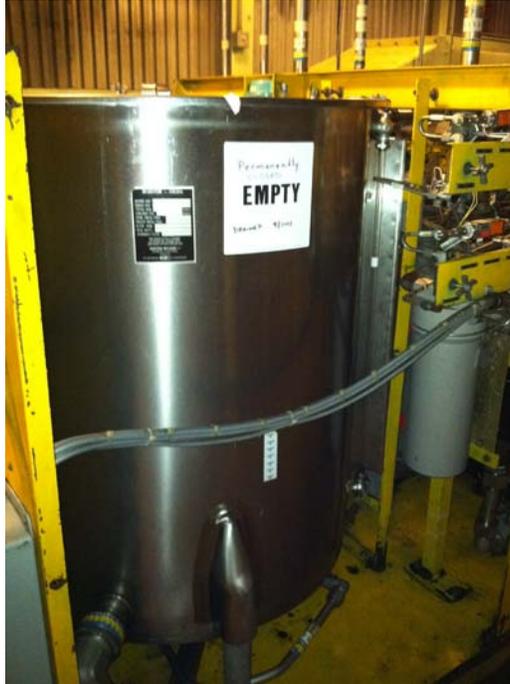
Figure 24. 2B - Hydraulic tank on pumper labeled “Empty/Permanently Closed”

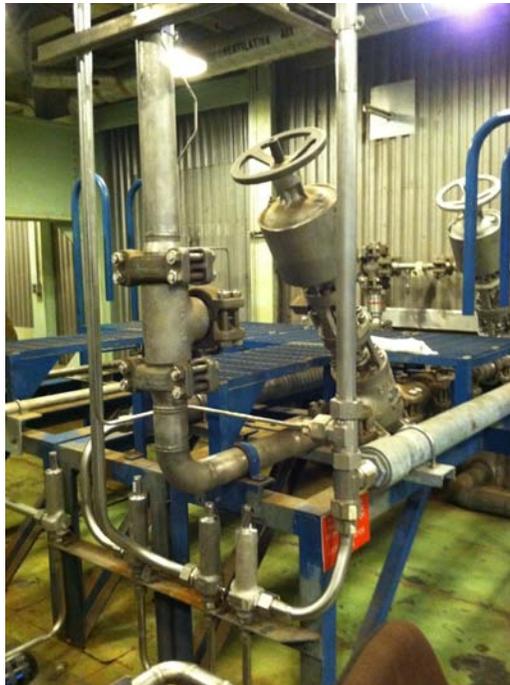
- 30AB - sound suppression and ventilation pipes.
- 31B - empty.
- 1B - sound suppression lines and the main facilities helium and nitrogen interface to the MLP (see Figure 25). The oxygen analyzer monitoring unit has been removed.

Figure 25. 1B - Main facilities helium and nitrogen interface to the MLP

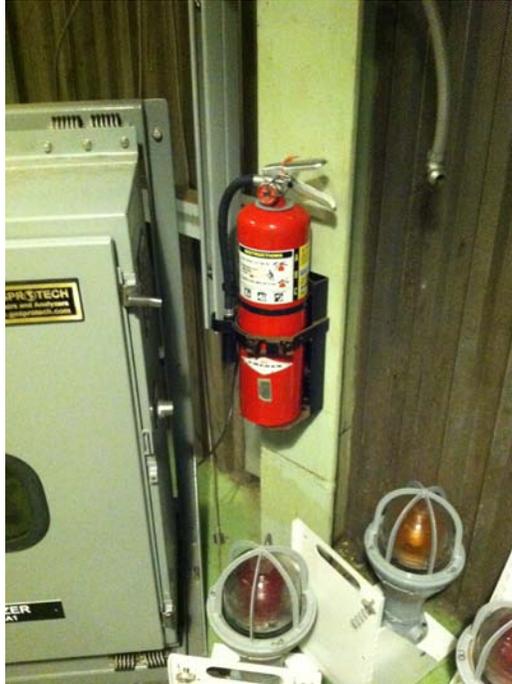
- 17A – fire hose.
- 2A- fire alarm sensor panel and oxygen analyzer monitoring unit removed. The hand held fire extinguisher was removed on August 14, 2012 (see Figure 26). HVAC carbon and HEPA filters and a fire hose. This compartment stored the aft orbiter platform which has been removed and stored in the VAB (see Figure 27).

Figure 26. 2A – Oxygen monitoring unit removed, hand held fire extinguisher and beacons removed. The hand held fire extinguisher was removed August 14, 2012.

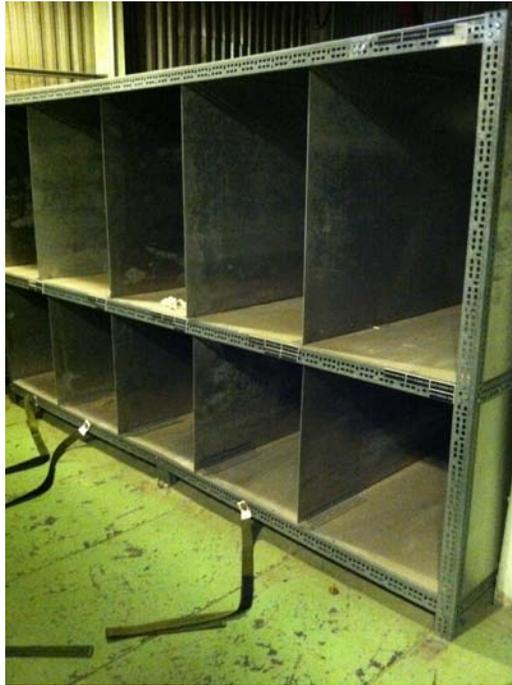
Figure 27. 2A – Storage area previously used for aft orbiter platform

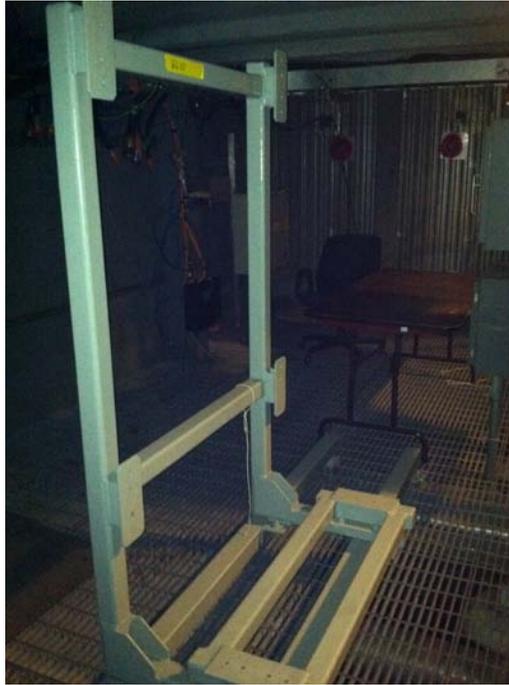
- 34A - a GN2 panel for Hubble support and a GN2 SRB TVC servicing panel.
- 33A- INCS removed (see Figure 28) and the ECS system particle counter.
- 31A - two SRB winches and two hold down posts.

Figure 28. 33A – INCS removed

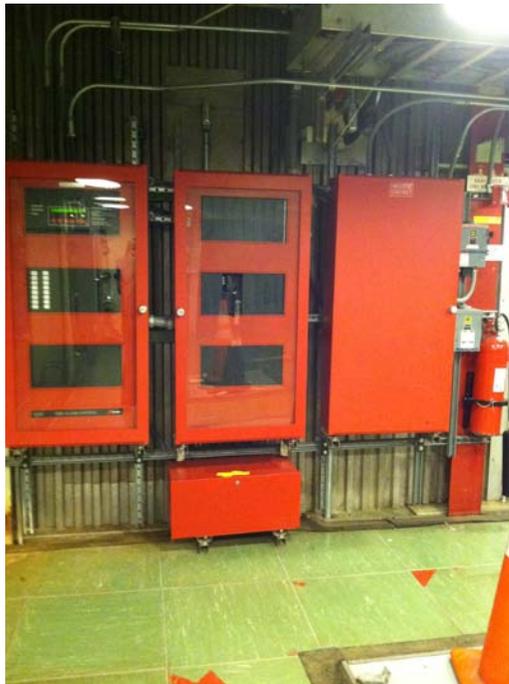
- 1A - a dry type transformer and ECS lines.
- 9A - halon fire suppression system control panel and battery rack control and monitor panel (see Figure 29). The two batteries associated with this rack are lead acid (see Figure 30). Two 400 hertz generators have been removed (see Figure 31).

Figure 29. 9A – Halon fire suppression system control panel, battery rack control and monitor panel, battery box. The hand held fire extinguisher was removed August 14, 2012.

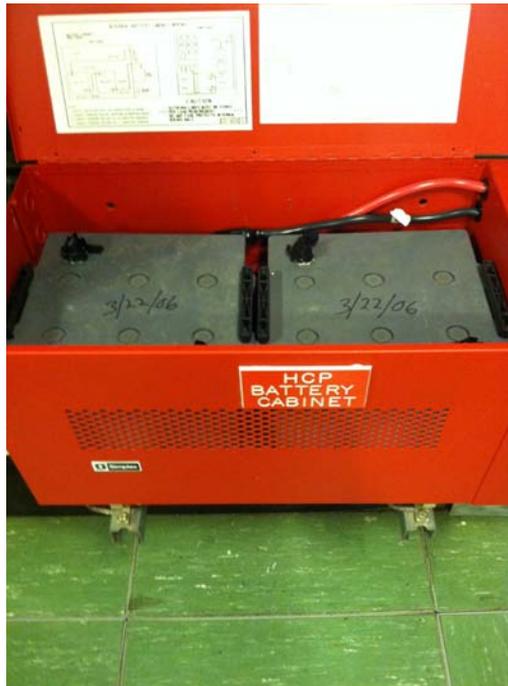
- Residual hydraulic fluid remains in equipment and ancillary hydraulic lines.
- Two lead acid batteries supporting the fire alarm system managed by the ISC Contract remain in a battery box in Compartment 9A.

Figure 30. 9A – two lead acid batteries

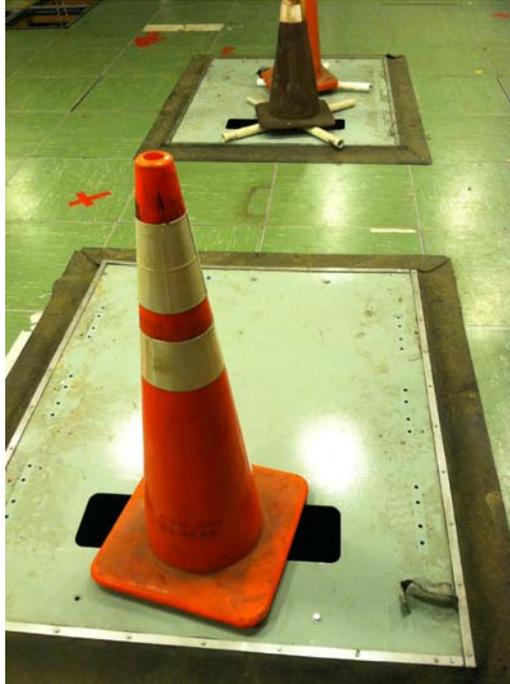
Figure 31. 9A – Two 400 hertz generators removed

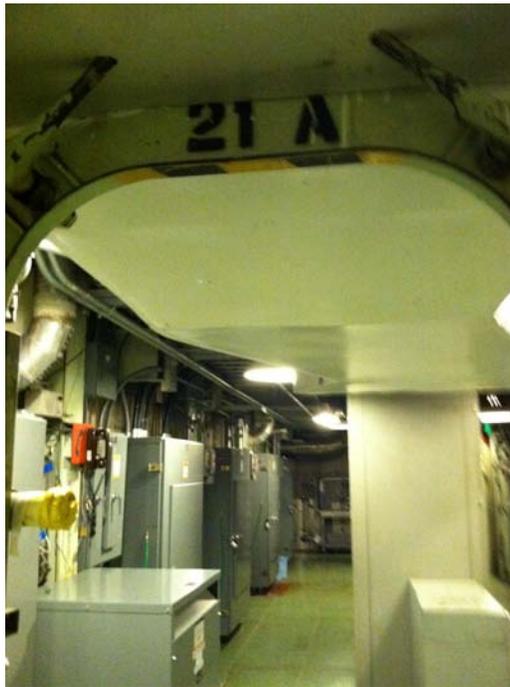
- 21A- two dry type transformers, power panels (see Figure 32) and a current transducer (see Figure 33). The Halon fire suppression system tanks previously located in this room have been removed (see Figure 34).

Figure 32. 21A – Dry type transformer and power panels

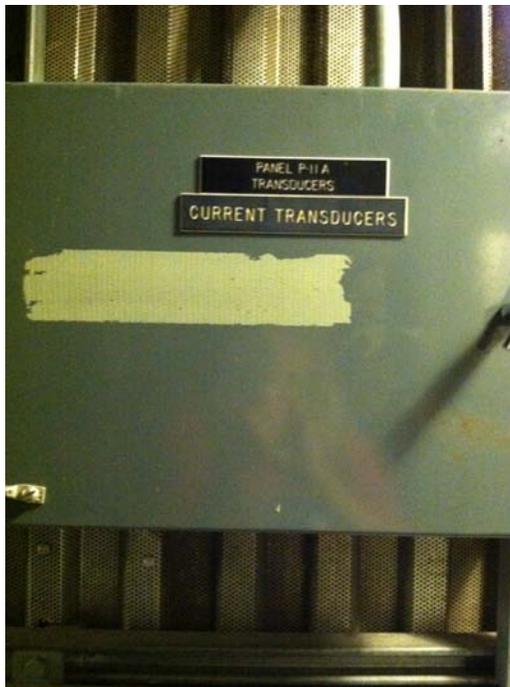
Figure 33. 21A – current transducer

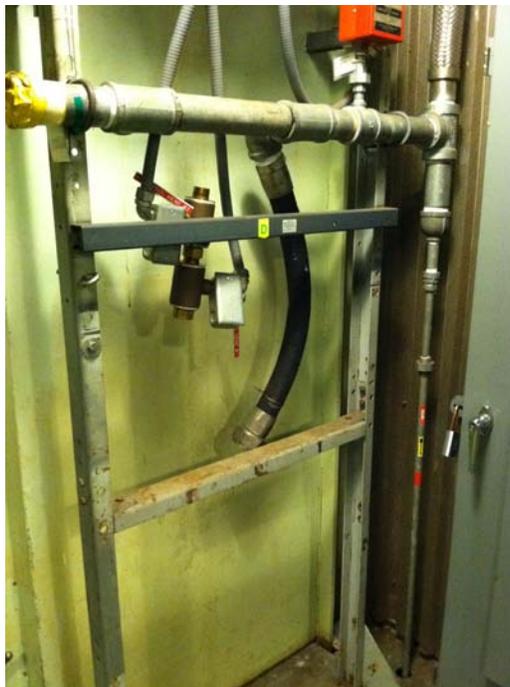
Figure 34. 21A – Halon fire suppression tanks removed

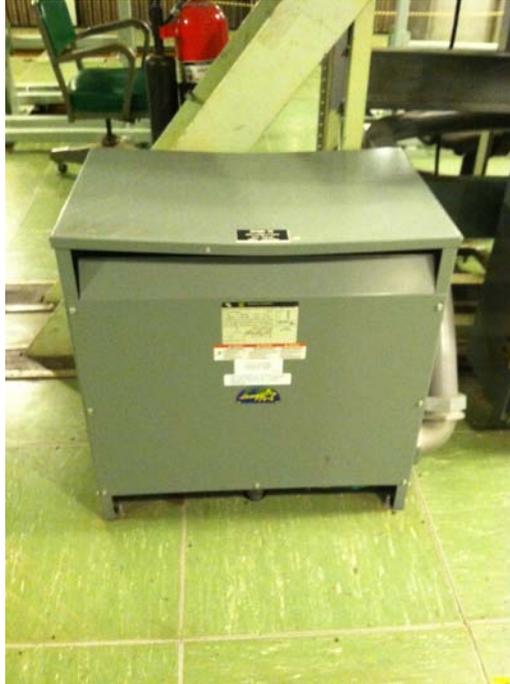
- 8A - stainless steel double sink, chilled water supply and two dry-type transformers (see Figure 35). The Halon fire suppression system tanks previously located in this room were removed.

Figure 35. 8A – Dry type transformer

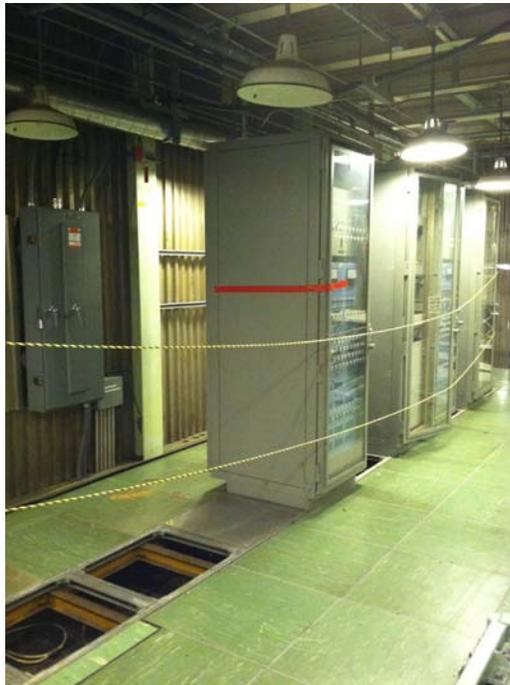
- 7A - the hand held fire extinguisher was removed on August 14, 2012, power supply for orbiter and SRB with a ni-cad battery back-up removed (see Figure 36), hazardous gas warning system, hydrogen umbilical mass spectrometer (HUMS) has been removed (see Figure 37), compressed gas tanks removed (see Figure 38) and a dry type transformer. The Halon fire suppression system tanks were removed see (Figure 39).

Figure 36. 7A – INCS removed

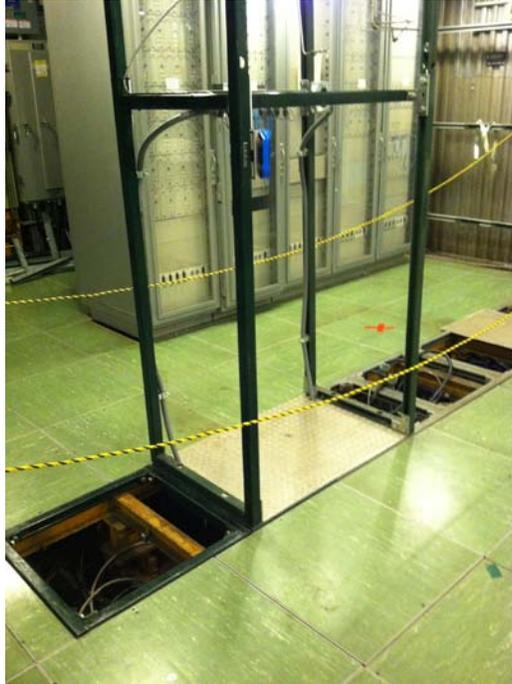
Figure 37. 7A – HUMS removed

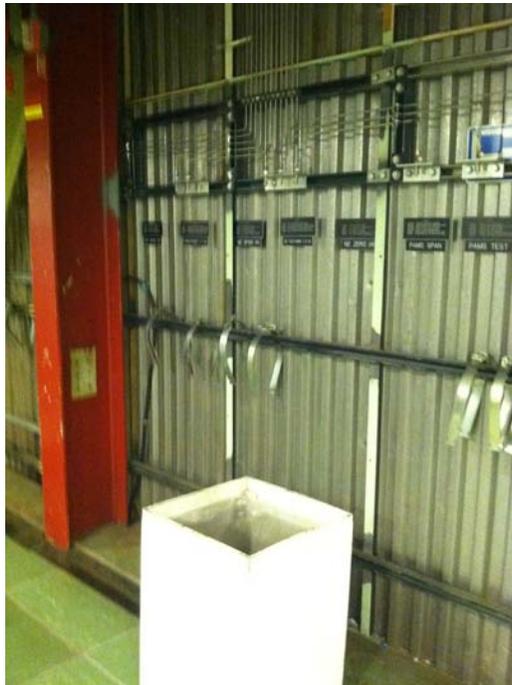
Figure 38. 7A – Compressed gas tanks removed

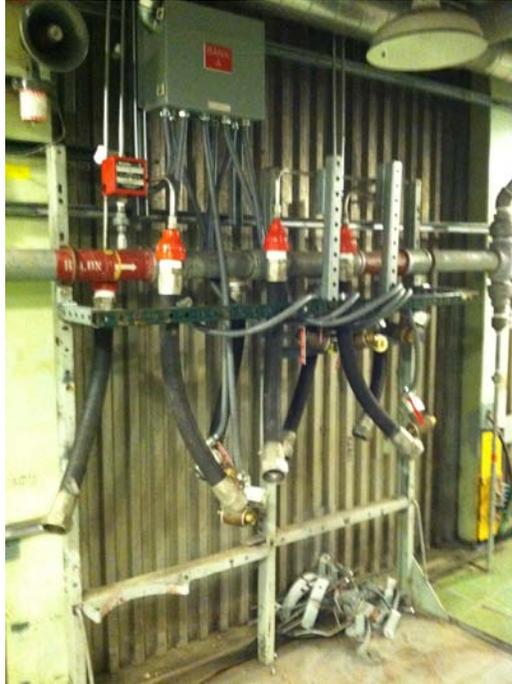
Figure 39. 7A – Halon tanks removed

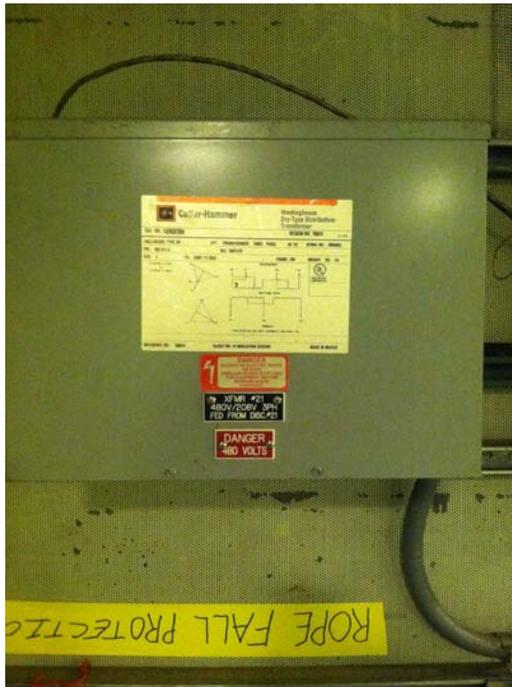
- 20A - empty.
- 18A - bathroom with two sinks, two toilets, two urinals and one drain (water supply turned off).
- 15A - sound-proof work room with one dry type transformer (see Figure 40), a HVAC unit (see Figure 41) and power panels.

Figure 40. 15A - Dry type transformer

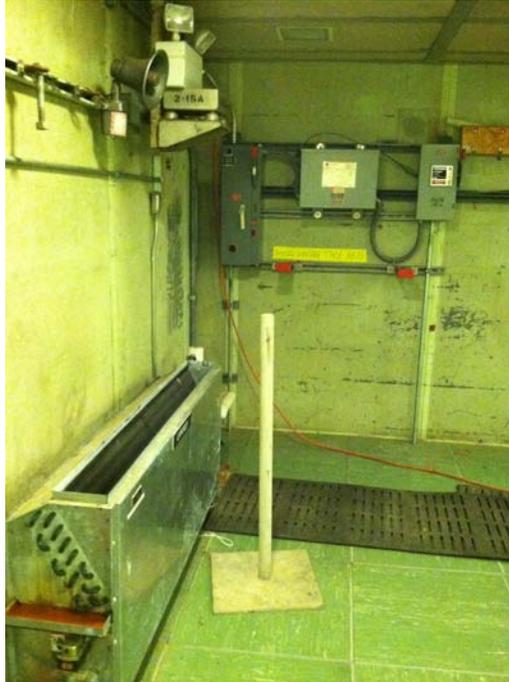
Figure 41. 15A – HVAC unit

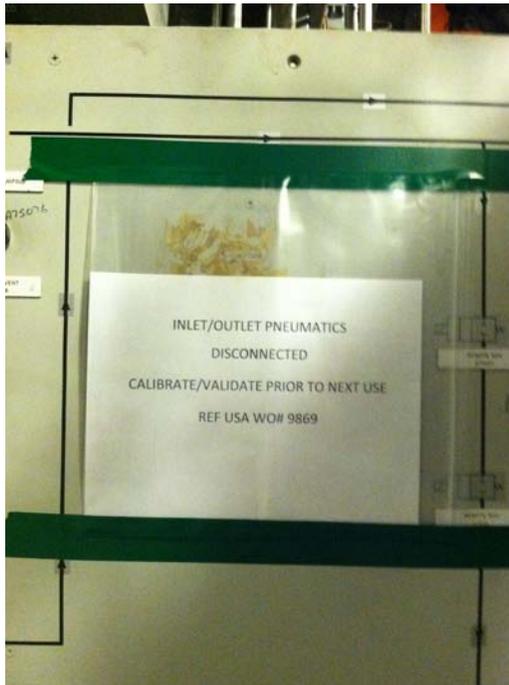
- 44A- phone, GN2 control panel, Firex lines, sound suppression system lines, and two empty helium tanks. The hydrogen system control panel and the SSME GN2 heater controller are labeled as disconnected (see Figure 42).

Figure 42. 44A – Hydrogen system control panel and SSME GN2 heater controller panel disconnected

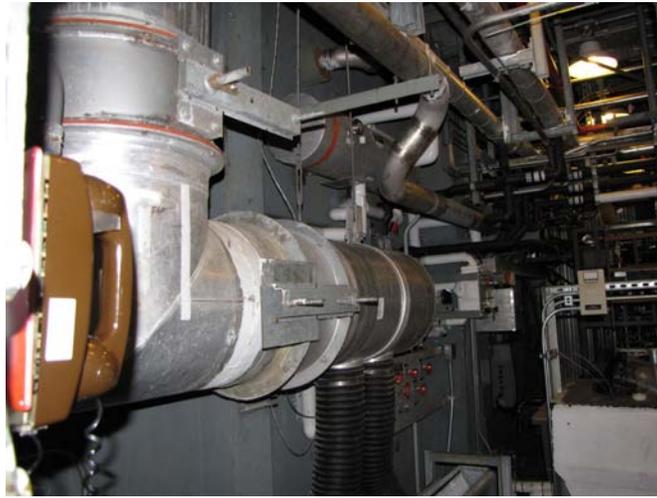
- 43A – empty Freon R-124 system (see Figure 43) with a tank for over-pressurization is deactivated, HVAC system lines, GN2 panel removed, INCS panel removed, hazardous warning panels removed, and all tanks of helium, nitrogen, shop air and breathing air for the hazardous gas warning systems removed.

Figure 43. 43A – Empty Freon 124 system
