ENVIRONMENTAL ASPECTS REVIEW
Of
MOBILE LAUNCH PLATFORM #1
Kennedy Space Center, Florida

Report Date: July 16, 2008
Project: Mobile Launch Platform 1 Turnover Assessment
[REDACTED]

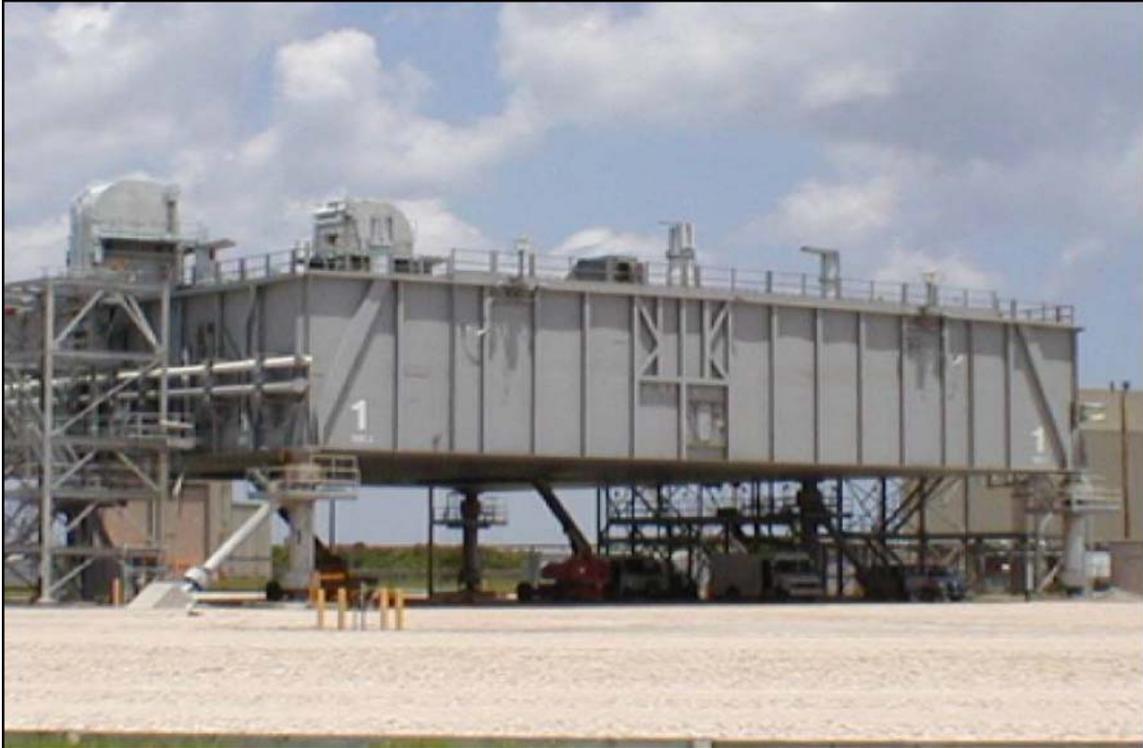
Mobile Launch Platform 1 at East MLP Parksite

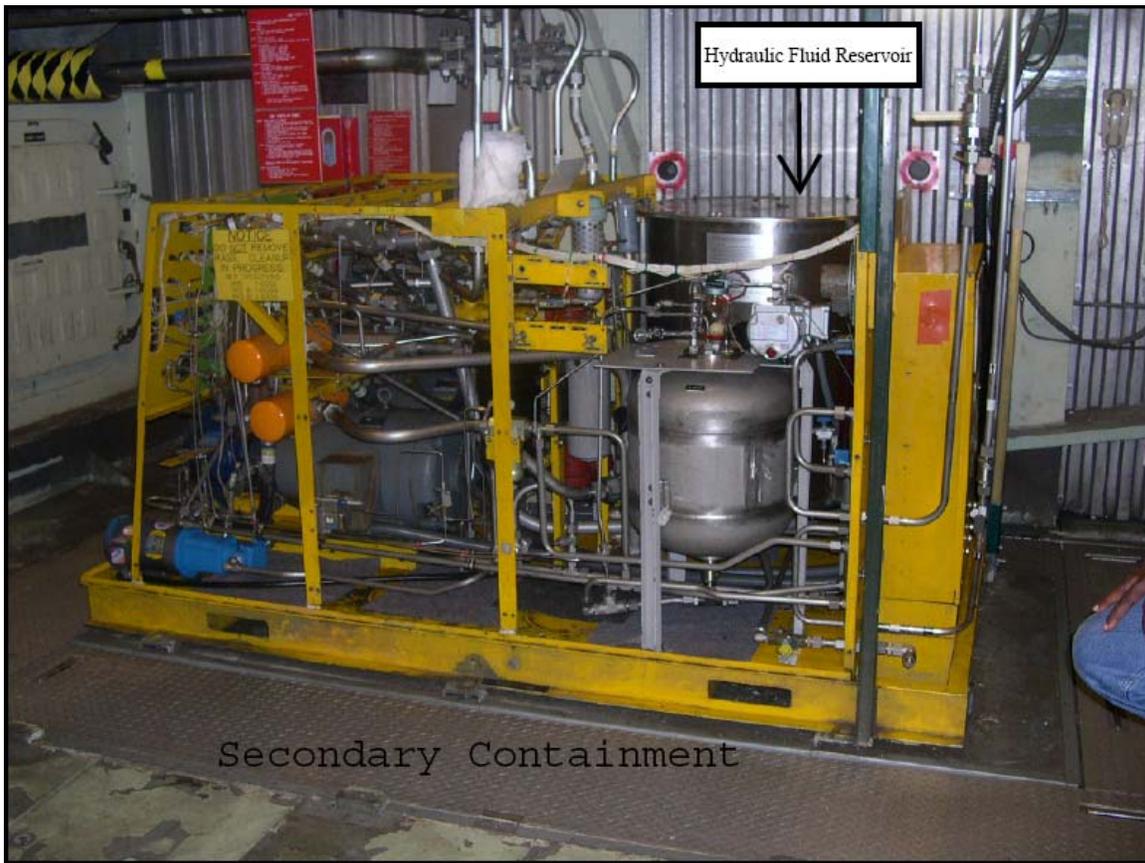
Photograph 1

- Hydraulics.
 - Hydraulic pumping systems exist to supply hydraulics to the Space Shuttle’s Solid Rocket Boosters and to the Orbiter. Three pumping units with 104-gallon capacity reservoirs exist in Compartments 2B, 43B, and 16B. Secondary containment “coffins” surround each pumping unit (see Appendix B, Photograph 1). Stainless steel piping supplies hydraulic fluid to the Zero-Level.

MLP-1 Orbiter Hydraulics System in Compartment 43B
(Reference File: OrbHyd-1.pdf)

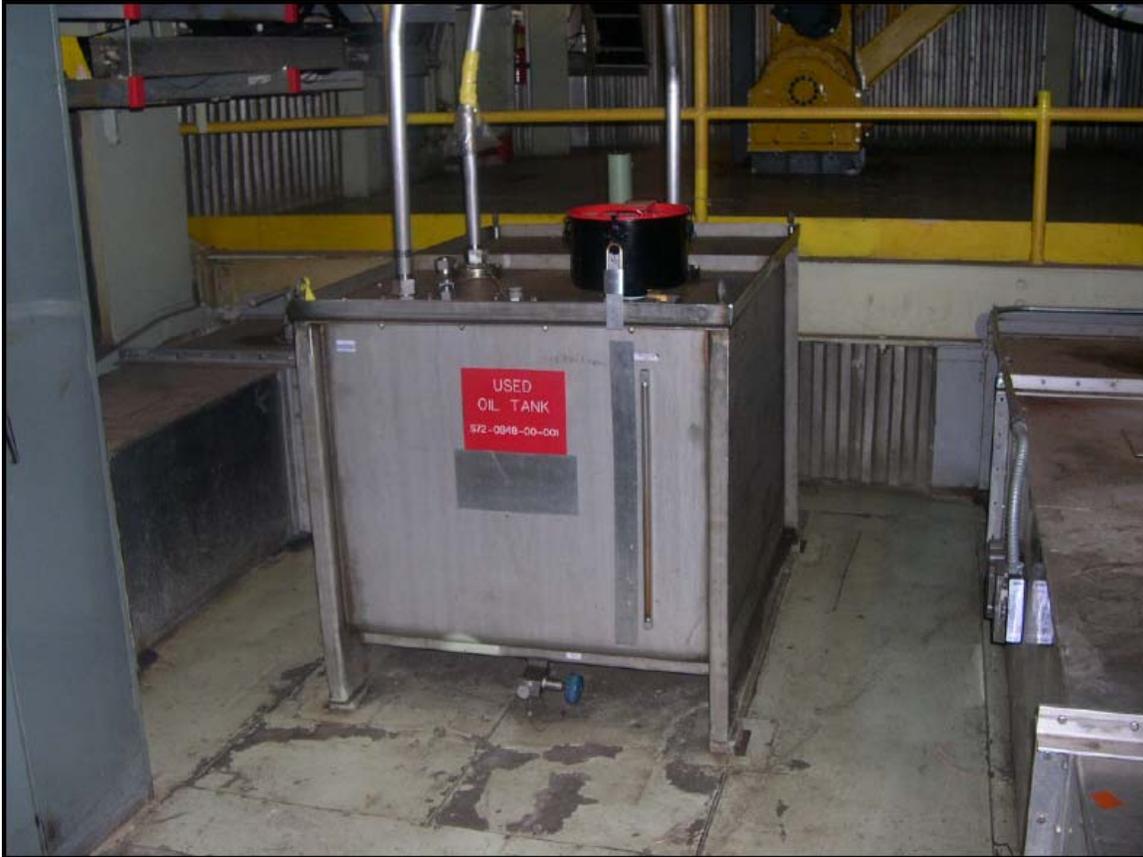
Photograph 2

- A 100-gallon capacity, single-walled, contingency tank exists in Compartment 16B to collect excess hydraulic fluid in case of an over-pressurization (see Appendix B, Photograph 2). The contingency tank is maintained “normally empty.”

Emergency Contingency Tank (Normally Empty) in Compartment 16B
(Reference File: EmergTank.pdf)

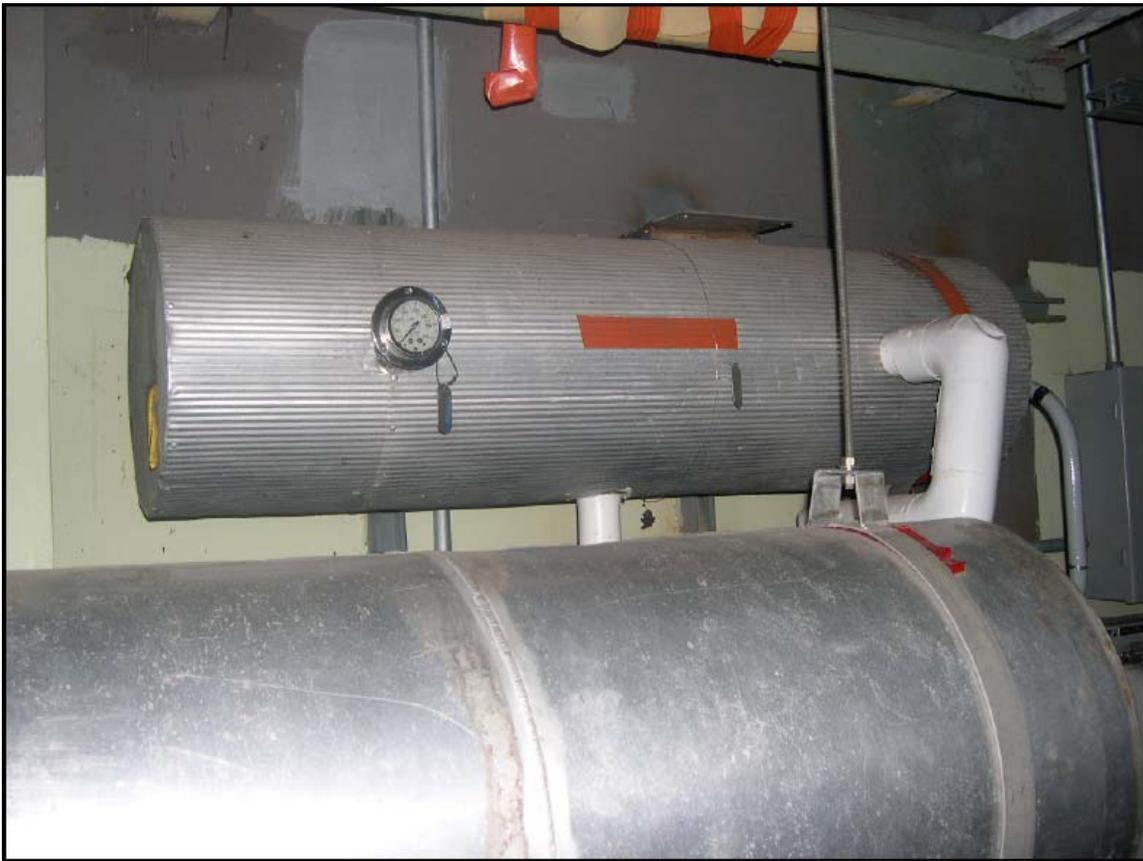
Photograph 3

MLP-1 Freon R124 Tank for Over-Pressurization in Compartment 43A
(Reference File: MLP1-43AFreonTank.pdf)

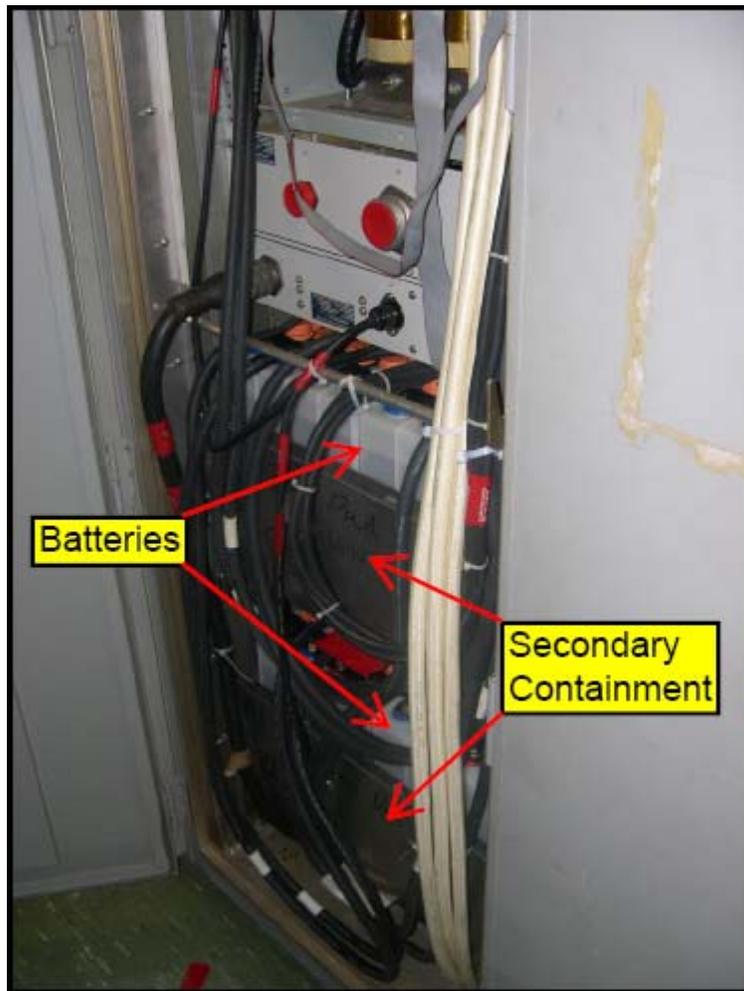
Photograph 4

- Ground Special Power. Back-up batteries exist in secondary containment tubs within power supply “racks” in Compartments 7A and 9A (see Appendix B, Photograph 4).

Typical Back-up Battery System on MLP-1
