Turnover Environmental Condition Assessment
(TECA)
for
Mobile Launch Platform 3 (MLP 3)

May 9, 2012

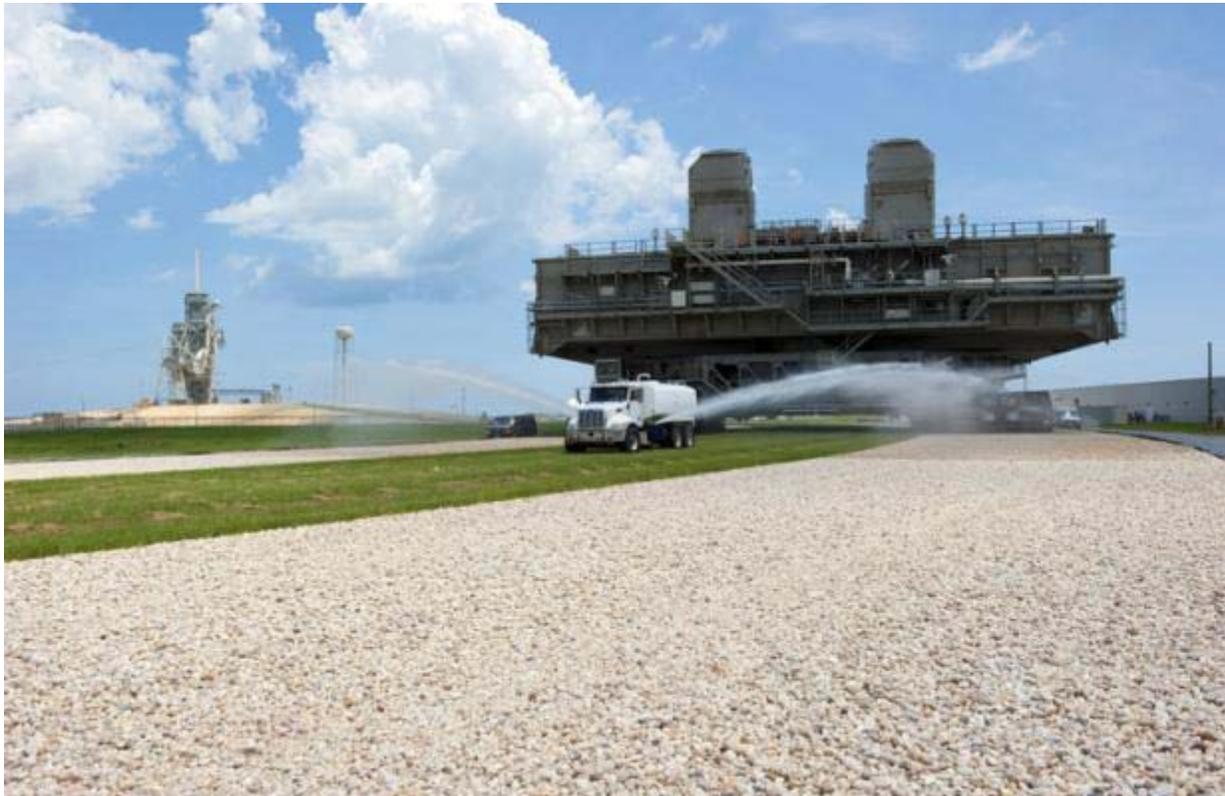
Built in 1967, the MLPs were designed for the Apollo/Saturn program and modified in the 1970's to support the Shuttle. There are three levels constructed of steel. There is a Tail Service Mast (TSM) on either side of the Main Engine exhaust vent. These 31-foot masts contain the feed lines through which liquid hydrogen (LH₂) and liquid oxygen (LOX) were loaded into the shuttle's external fuel tank, as well as electrical hookups and flares which eliminated free hydrogen present prior to main engine ignition. At launch, the umbilical was pulled away from the orbiter and retracted into the TSM, where protective hoods rotated closed to shield them from the exhaust flames. Each TSM assembly is 15 feet (4.6 meters) long, 9 feet (2.7 meters) wide, and rises 31 feet (9.4 meters) above the Platform deck. Other umbilical's carried helium and nitrogen, as well as ground electrical power and communications links. MLP-3, in total, weighs approximately 9.25 million pounds (4.2 Mkg) and measures 160 feet by 135 feet (49 meters by 41 meters), and is 25 feet (7.6 meters) high (Figure 1).

Figure 1. MLP 3 returning from Launch Pad 39A to the VAB (NASA Archive)

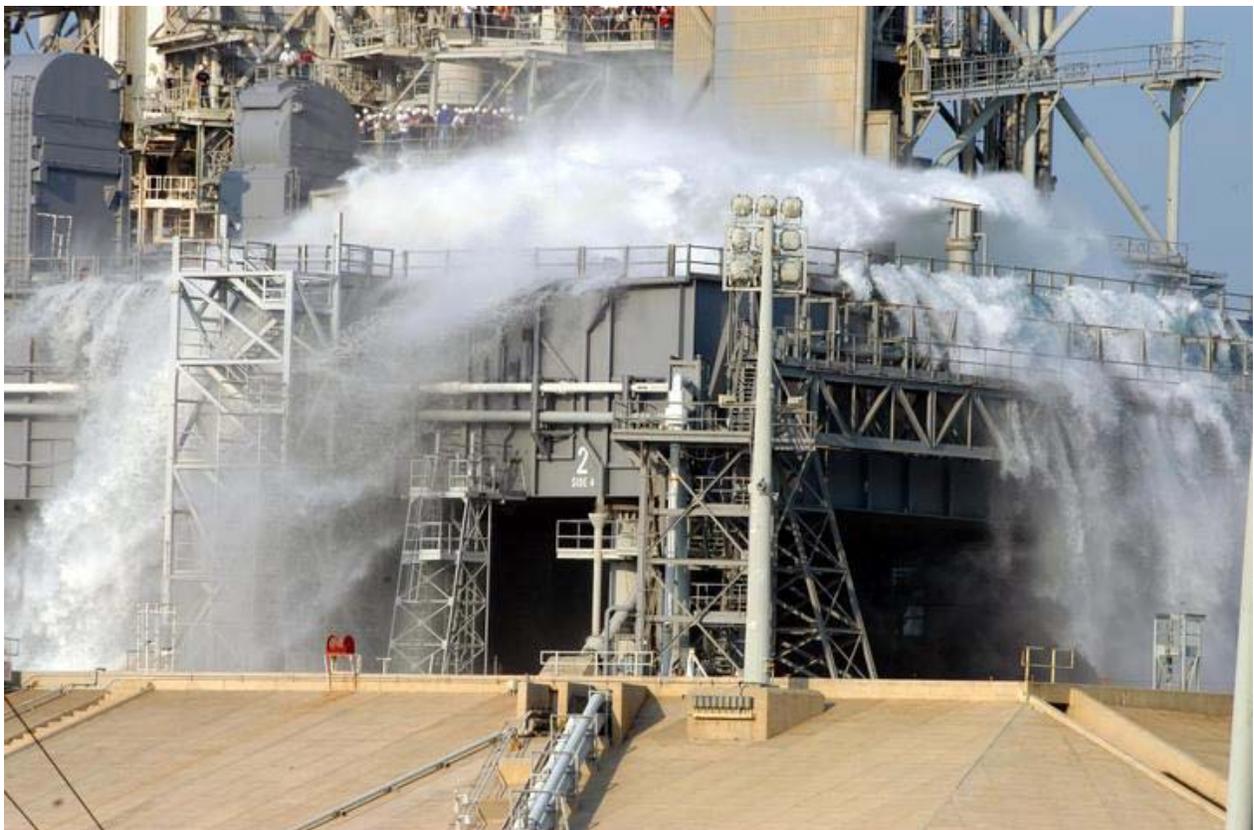
Eight attach posts, four on the aft skirt of each SRB, supported and held the Space Shuttle on the Mobile Launcher Platform. These posts fit on counterpart posts located in the Platform's two solid rocket booster support wells. The space vehicle disconnected from the Platform by explosive nuts. Sound suppression water was transmitted into the exhaust vents of the MLP (Figure 2).

Figure 2. Sound Suppression Test Pad 39A (NASA Archive)

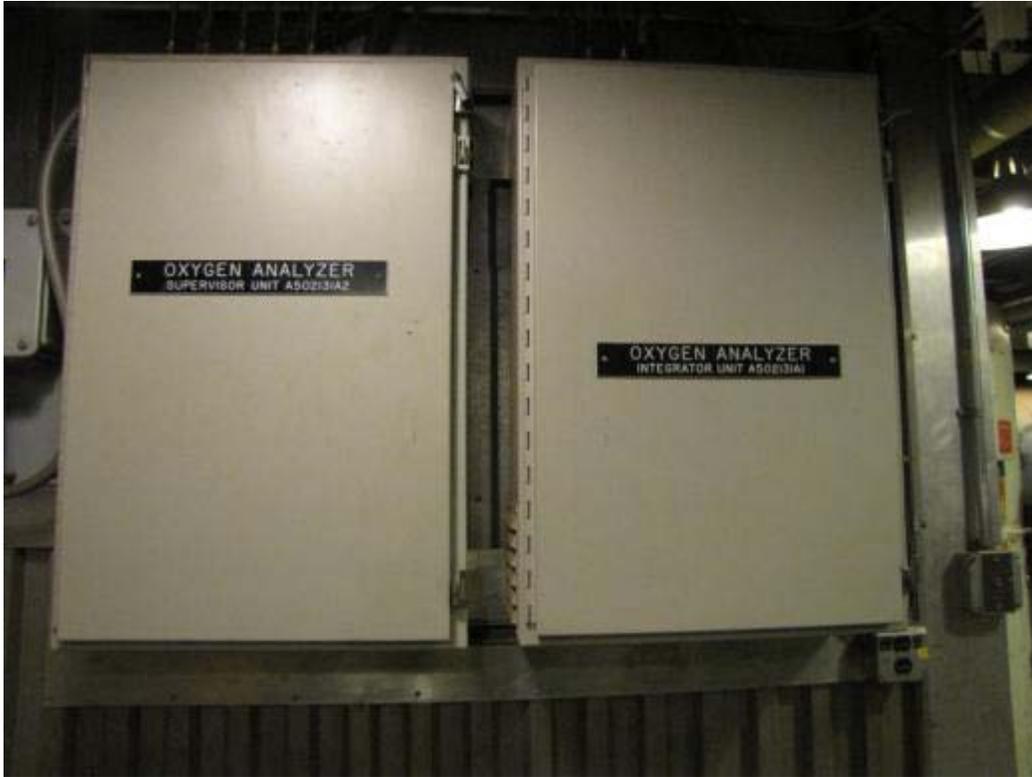
- The following systems/equipment can be found in the numbered compartment of the MLPs:
 - 8B - empty cabinets, a dry type transformer, chilled water supply lines, a stainless steel sink which is hooked up to potable water but not used (see Figure 4) and oxygen analyzer supervisor panel and oxygen analyzer integration unit panel (see Figure 5).

Figure 5. 8B - Oxygen analyzer panels

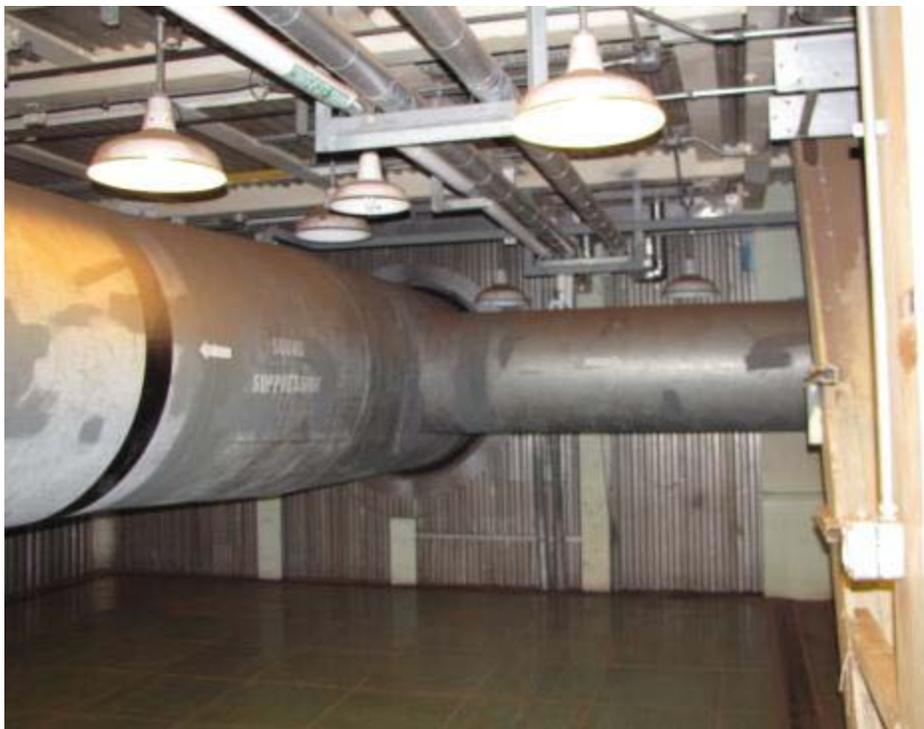
- 7B - sound suppressions lines (see Figure 6), one hand- held fire extinguisher (see Figure 7) and chilled water HVAC units (see Figure 8).
 - 10B - sound suppression lines, HVAC lines, power panels and communications.

Figure 6. 7B - Sound suppression

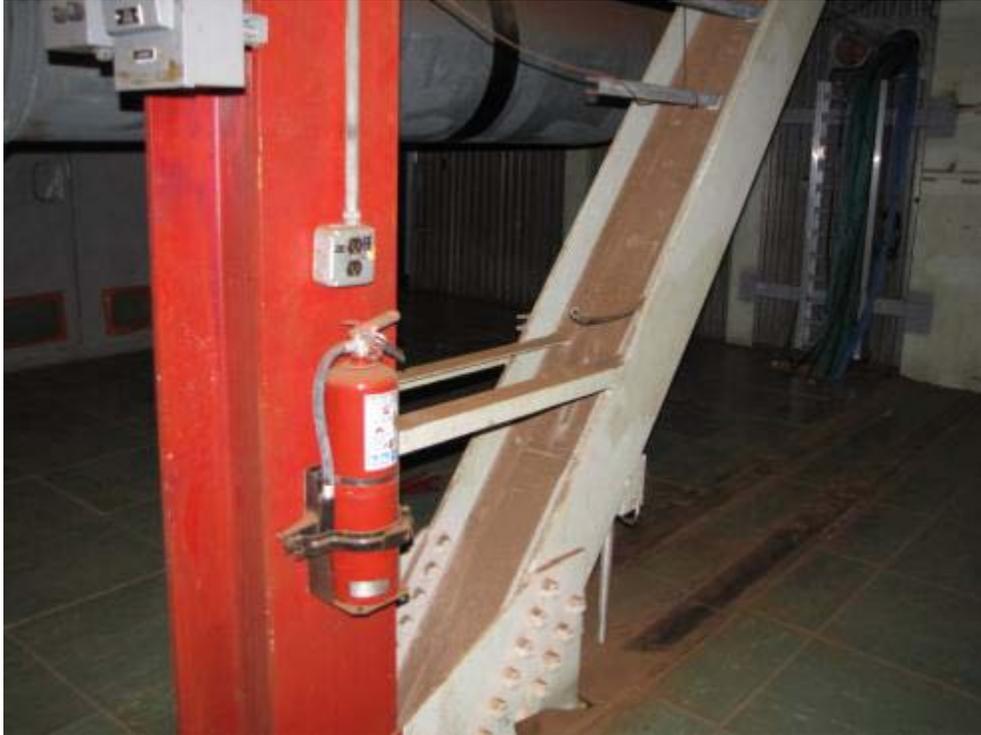
Figure 7. 7B - Hand-held fire extinguisher

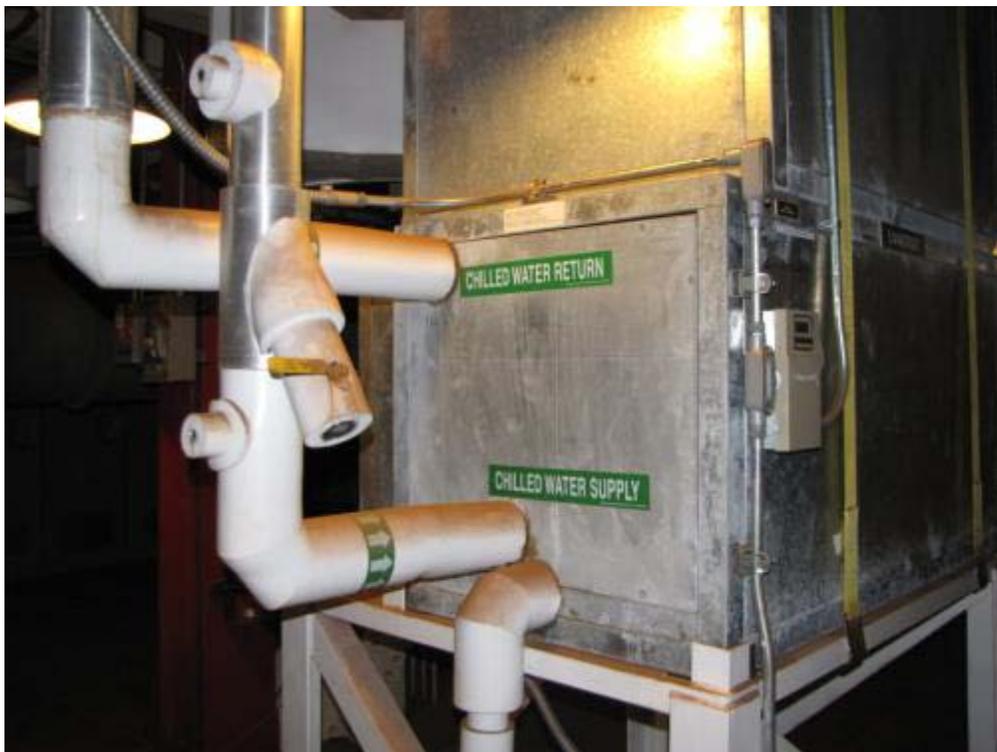
Figure 8. 7B - HVAC unit

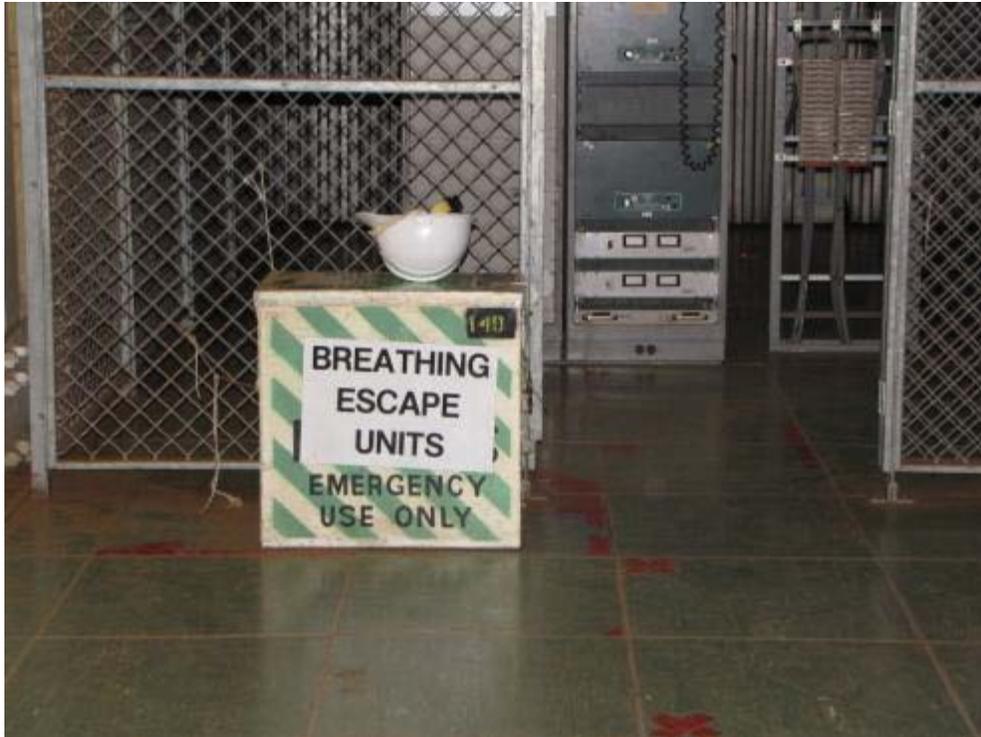
- 9B - ELSA box (see Figure 9), the empty cage that formally housed a Satellite Accumulation Area (SAA) when at the Launch Pads (see Figure 10), heater power switching panels (see Figure 11) and a dry type transformer.

Figure 9. 9B - ELSA box

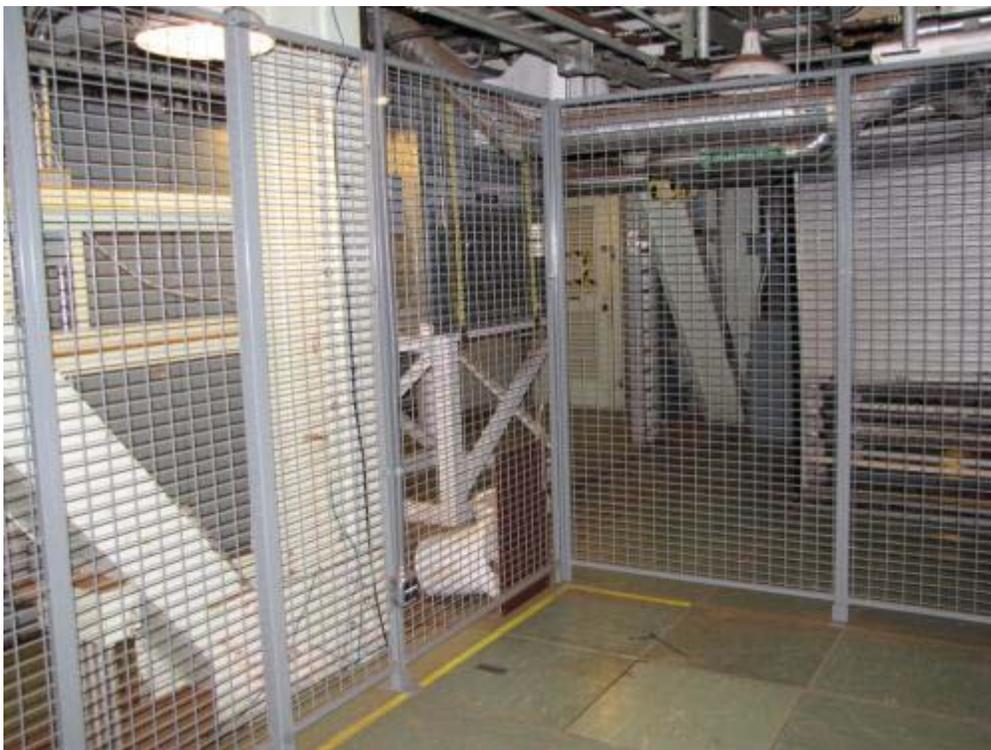
- All hazardous wastes produced by USA operations have been removed and the Satellite Accumulation Area (SAA) in Room 9B was formally closed on October 27, 2011. This mixed crib operated only while the MLP was on the Pad with a Shuttle. Small quantities of solvents were issued from this area to support orbiter operations as needed. The chemicals were removed from this area and the site would remain inactive at all other times.

Figure 10. 9B - Empty caged area that formally housed a Satellite Accumulation Area

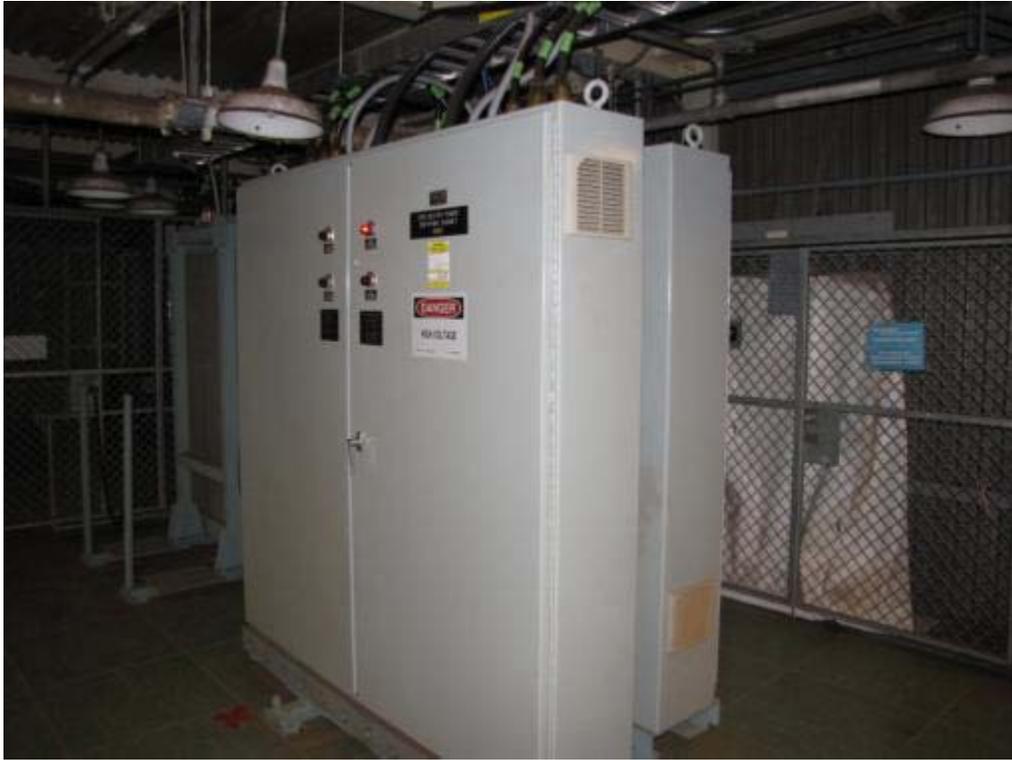
Figure 11.9B - Heater power switching unit

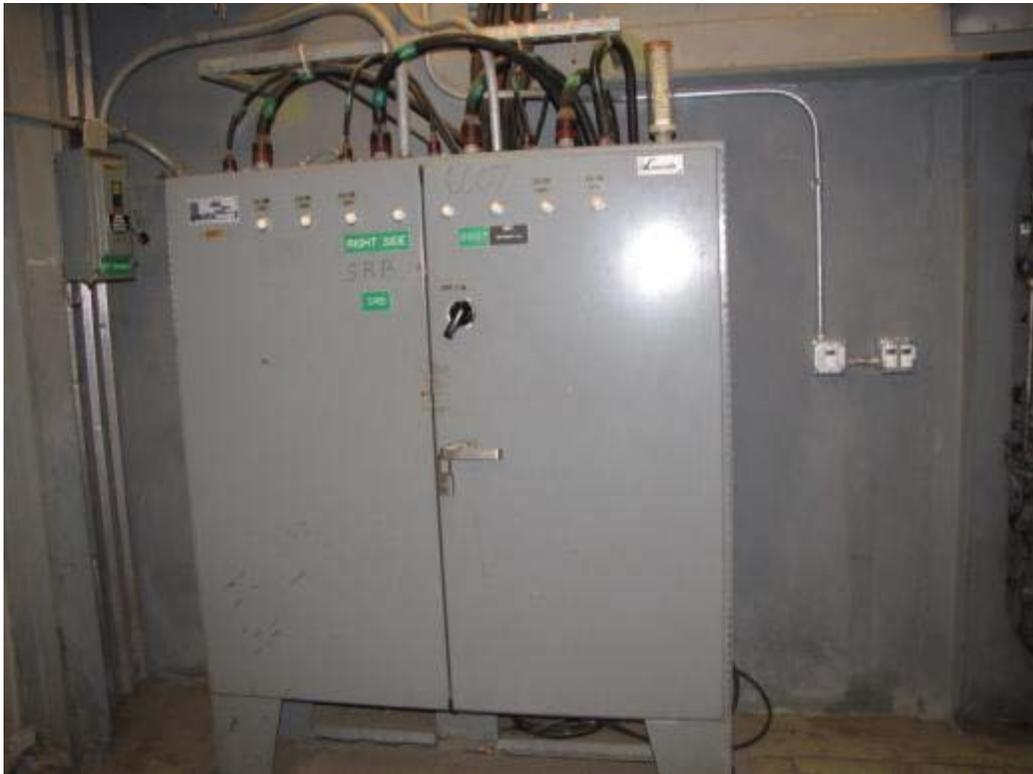
- 48B is an instrumentation room.
 - 36AB has sound suppression and power lines.
 - 37AB - power supply for the Solid Rocket Booster (SRB) winches (see Figure 12).

Figure 12.37AB - Power supply for SRB winches

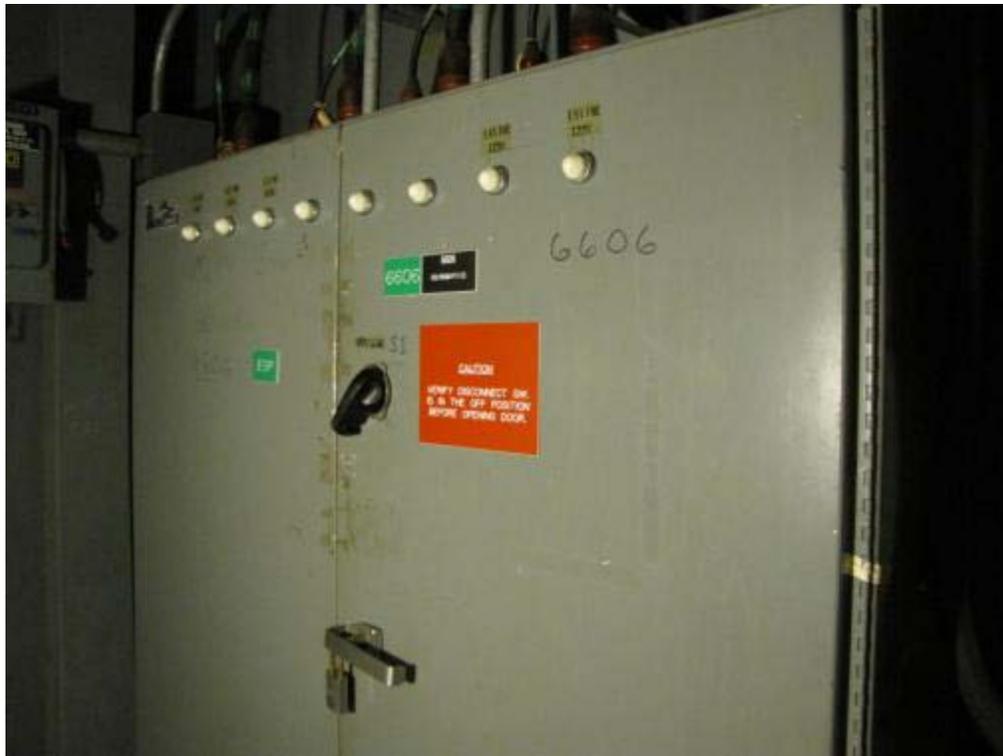
- 38AB - power supply for Space Shuttle Main Engine (SSME) winches (see Figure 13).
 - 37A - Four SRB winches are in this compartment (see Figure 14).
 - 47AB - water lines for the sound suppression system.

Figure 13. 38AB - SSME power supply

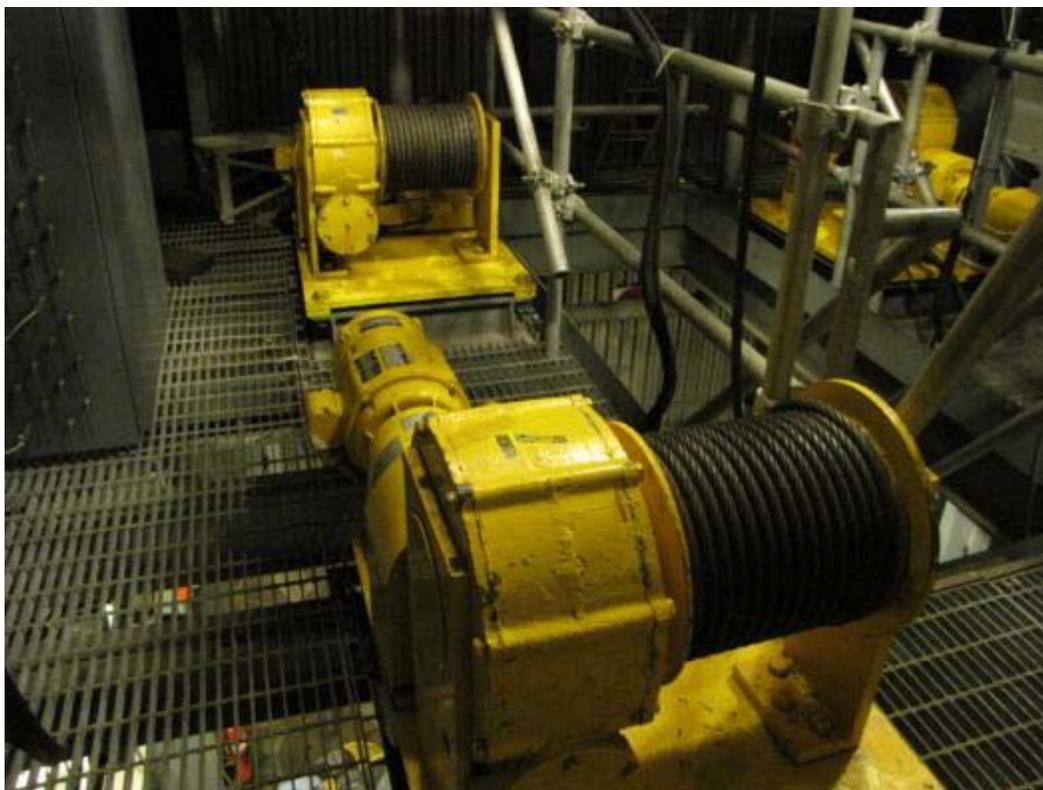
Figure 14. 37A - SRB winches

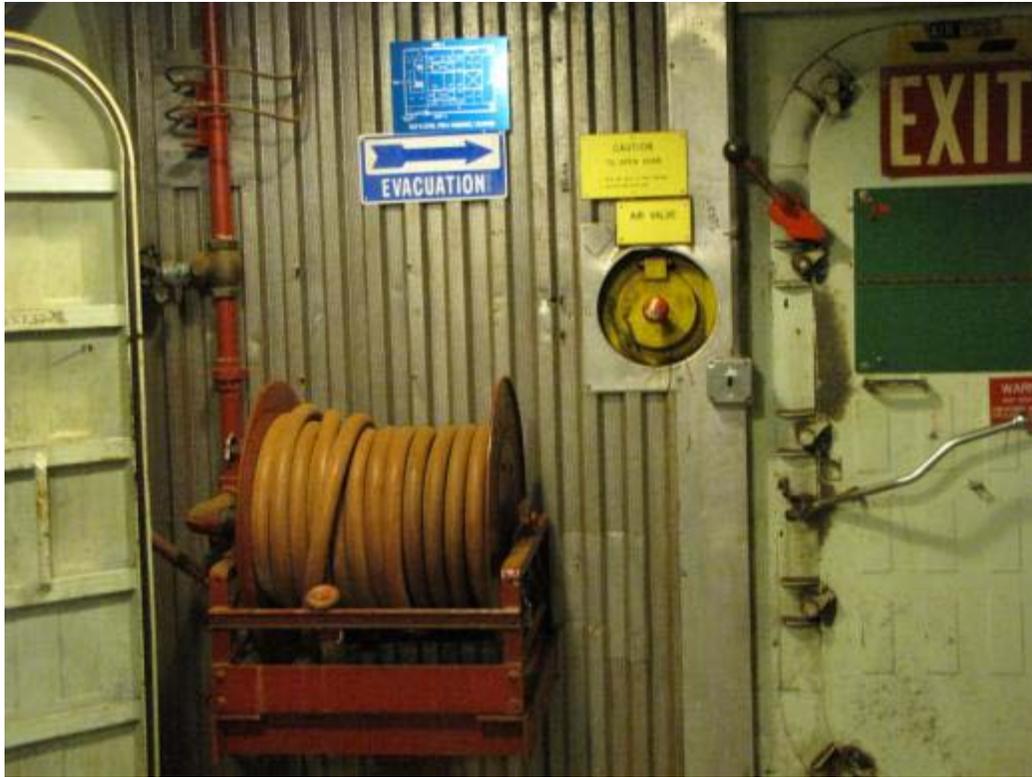
- 15B – Fire suppression hose (see Figure 15), Integrated Network Control System (INCS) panel (see Figure 16), ELSA box and a dry type transformer.
 - 16B - oxygen analyzer monitoring unit (see Figure 17), chilled water lines, SRB hydraulic pumper with 104 gallon hydraulic oil tank , S/N S72-0841-01-010, (see Figure 18), SSME winches, two hand-held fire extinguishers, an alarm distribution panel (see Figure 19) and the empty 100 gallon contingency tank (see Figure 20). The hydraulic pumper is tagged with “Inactive – Verify Certification Before Reuse” and dated 10/31/2011. The hydraulic oil remains and the SPCC inspections will continue under GOC.

Figure 15. 15B - Fire suppression hose

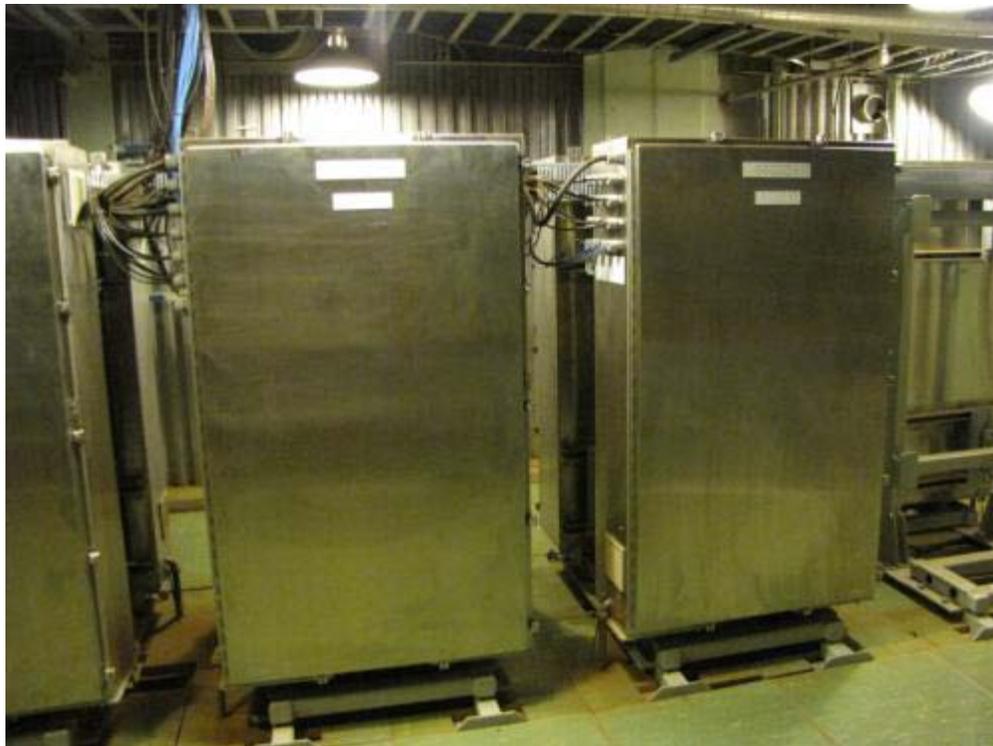
Figure 16. 15B - INCS

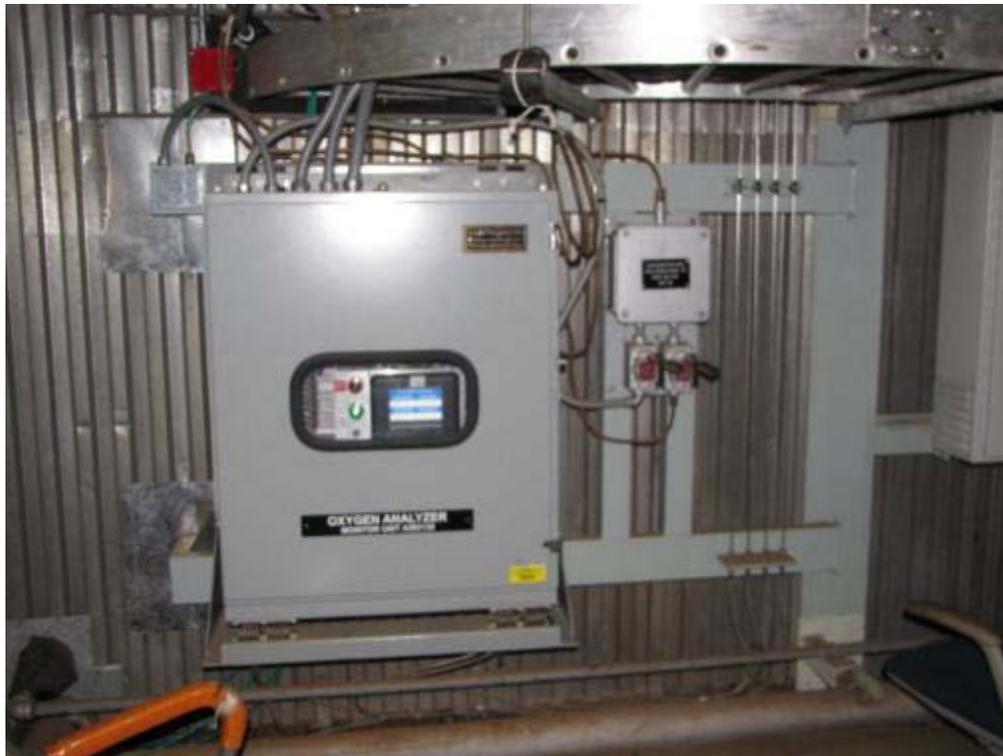
Figure 17. 16B - Oxygen analyzer monitoring unit

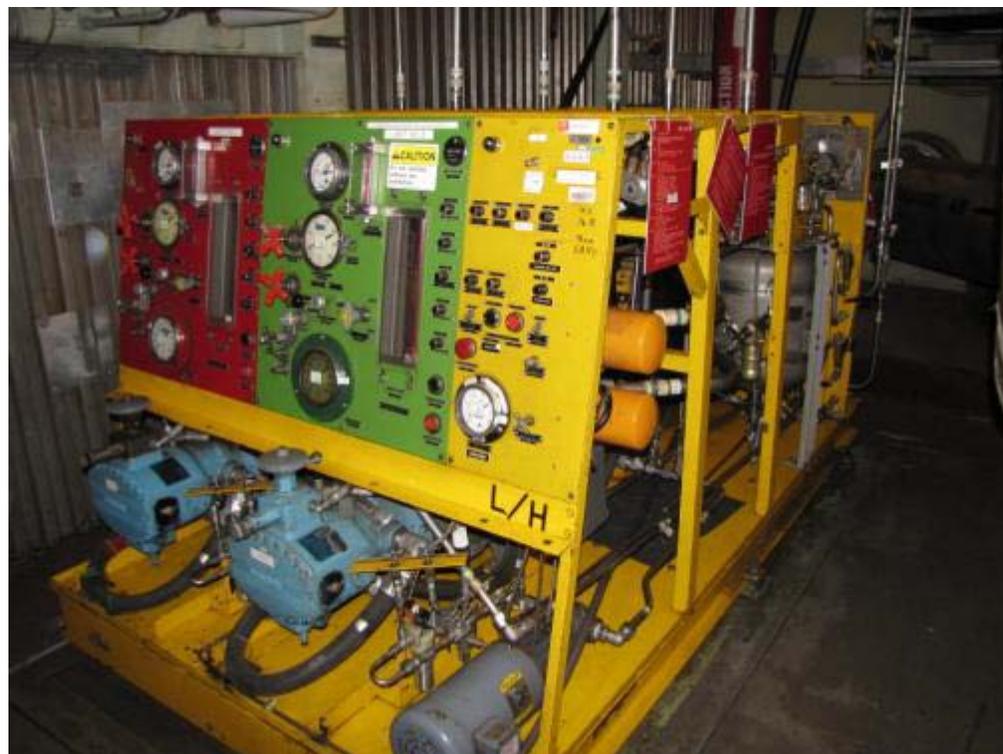
- The hydraulic pumping systems existed to supply the Space Shuttle's SRBs and Orbiter with hydraulics. The three 104 gallon capacity reservoirs are located in Compartments 2B, 43B, and 16B. There is secondary containment "coffins" surrounding each pumper. Stainless steel piping supplies hydraulic fluid to Zero-Level.

Figure 18. 16B - Hydraulic pumper

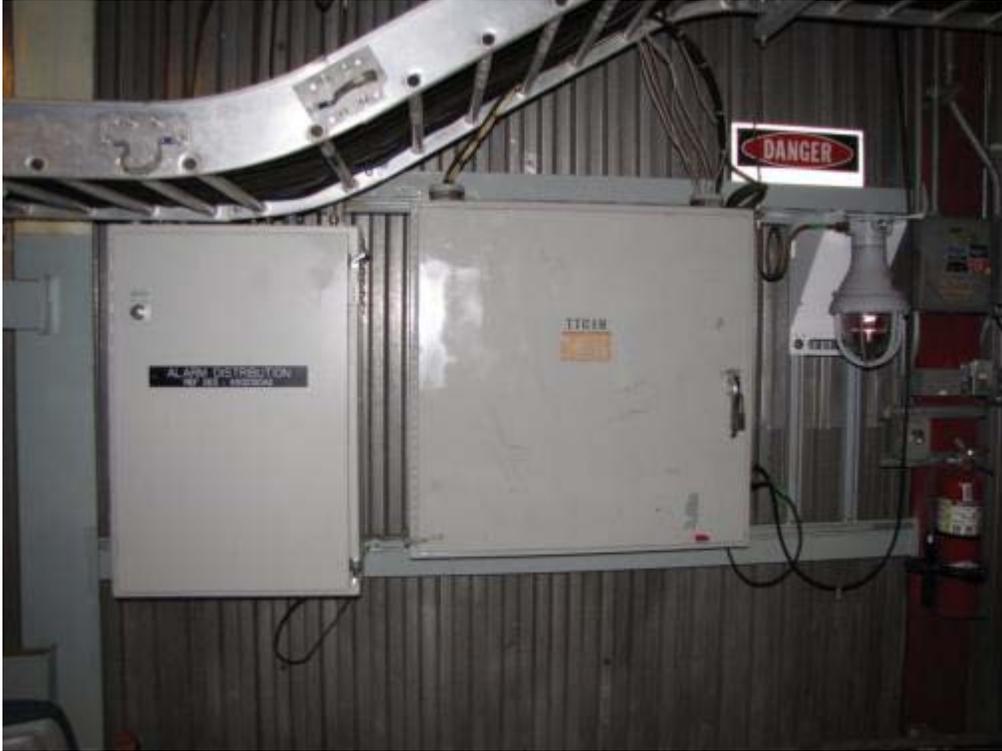
Figure 19. 16B - Alarm distribution panel

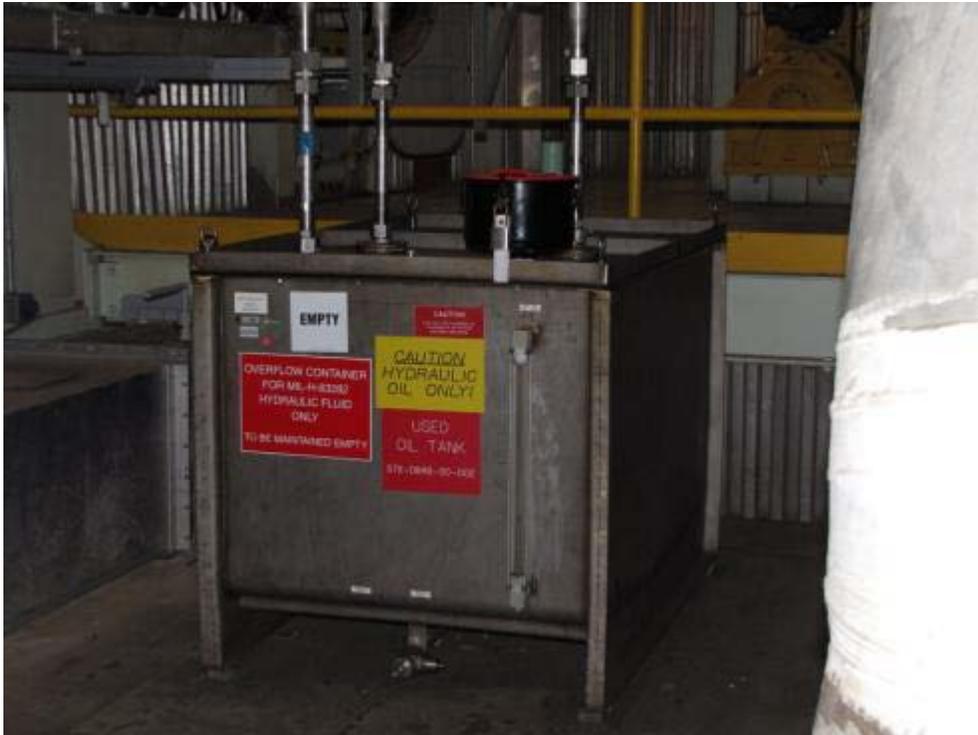
- In compartment 16B there is a 100-gallon capacity, single-walled contingency tank to collect excess hydraulic fluid in case of over-pressurization. The tank is labeled as empty.

Figure 20. 16B - Empty 100 gallon contingency tank

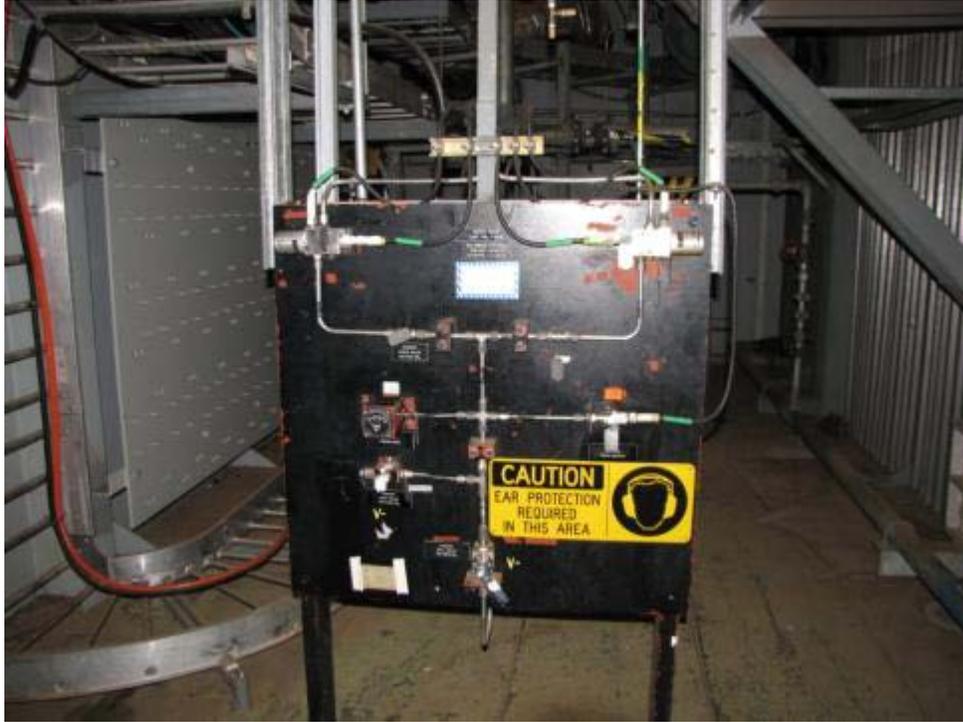
- 40AB - water valve control panel for the sound suppression system (see Figure 21).
- 41B - compressed air tank, potable water system and Firex (see Figure 22).

Figure 21. 40AB - Water valve control panel

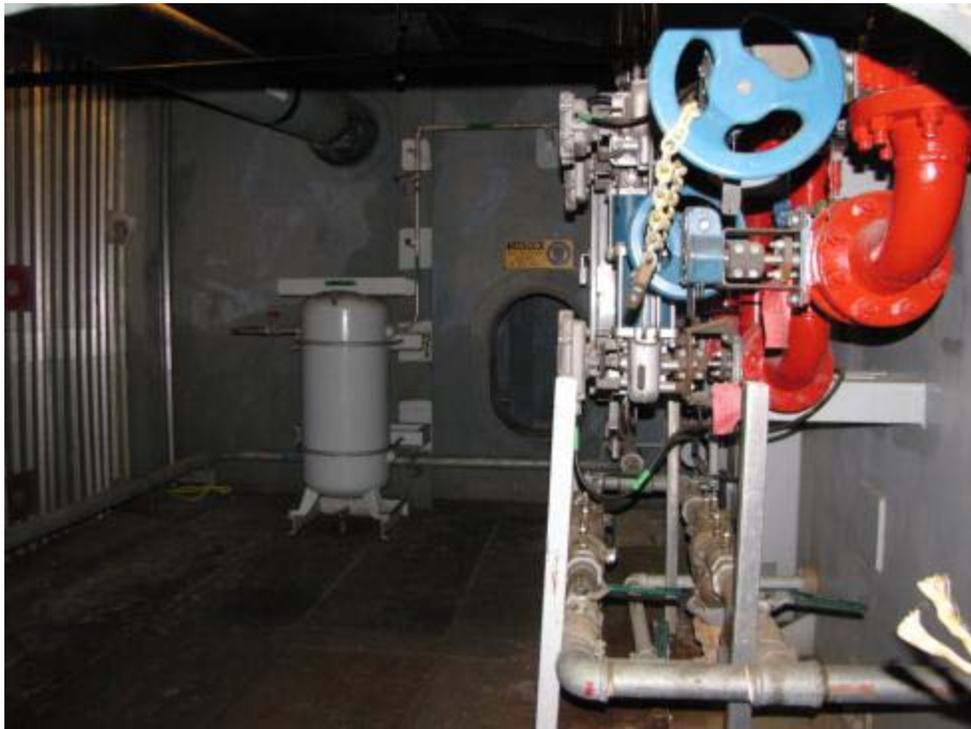
Figure 22. 41B - Compressed air tank, potable water system and fire suppression

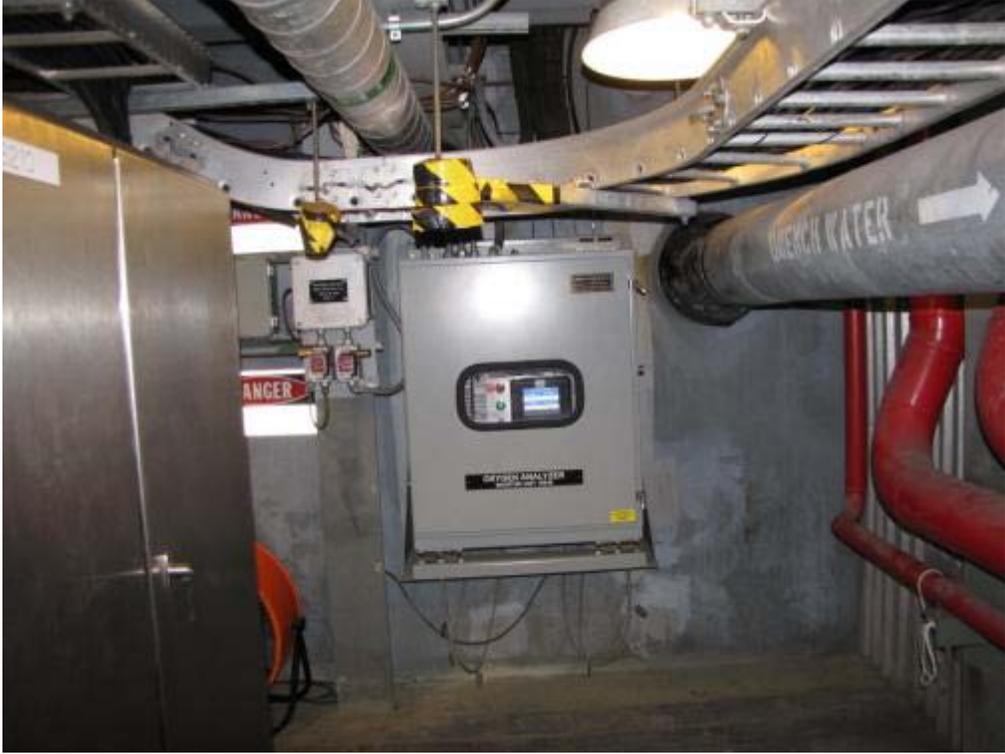
- 44B - INCS panels, oxygen analyzer, an alarm distribution panel, sound suppression water pipes and Firex (see Figure 23). The SSME heater panel and the GN2 panel for the LOX system have been removed.

Figure 23. 44B - Oxygen analyzer panel, INCS, sound suppression and Firex

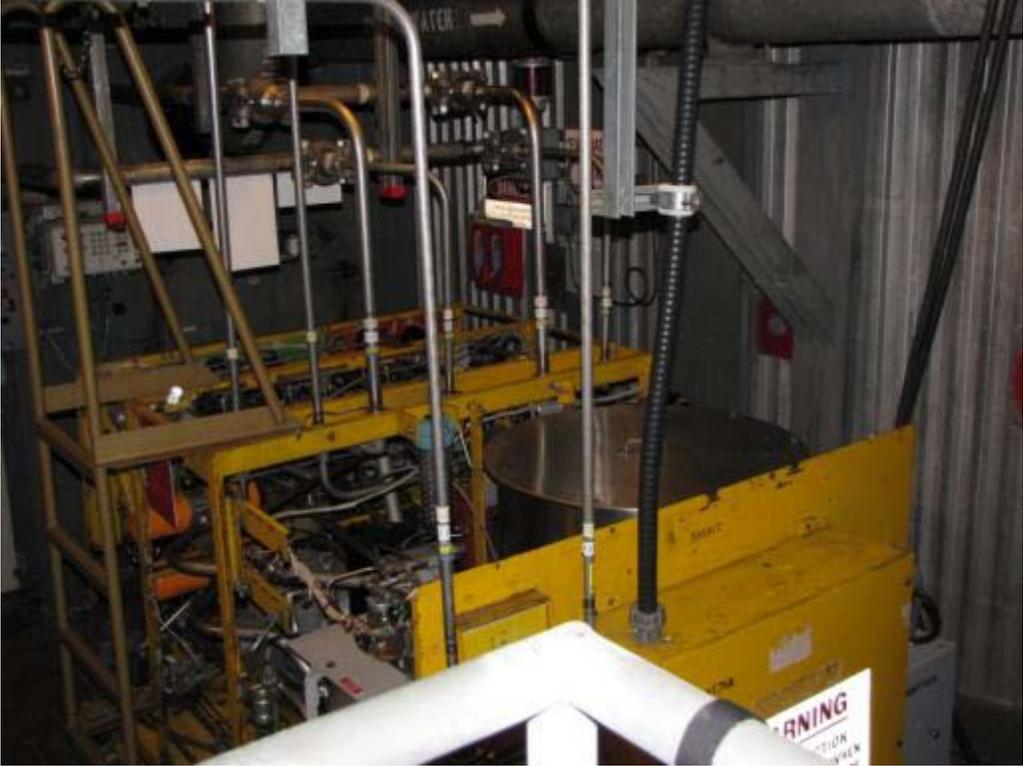
- 43B - Orbiter hydraulic pumper with 104 gallon hydraulic oil tank, S/N S72-0841-01-006, (see Figure 24).). The hydraulic oil remains and the SPCC inspections will continue under GOC.

Figure 24. 43B - Hydraulic pumper

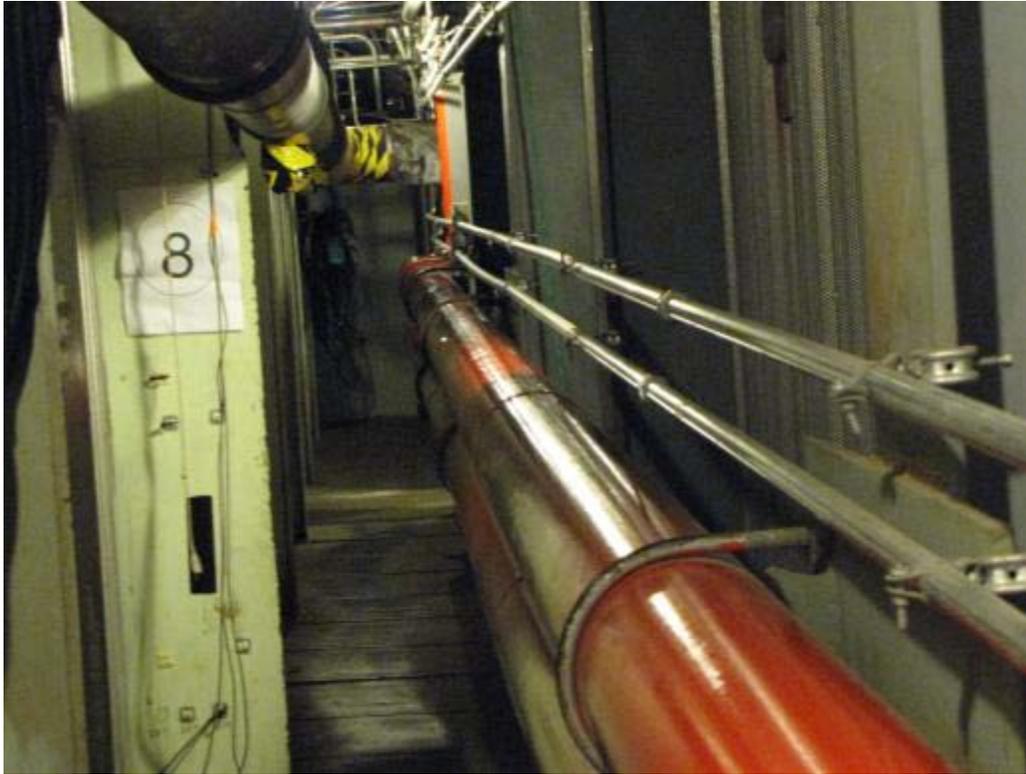
- 42B - sound suppression and ventilation lines.
- 45AB - fire suppression pipes (see Figure 25).
- 34B - two oxygen analyzer monitoring units, two ELSA boxes, and Firex lines. The helium panel and LH2 panel have been removed.

Figure 25. 45AB - Fire suppression lines

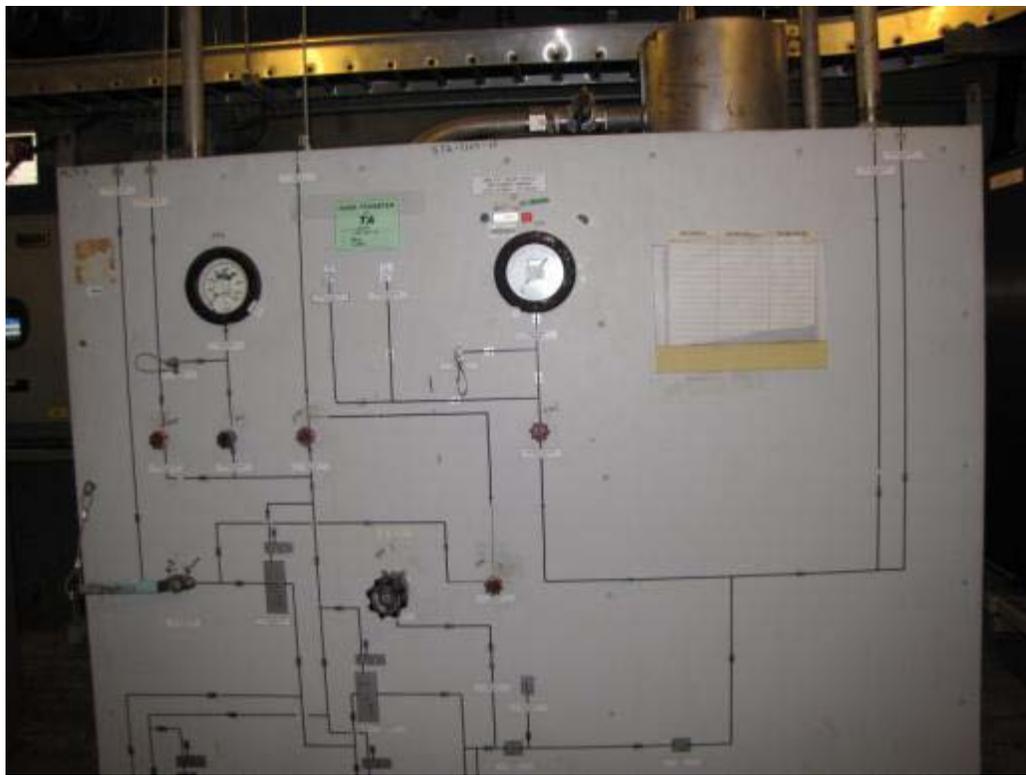
- 33B - SRB Aft Skirt Purge panel (see Figure 26), alarm distribution panel and an oxygen analyzer monitoring unit. The Orbiter Helium Anti/Ice panel has been removed (see Figure 27).

Figure 26. 33B - SRB aft skirt purge panel

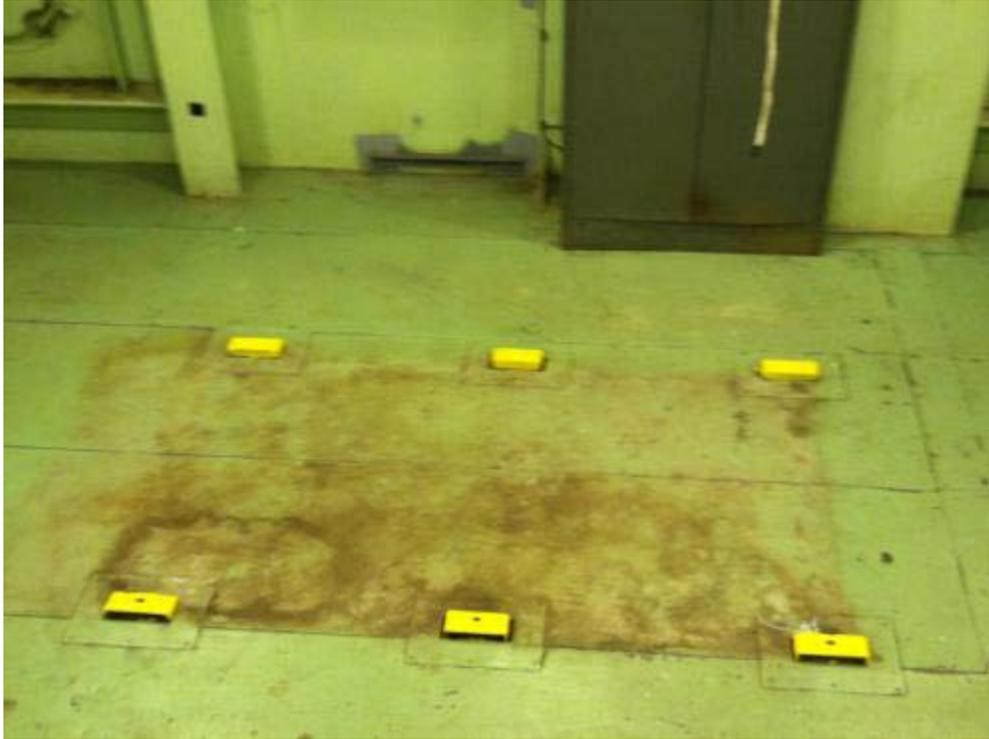
Figure 27. 33B – The Orbiter Helium Anti/Ice Panel has been removed

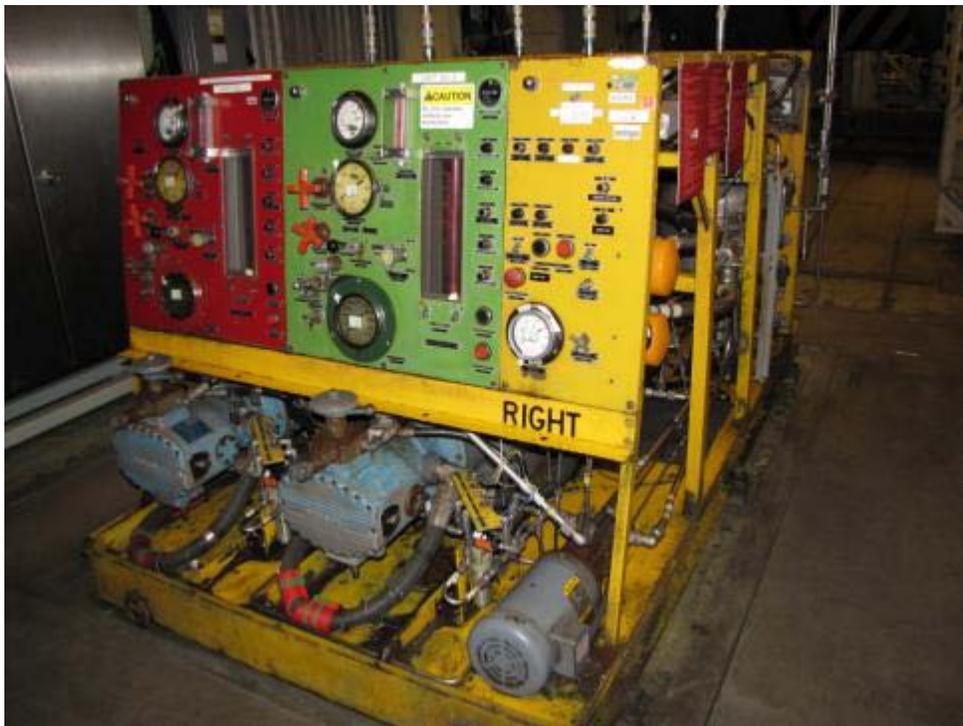
- 35AB, 32AB, 39AB and 42AB all contain sound suppression lines.
- 2B - two SSME winches, hand held fire extinguisher, ELSA box, oxygen analyzer monitoring unit, SRB hydraulic pumper unit, S/N S72-0841-01-004, (see Figure 28), Orbiter/SRB Control Panel and ventilation lines. The hydraulic oil remains and the SPCC inspections will continue under GOC.

Figure 28. 2B - Hydraulic pumper

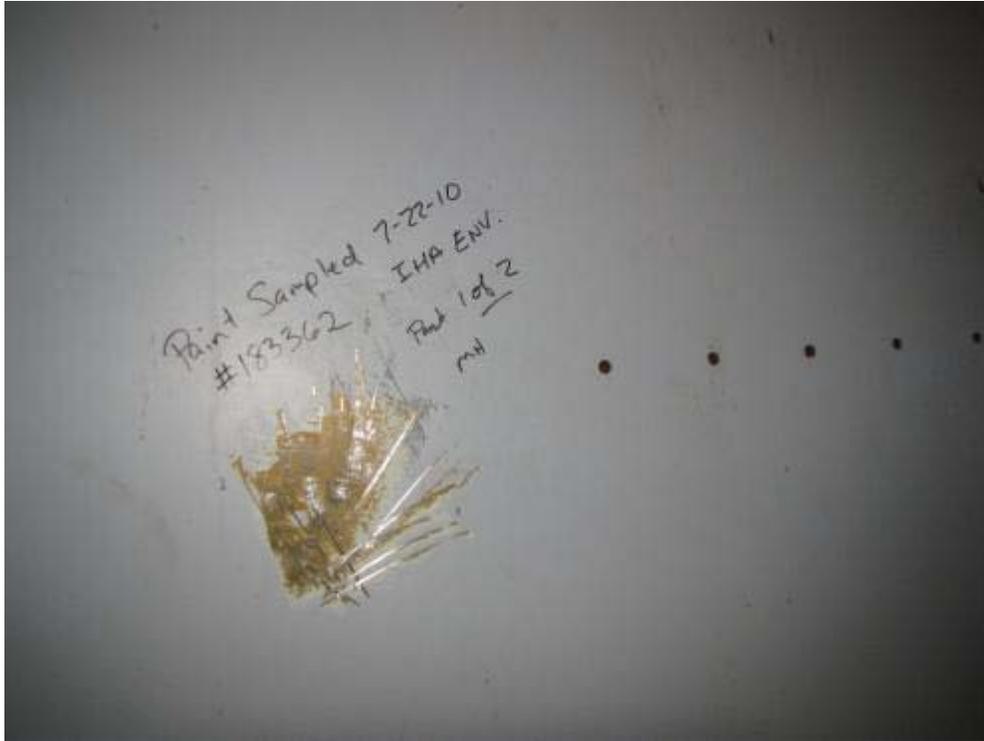
- An asbestos survey, performed in May 1997 indicated friable asbestos in MLP 3. Lead and polychlorinated biphenyl (PCB) contaminated paints are also known to be present. Information regarding the location and quantity of known asbestos as well as contaminated paints will be provided to any occupant of this facility through the Medical Environmental Support Contractor (MESC) Environmental Health office.
- Residual hydraulic fluid remains in equipment and ancillary hydraulic lines.

- 30AB - sound suppression and ventilation pipes. There is also an area where paint was sampled (see Figure 29). Paint sampling areas were noted throughout the MLP.

Figure 29. 30AB - Example of paint sampling site
