Turnover Environmental Condition Assessment
(TECA)
for
Mobile Launch Platform 3 (MLP 3)

May 9, 2012

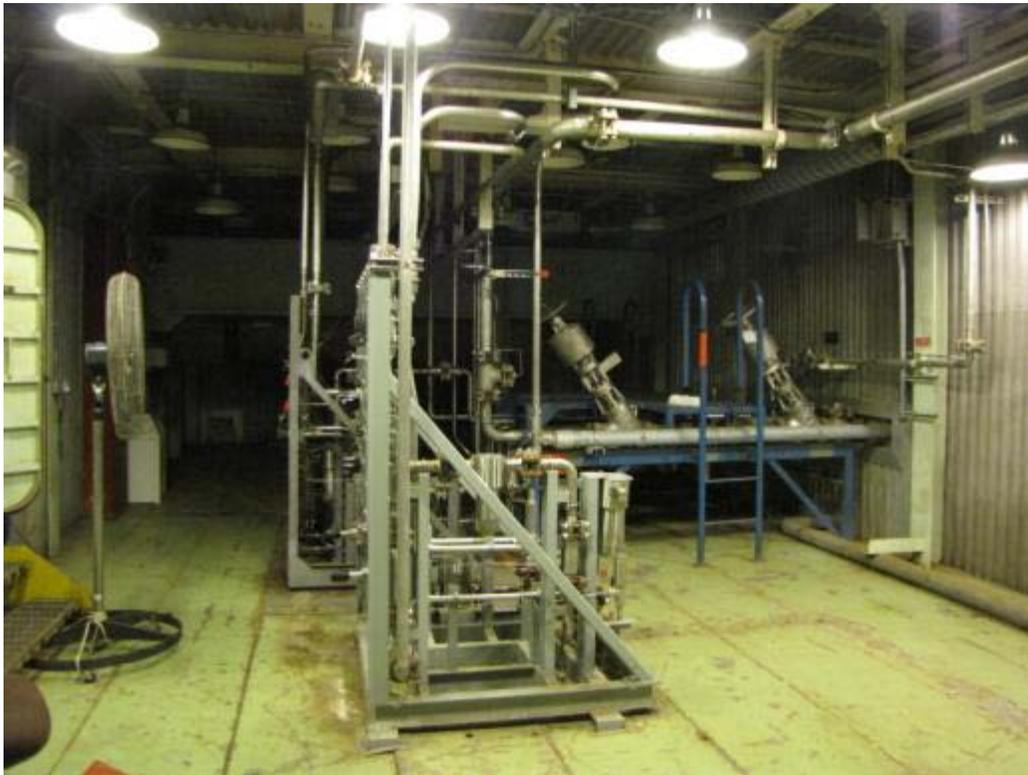
- 31B - ELSA box.
- 1B - hand held fire extinguisher, oxygen analyzer monitoring unit, alarm distribution panel and the main facilities helium and nitrogen interface to the MLP (see Figure 30).

Figure 30. 1B - Main facilities helium and nitrogen interface to MLP

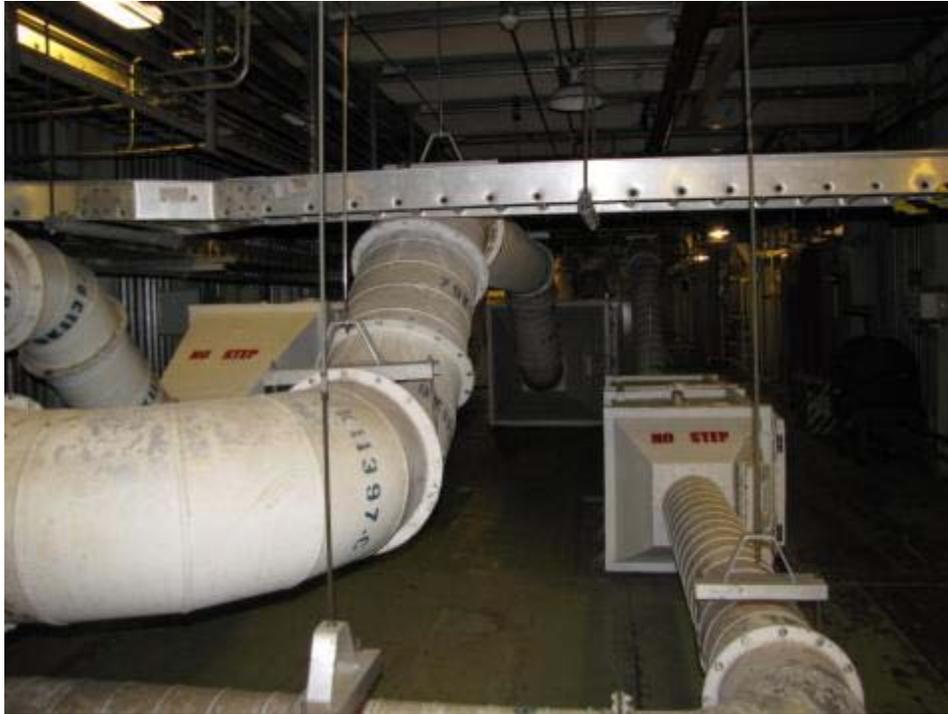
- 2A- two ELSA boxes, Fire alarm sensor panel, oxygen analyzer monitoring unit, hand held fire extinguisher and orbiter ECS system lines and filters (see Figure 31). This compartment stored the aft orbiter platform which has been removed and stored in the VAB (see Figure 32).

Figure 31. 2A - ECS system lines for orbiter

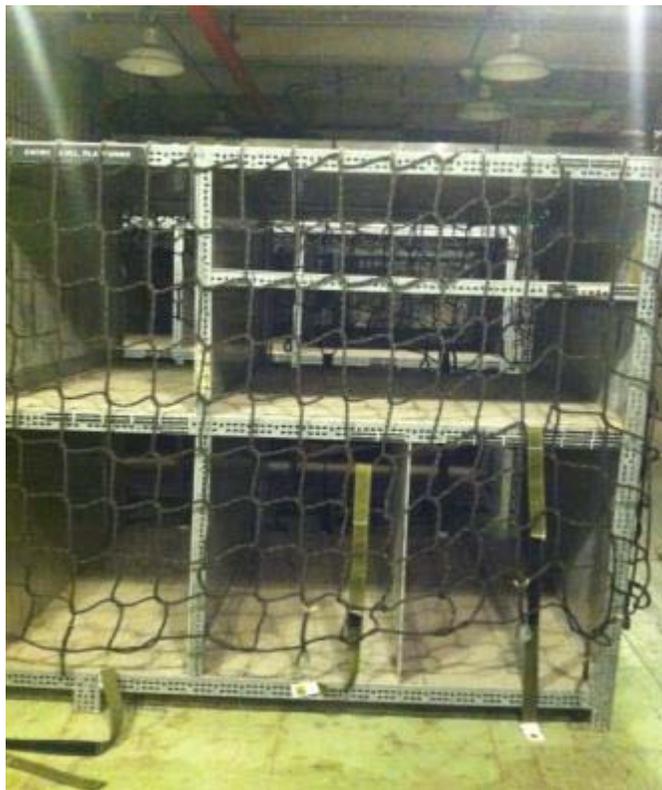
Figure 32. 2A - Storage area formally used for aft orbiter platform

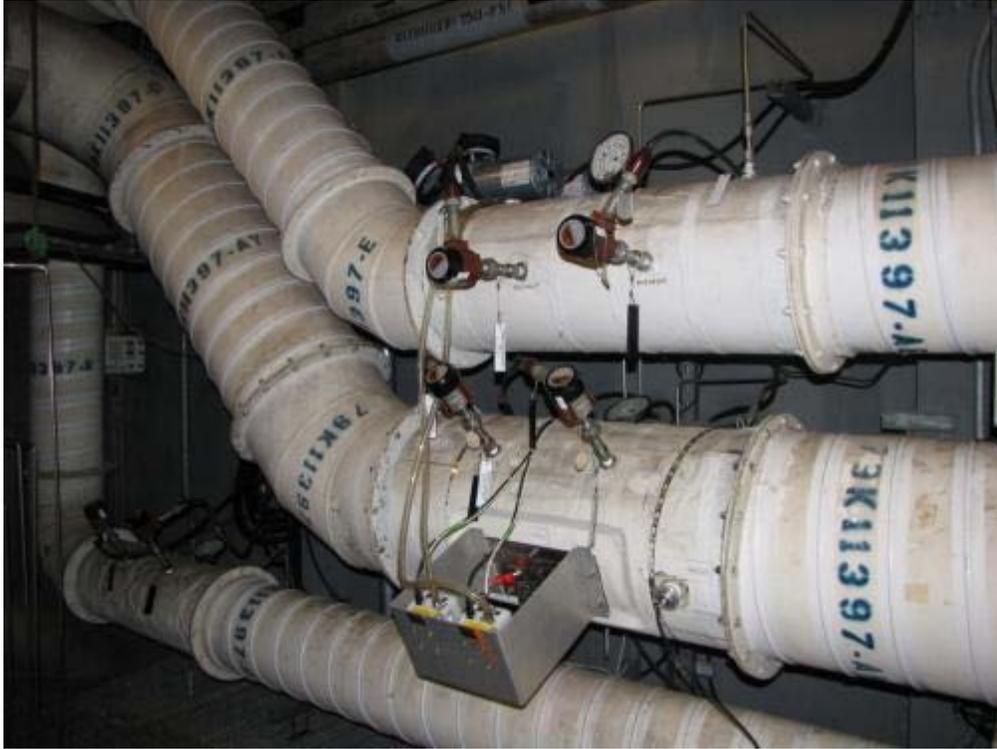
- 33A- INCS control panels and the ECS system particle counter (see Figure 33).
- 31A - two SRB winches.
- 1A - a dry type transformer, hand held fire extinguisher and ECS lines.

Figure 33. 33A - ECS system particle counter

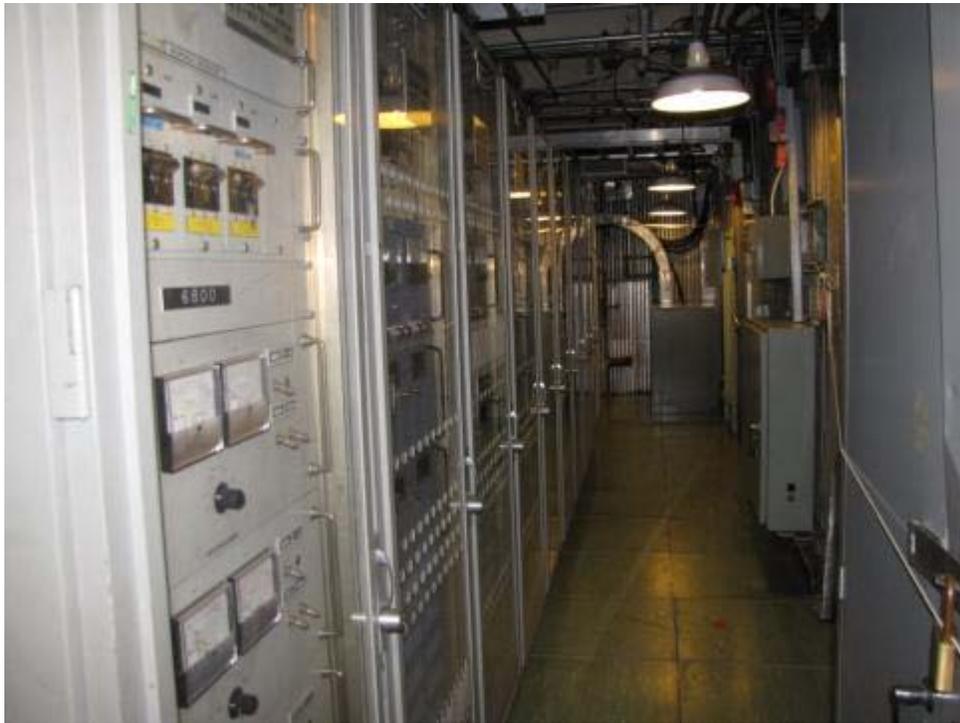
- 21A- two dry type transformers, main power supply control panel (see Figure 34), ni-cad batteries and a hand held fire extinguisher. The Halon fire suppression system tank previously located in this room was removed.

Figure 34. 21A - Main power supply control panel

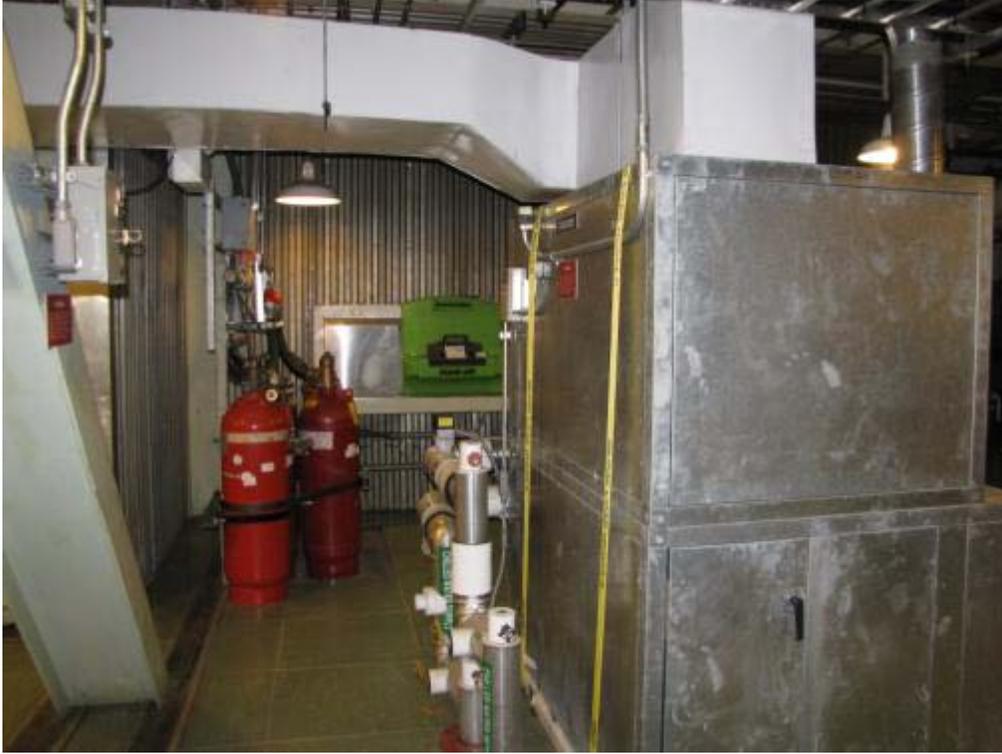
- 8A - portable eyewash station, stainless steel double sink, chilled water supply (see Figure 35) and two dry-type transformers. The Halon fire suppression system tanks previously located in this room were removed.

Figure 35. 8A - Halon, portable eyewash station, stainless steel sink and chilled water supply

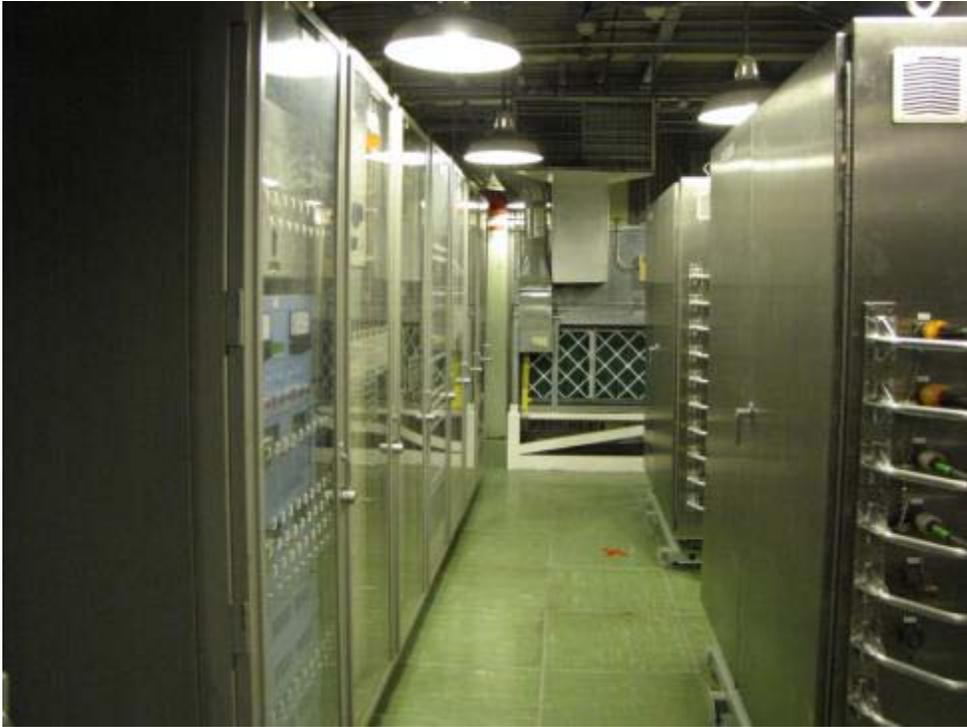
- 7A - a helium tank, hand held fire extinguisher, power supply for orbiter and SRB (see Figure 36) with a battery back-up (see Figure 37), hazardous gas warning system, hydrogen umbilical mass spectrometer (HUMS) (see Figure 38), and a transformer. The Halon fire suppression system tanks were removed.

Figure 36. 7A - power supply

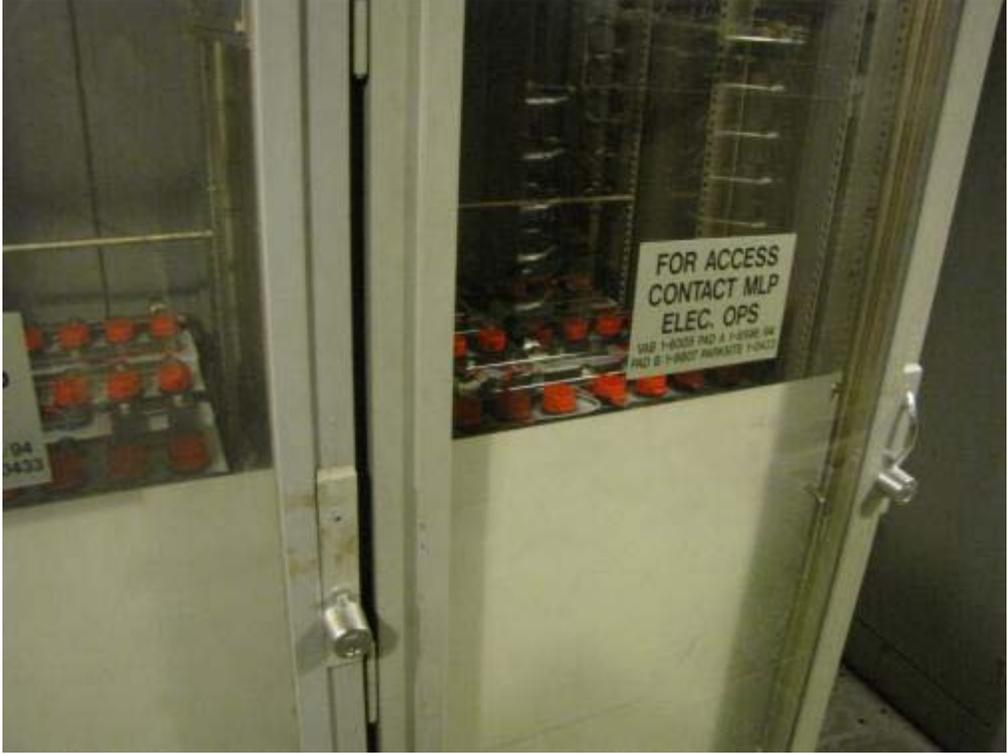
Figure 37. 7A - Battery backup

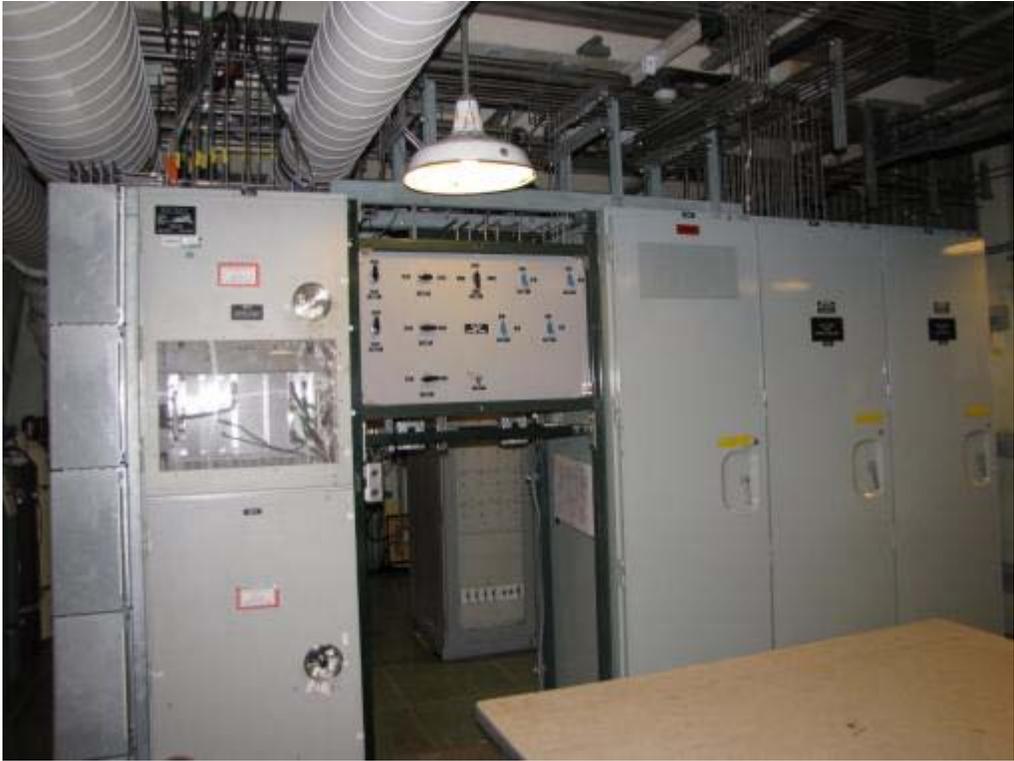
Figure 38. 7A - HUMS

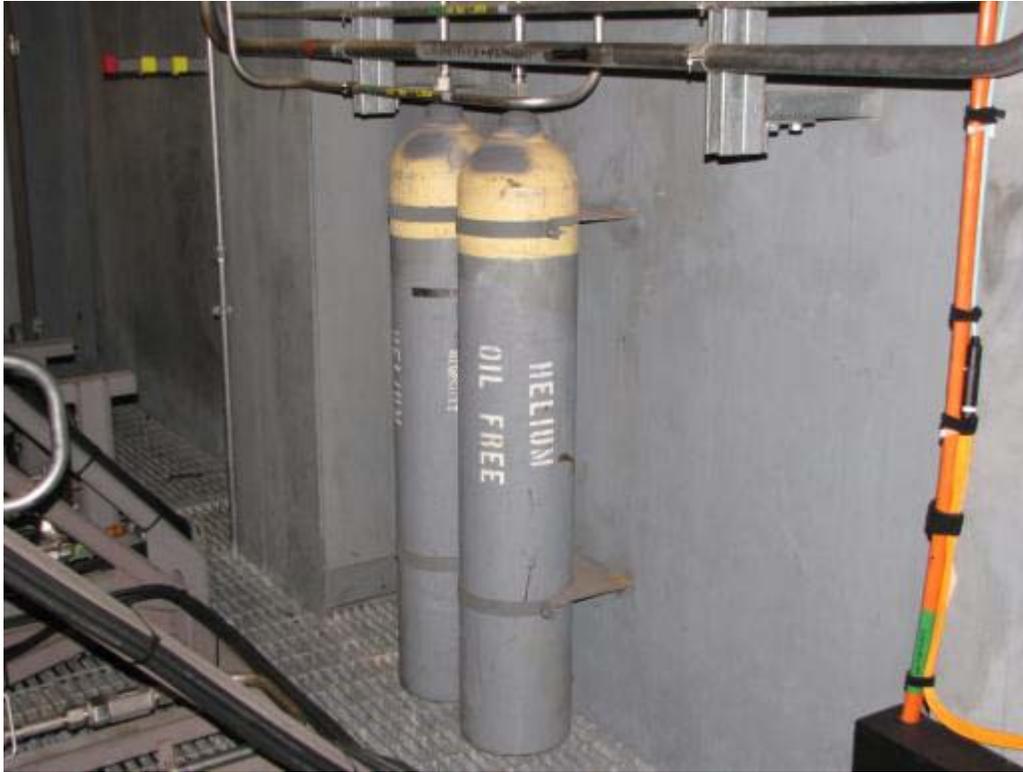
- 44A-a hand held fire extinguisher, phone, GN2 control panel, Firex lines, sound suppression system lines, and two helium tanks. The hydrogen system control panel and the SSME GN2 heater controller were removed.
- 43A - Freon R-124 system which is currently empty, (see Figure 40) with a tank for over-pressurization (see Figure 41), HVAC system lines, GN2 panel, and tanks helium, nitrogen, shop air and breathing air for the hazardous gas warning systems.
- 41A - two SRB winches.

Figure 39. 44A - Helium tanks

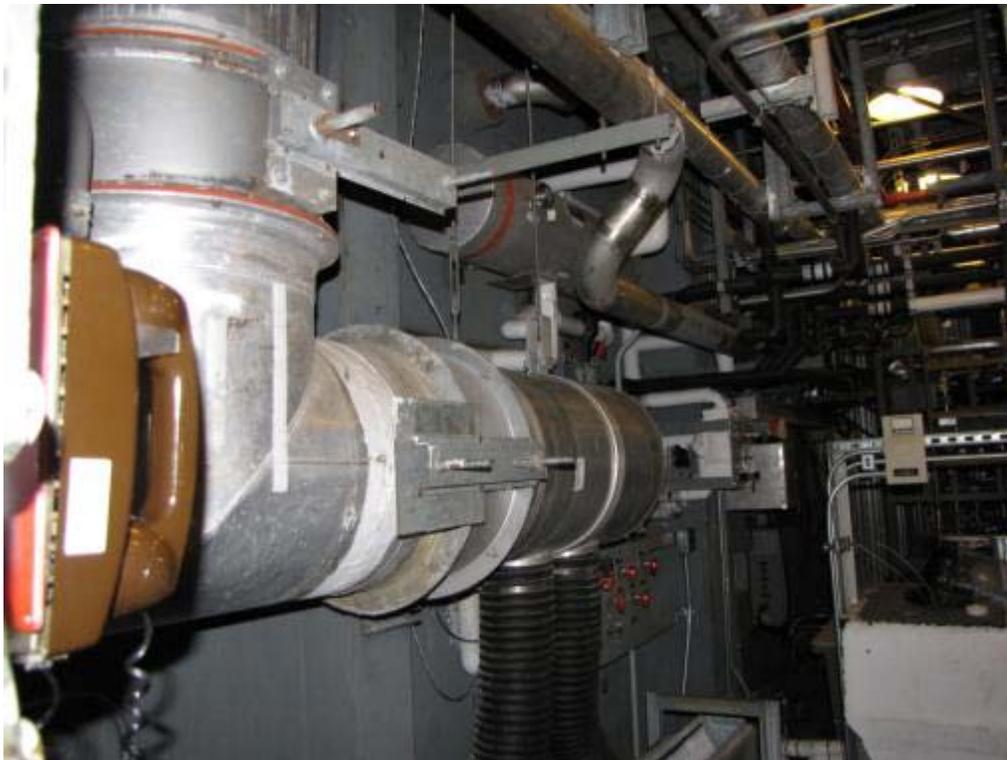
- The MLPs have multiple petroleum-containing lubrication and compressed gas systems.
 - The ground cooling system utilizes Freon R124 It includes a heat exchanger, catch tank for over-pressurization) and an emergency vent. This system was drained and purged with GN2 after each launch.

Figure 40. 43A - Freon 124 system

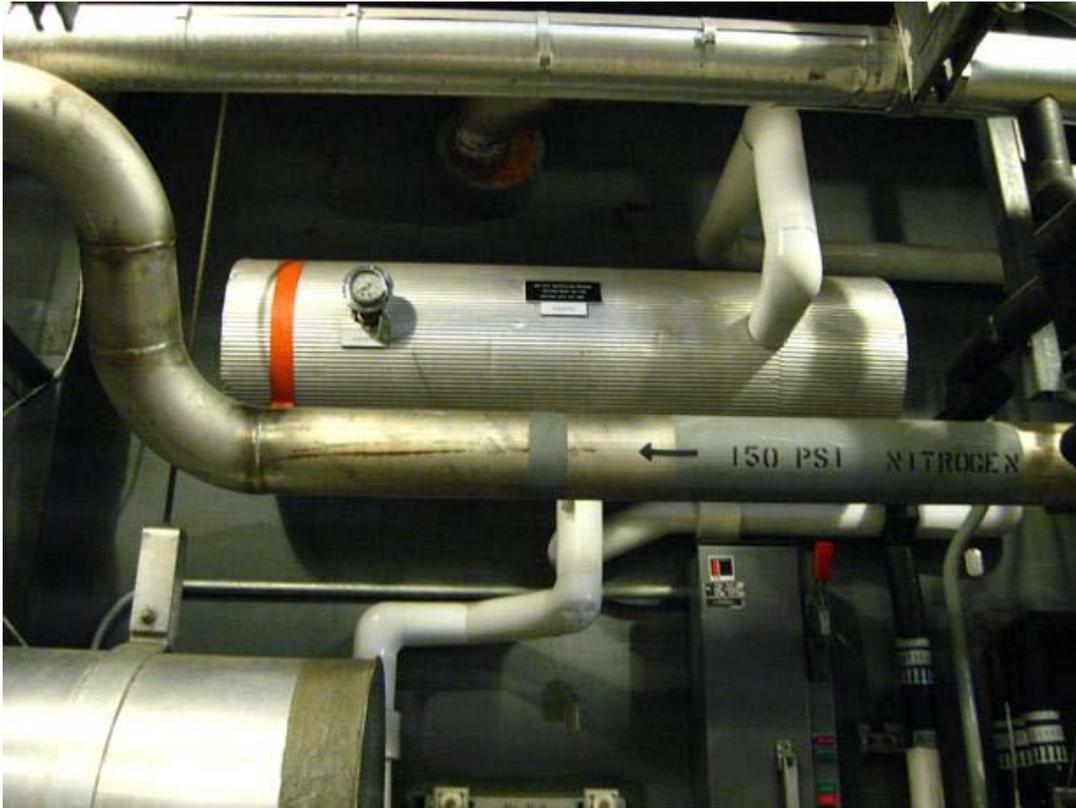
Figure 41. 43A - Freon R124 Tank for Over-Pressurization
