FACILITY INSPECTION REPORT

Facility No:	K6-1145, K6-1145A		Fiscal Year:	2012
Facility Name:	Multi-Function Facility, Electrical Substation		Inspection Date:	12/11
Location:	Kennedy Space Center (KSC) VAB Area		Facility Owner:	NASA
RPI CRV:	\$3,439,185 and 58,442 as of 2010	Original Construction Date:	1985	
ISC Maintained Systems/Codes:	AC/FG/LU(ELV), AC(EHV), AI(MEC), FA/SC/SY(PHY), HV(HVC), PR/SR(STR), SS/WP(WWS)		FCA Type:	Refresh
Inspector(s):	Justin Gilman, Shannon Gordon

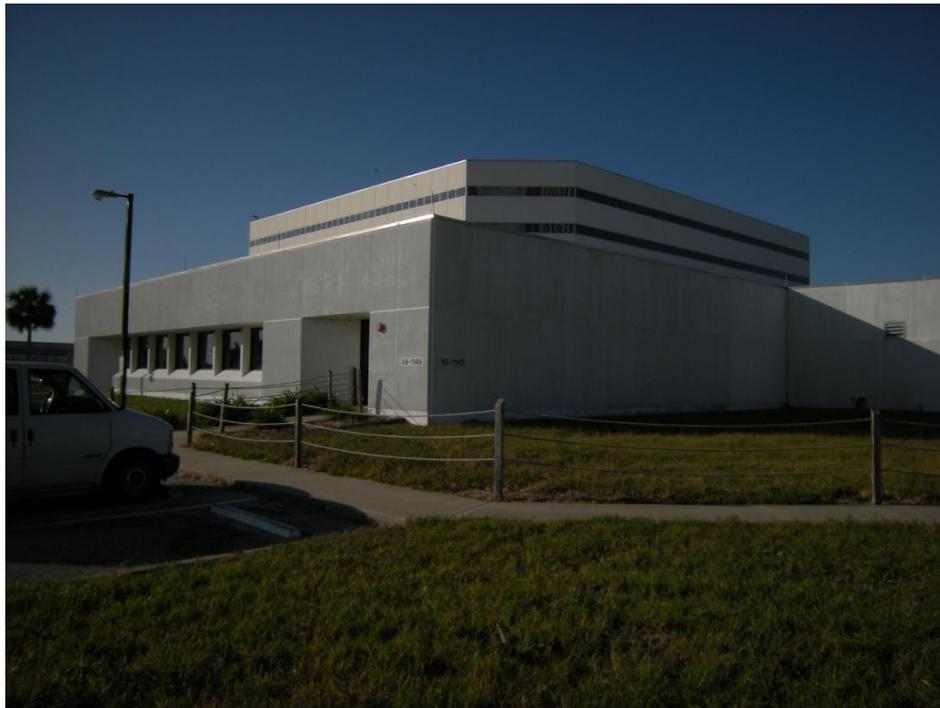
Figure 1. K6-1145 General View

K6-1145 – The facility has a concrete foundation and concrete pre-cast walls. Glass windows run the length of the East and South sides. (See Figures 1 & 2). The building has two sets of exterior storefront doors as well as two functioning power storefront doors. The south side of the facility exterior is partially covered, and there is a court yard that is not covered due to a removed awning. The rear of the facility consists of a loading dock area for the cafeteria and a drop off location for the medical facility.

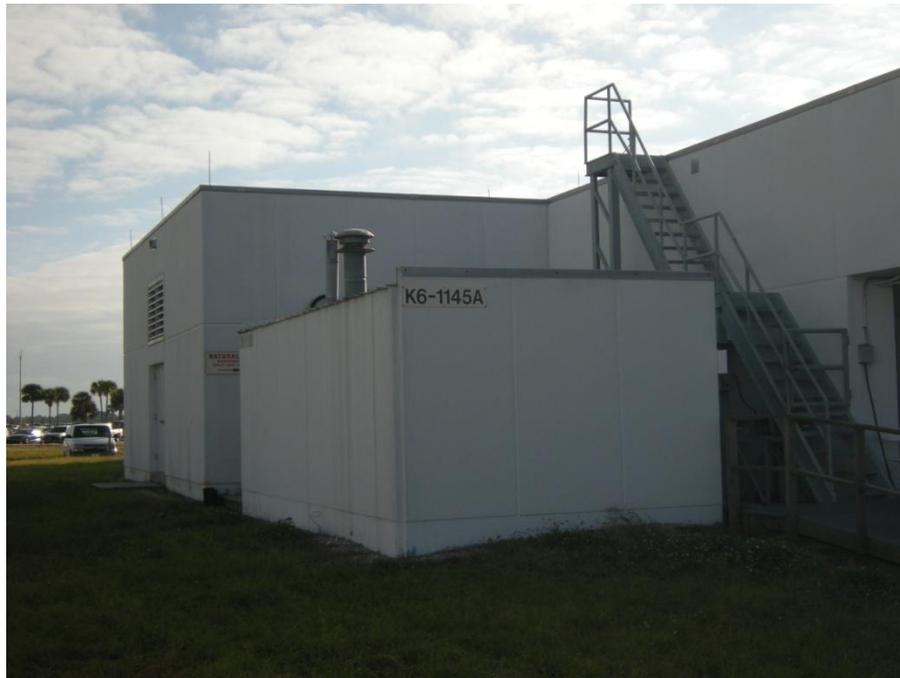
Figure 3. K6-1145A Rear View

Facility K6-1145A is a 192 square-foot facility that was constructed on a concrete foundation with pre-cast concrete walls and a corrugated metal roof system. The facility houses equipment that is responsible for supplying hot water to K6-1145 as well as a 300 Kilo Volt Amp transformer. See Figure 3.

K6-1145A – Half of the facility has a concrete foundation and concrete pre-cast walls. The west side is open at the south side and houses a transformer. The east side is enclosed and houses the water heaters and for K6-1145.
