**Asbestos Survey and Assessment of Vehicle Assembly
Building Lower Bays and Utility Annex Roofing**

Kennedy Space Center, Florida

BEST Project # 412-015
RS&H Project # 302-3354-019

**January 6, 2005
Amended February 3, 2005**

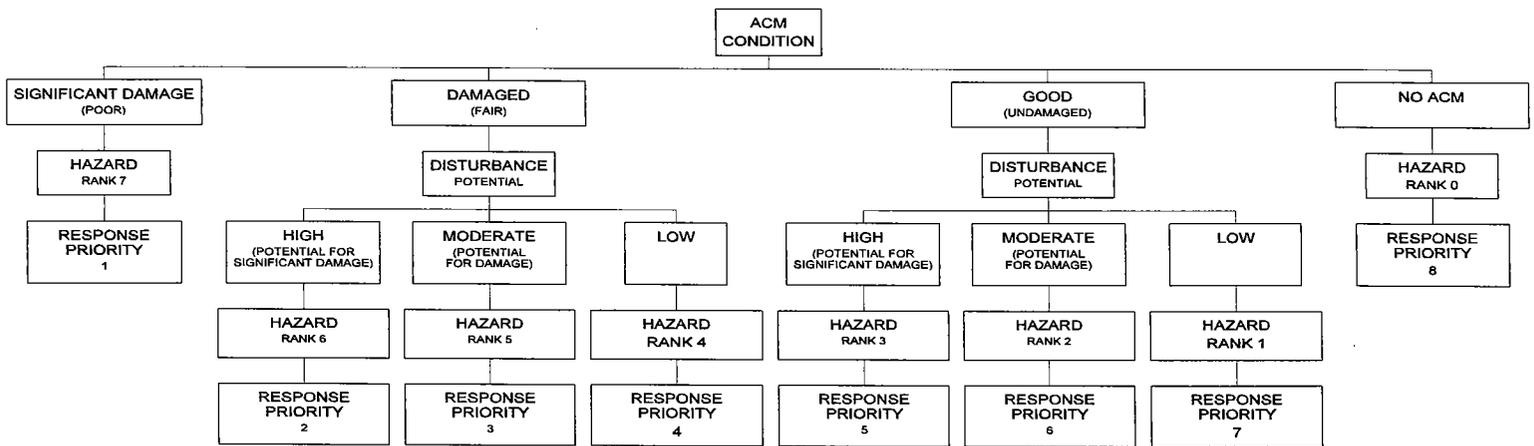
Figure 2-1
ASBESTOS HAZARD ASSESSMENT TREE

ASBESTOS HAZARD ASSESSMENT DECISION TREE

THE HIGHER THE HAZARD RANKING THE MORE SEVERE THE PROBLEM, AND BECAUSE PEOPLE TEND TO EQUATE A "1" WITH TOP PRIORITY, THE ASSIGNMENT NUMBERS FOR THE RESPONSE PRIORITY ARE REVERSED TO MAKE "1" THE HIGHEST RANKED.

<u>Figure</u>	<u>Page</u>
2-1 Asbestos Decision Tree	2-3

Using the above parameters, a risk assessment was conducted.
