Date:	2/11/13	Time:	12:45 PM	Weather:	41F Windy
Outfall System:	06	Structure ID:	4100	Shape:	Round
Structure Type:	SCB	General Appraisal:	8	Diameter:	2.2'
Casting labeled "STORM":	NO	Invert:	10.5'	Water Depth:	1"
Housing Material:	CONC				
Location:	East side of Building 57, in grass.

**Storm Sewer Inspection Reports**

**BARR & PREVOST**

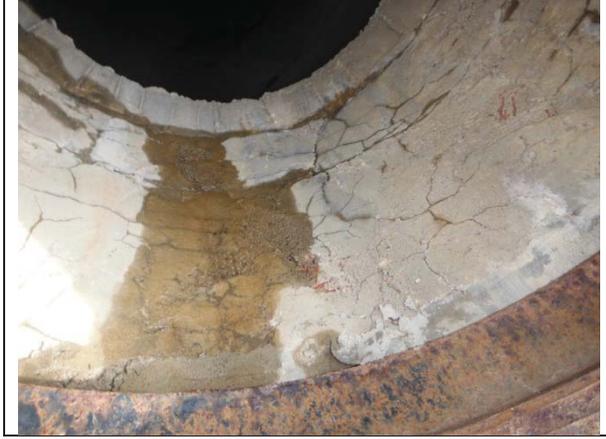
Map cracking on chimney. The map cracking has not appeared to affect the pipes coming into and out of the structure.

7: Map Cracking

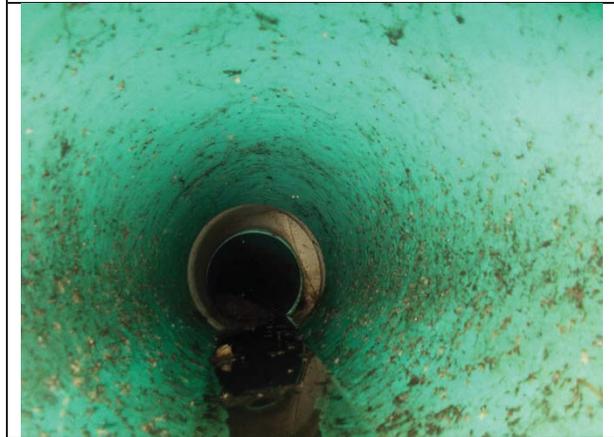
4: 10 INCH PVC - 5.9 FT INVERT - 2 O'CLOCK POSITION

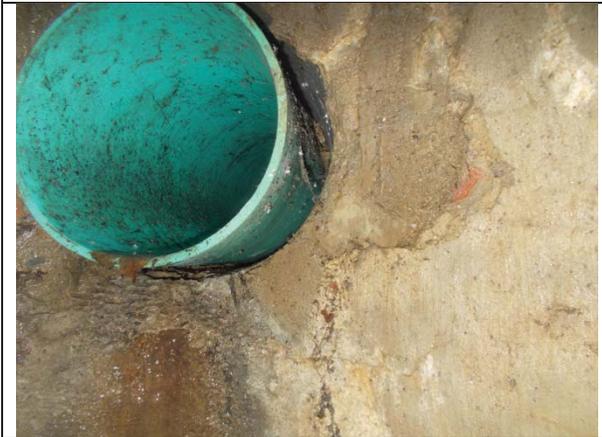
5: 10 INCH PVC - 5.9 FT INVERT - 2 O'CLOCK POSITION

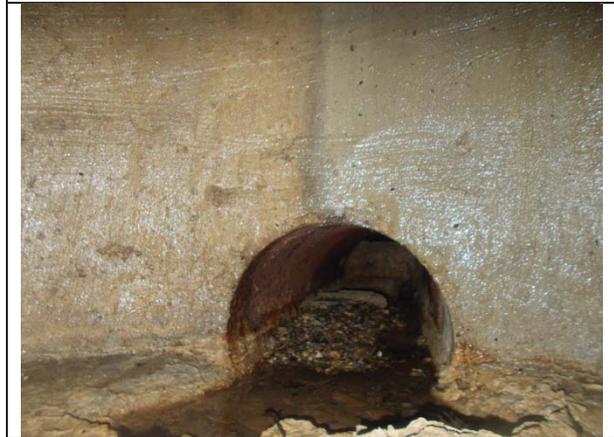
6: 18 INCH RC - 19 FT INVERT - 1 O'CLOCK POSITION

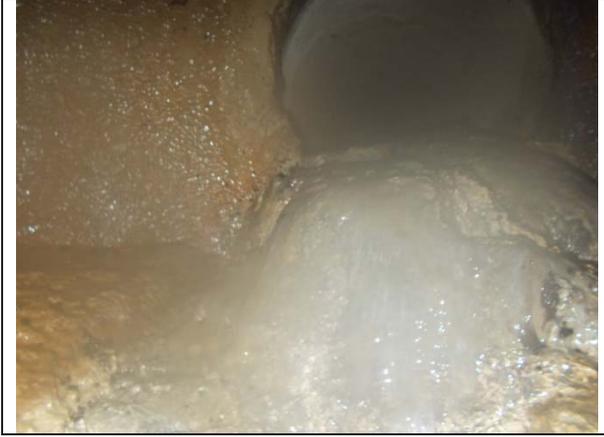
7: 18 INCH RC - 20.1 FT INVERT - 10 O'CLOCK  
POSITION

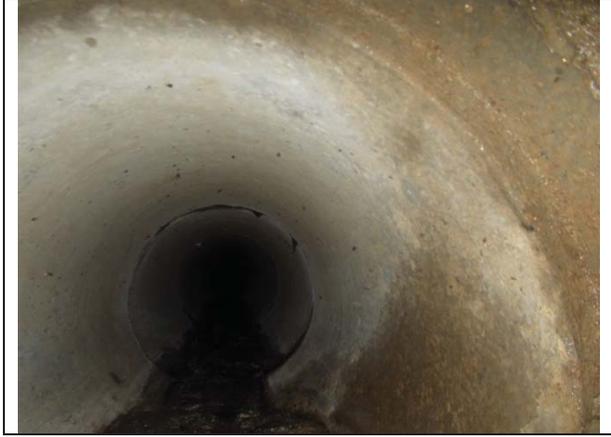
8: 12 INCH RC - 19.3 FT INVERT - 4 O'CLOCK  
POSITION

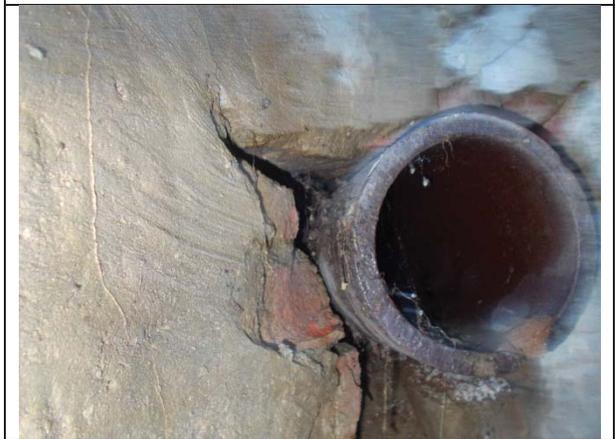
4: 6 INCH IRON - 2.7 FT INVERT - 5 O'CLOCK POSITION

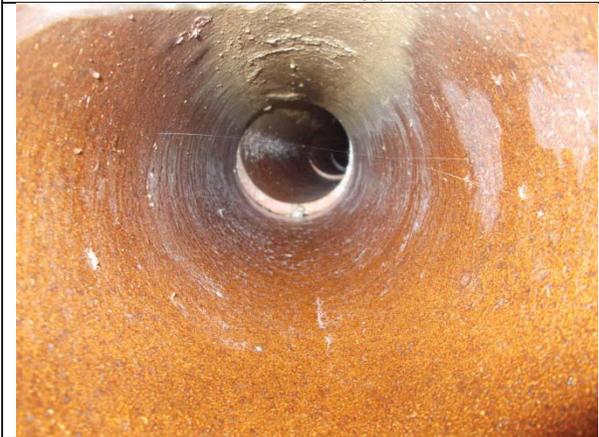
5: 6 INCH IRON - 2.7 FT INVERT - 5 O'CLOCK POSITION (2)

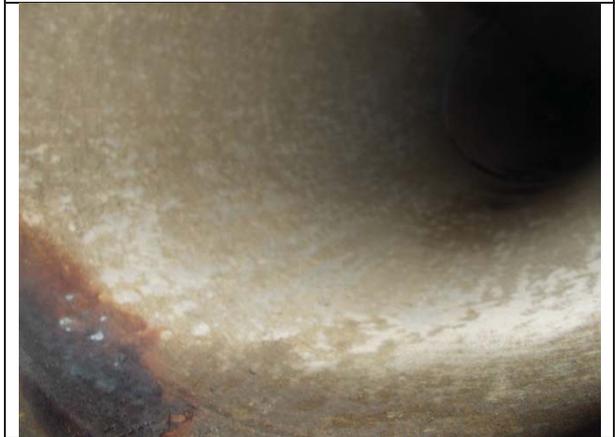
6: 18 INCH RC - 16.6 FT INVERT - 7 O'CLOCK POSITION

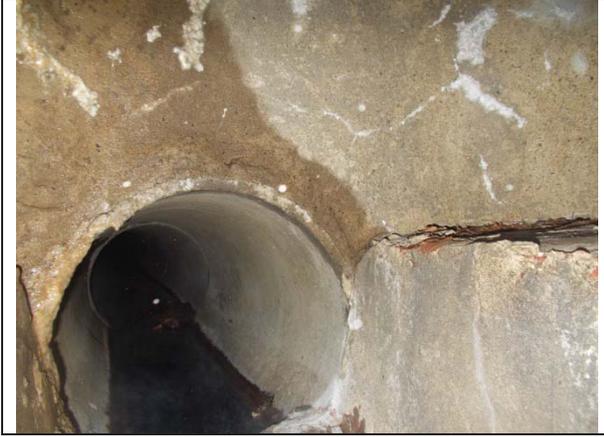
7: 18 INCH RC - 16.7 FT INVERT - 4 O'CLOCK POSITION

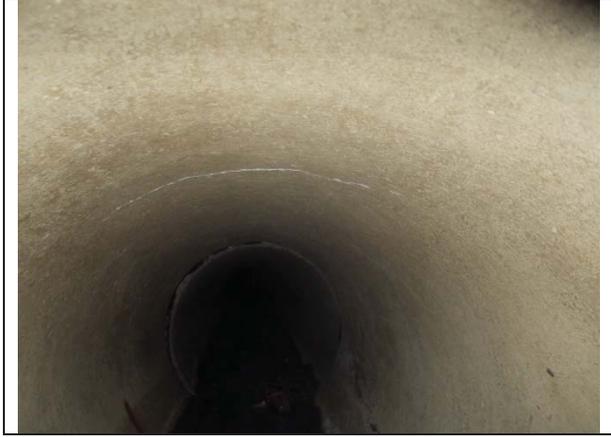
8: 18 INCH RC - 16.7 FT INVERT - 4 O'CLOCK POSITION (2)

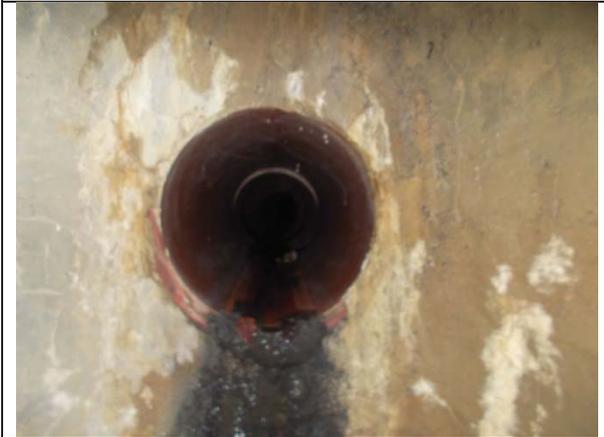
9: 18 INCH VC - 6.5 FT INVERT - 10 O'CLOCK POSITION

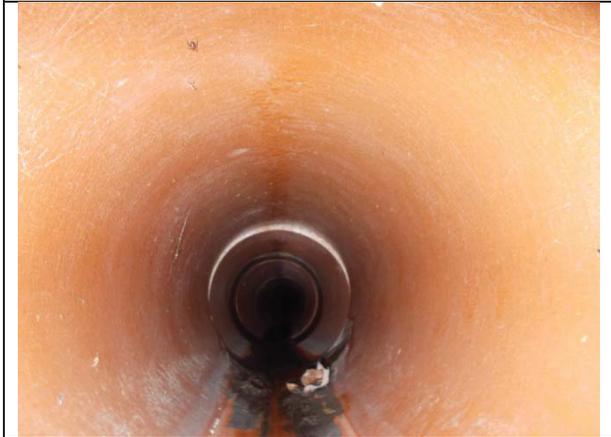
10: 18 INCH VC - 6.5 FT INVERT - 10 O'CLOCK POSITION (2)

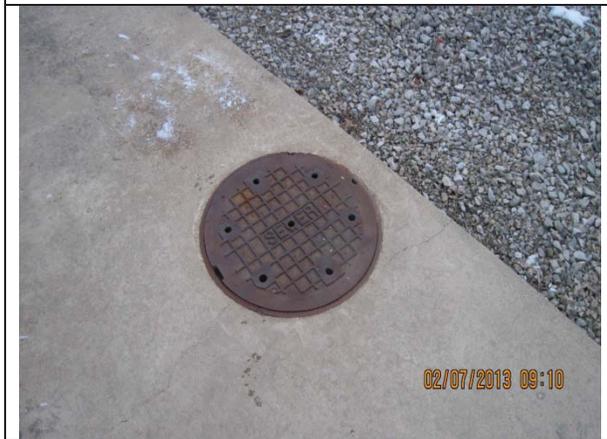
Lid labeled "SEWER."  
 Steam in the manhole due to the cold temperatures.

3: Lid

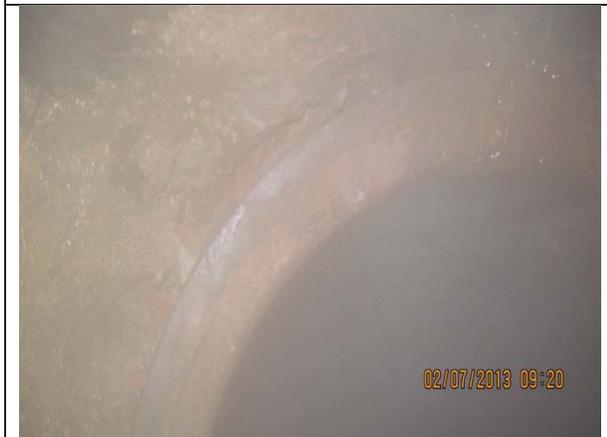
5: 15 INCH RC - 15.9 FT INVERT - 1 O'CLOCK POSITION

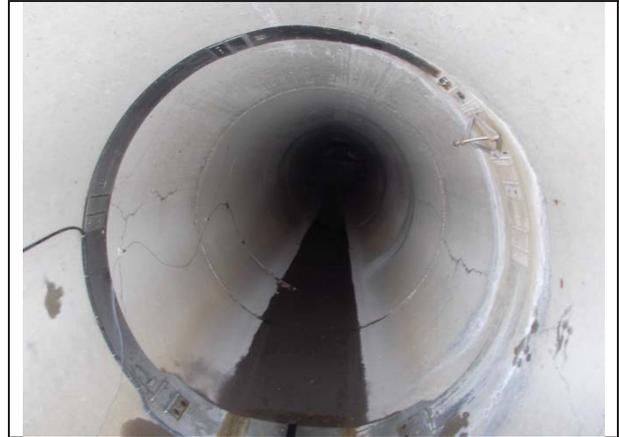
2: 60" Pipe at Outfall

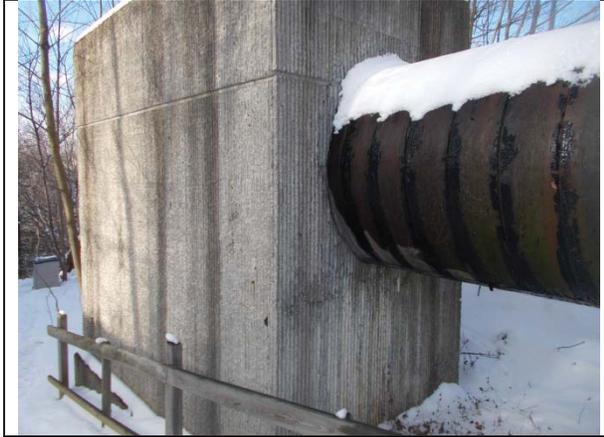
Structure is 20 or 25 feet above ground. It is more convenient to take measurements by entering the manhole through Outfall 08. We did not reach the top of the structure to inspect the manhole lid.

1: Picture of structure above ground

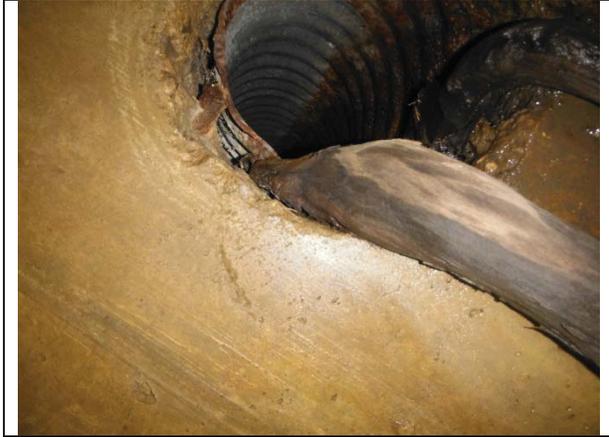
2: 8 INCH CM - 17.5 FT INVERT - 1 O'CLOCK POSITION

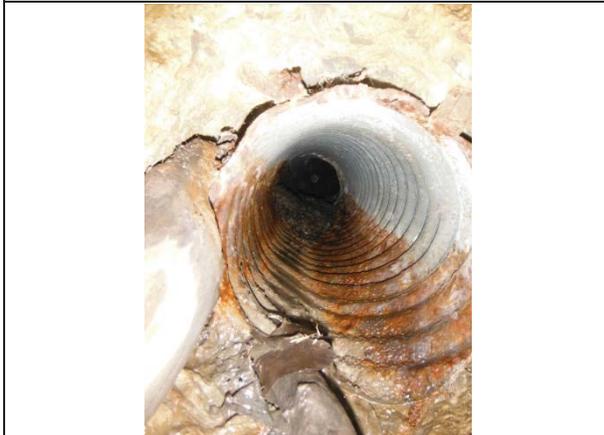
3: 8 INCH CM - 17.5 FT INVERT - 1 O'CLOCK POSITION (2)

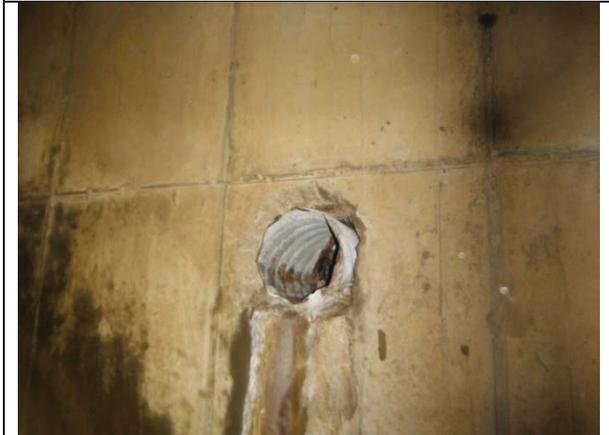
4: 8 INCH CM - 17.8 FT INVERT - 9 O'CLOCK POSITION

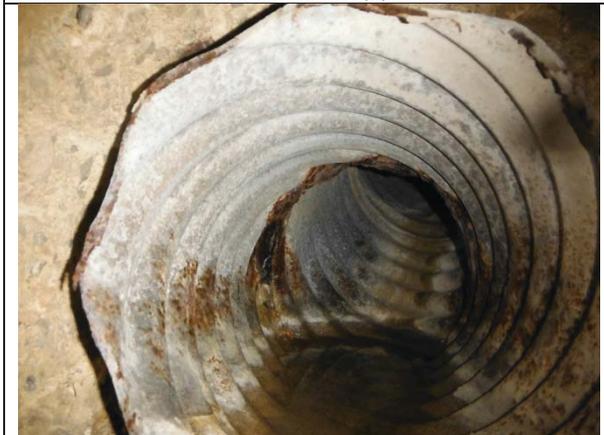
5: 8 INCH CM - 17.8 FT INVERT - 9 O'CLOCK POSITION (2)

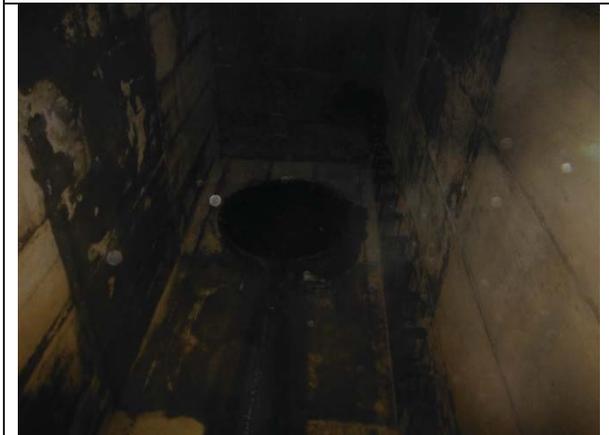
6: 60 INCH RC - 8.1 FT INVERT - 4 O'CLOCK POSITION

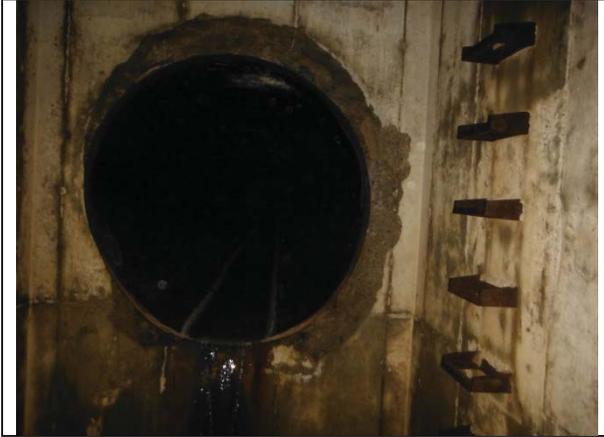
7: 60 INCH RC - 8.1 FT INVERT - 4 O'CLOCK  
POSITION (2)

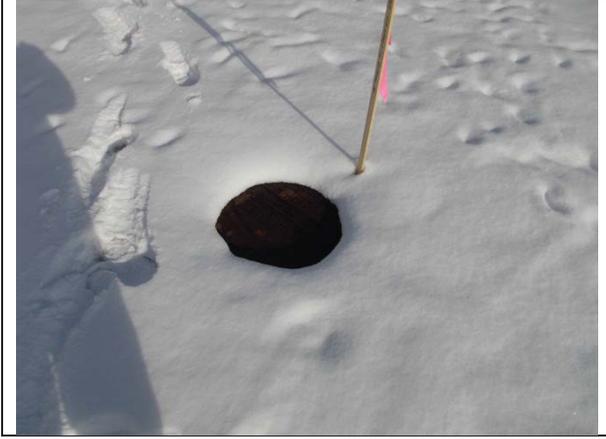
1: Casting

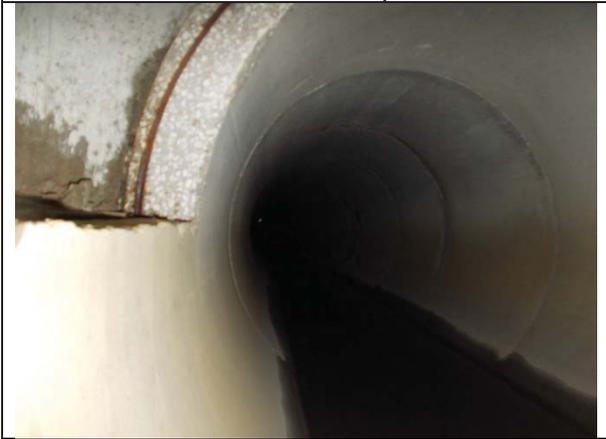
3: 60" RC, 4 o'clock position

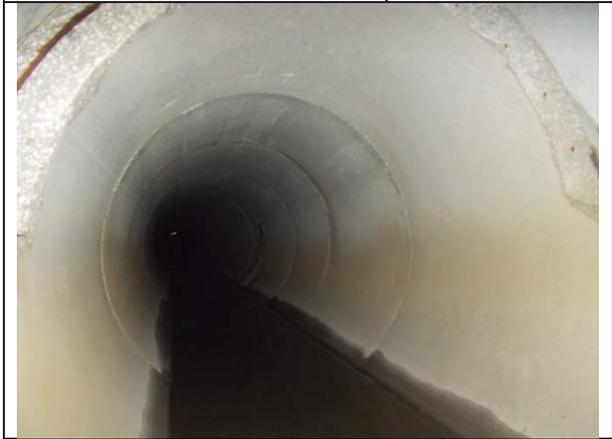
4: 60" RC, 4 o'clock position

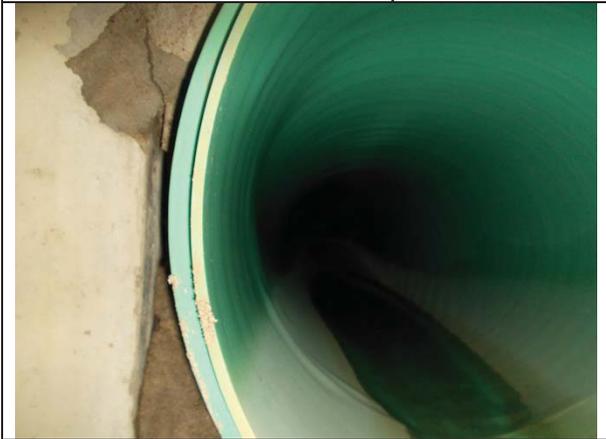
5: 24" PVC, 7 o'clock position

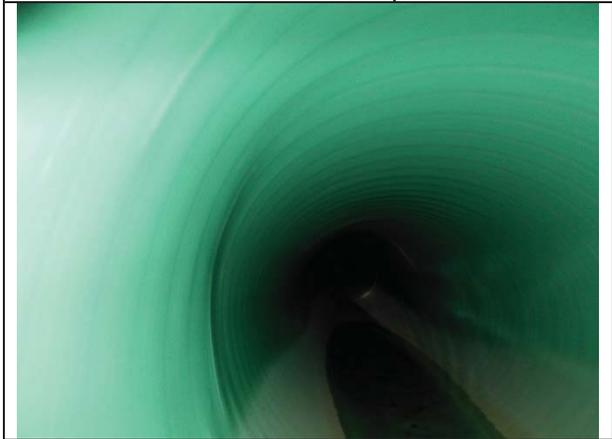
6: 24" PVC, 7 o'clock position

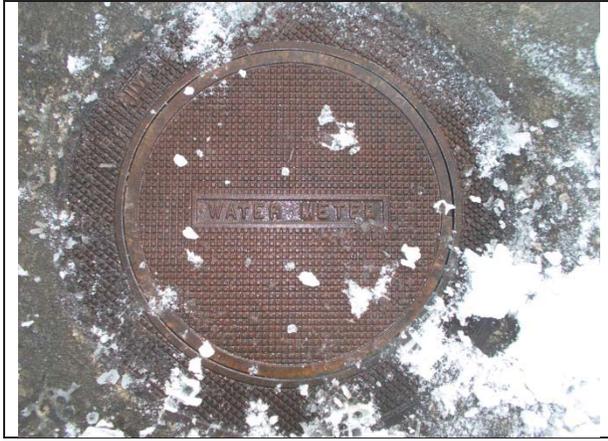
Lid is solid – LABELLED "WATER METER."

1: Casting

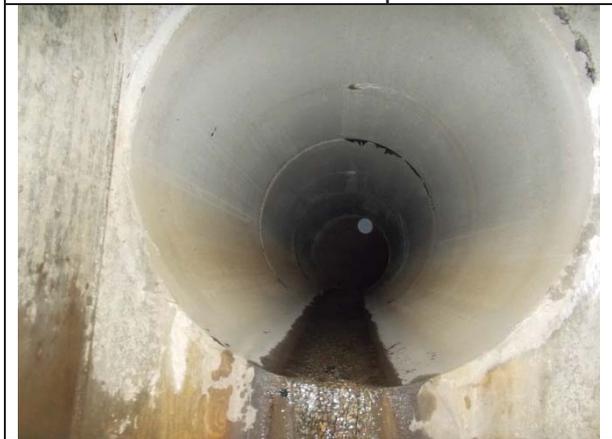
4: 60" RC, 3 o'clock position

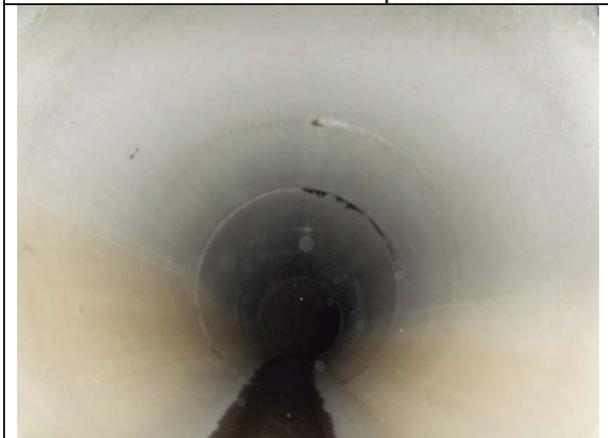
5: 60" RC, 3 o'clock position

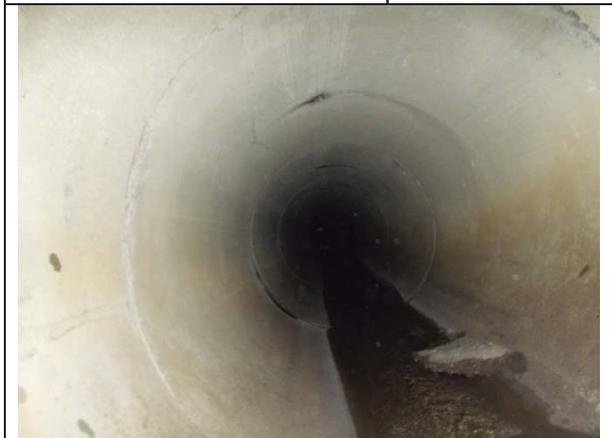
6: 60" RC, 9 o'clock position

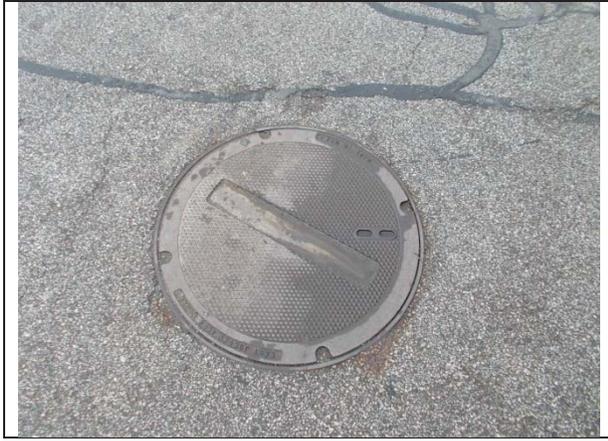
Lid is solid, labeled "EAST JORDAN IRON WORKS, MADE IN USA."  
 Conduit from 08-3000 is 36" RC and not 120" as labeled in basemap.

1: Lid

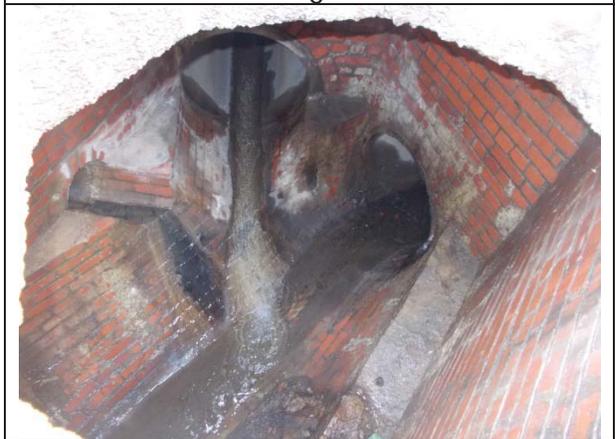
4: Incoming conduits

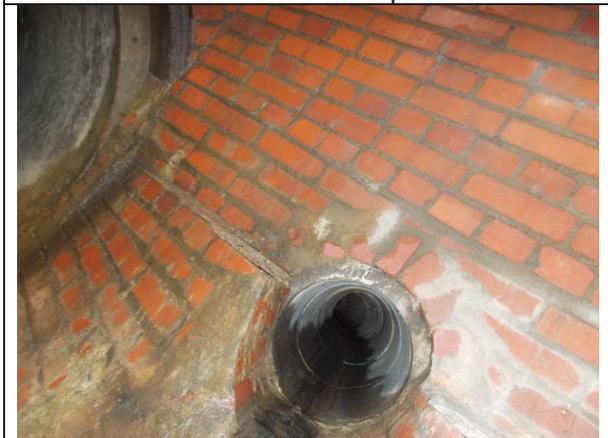
5: 12" VC, 12 o'clock position

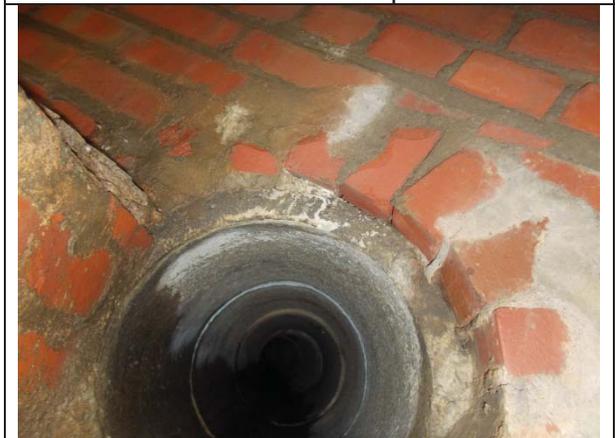
6: 12" VC, 12 o'clock position

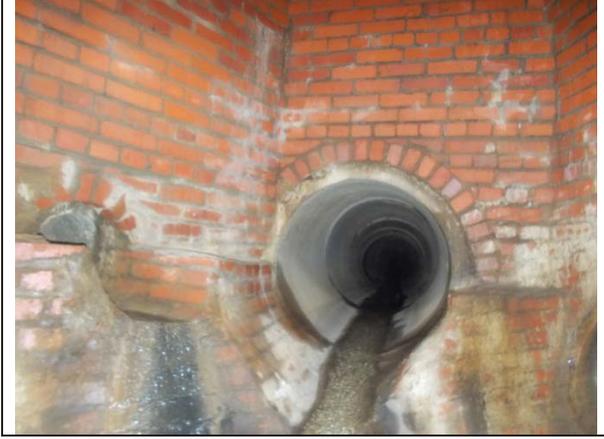
7: 36" RC, 3 o'clock position

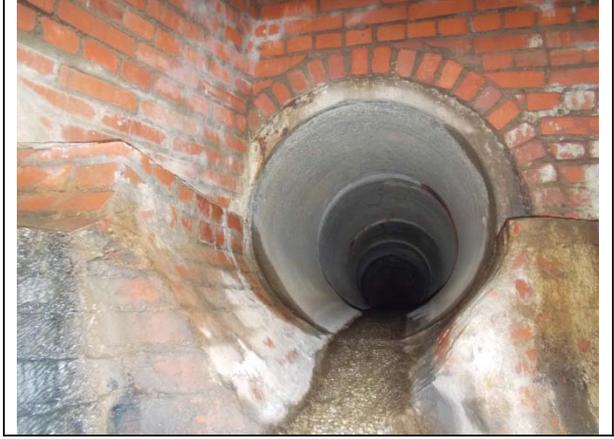
8: 36" RC, 3 o'clock position

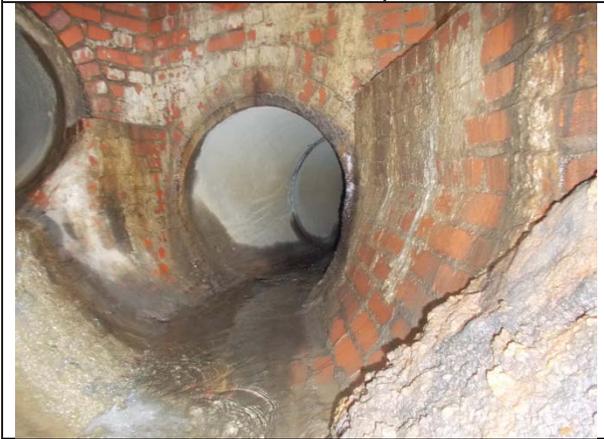
9: 36" RC, 5 o'clock position

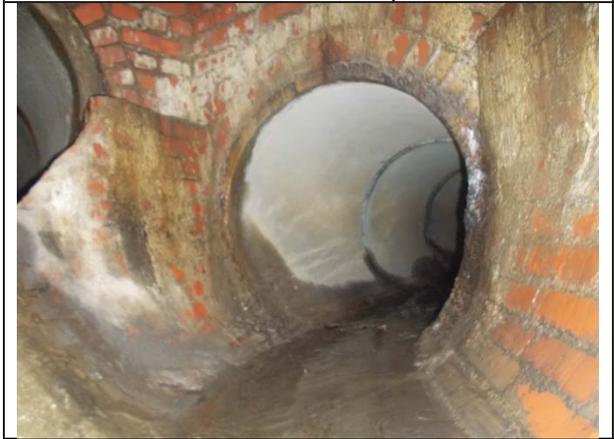
10: 36" RC, 5 o'clock position

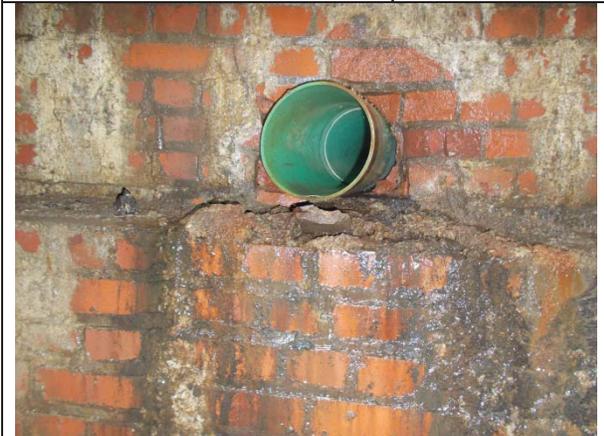
11: 8" PVC, 8 o'clock position

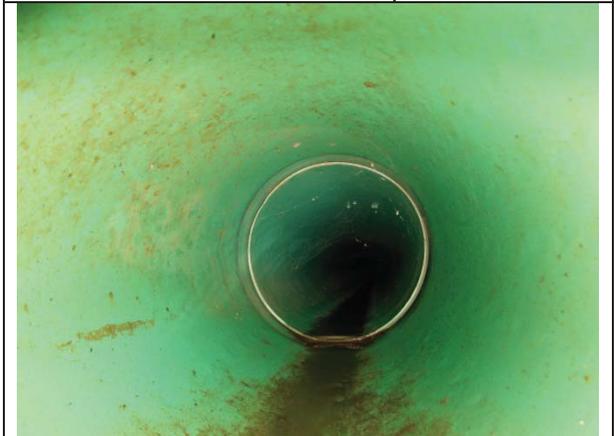
12: 8" PVC, 8 o'clock position

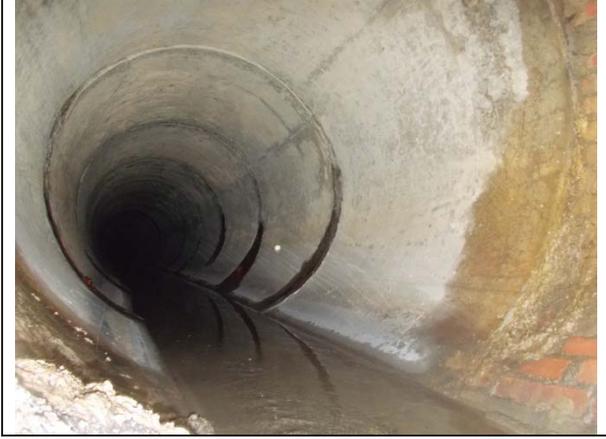
13: 60" RC, 10 o'clock position

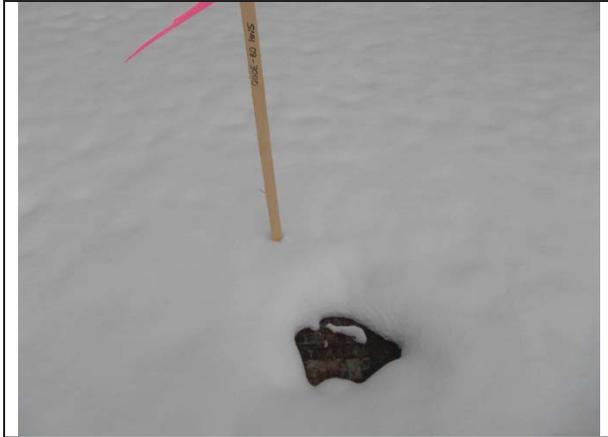
Lid is solid, reads "THE MADISON FDRY CO, CLEVELAND O".  
 Steps have failed- 90% section loss.  
 The 8" VC pipe located 3.6 feet down and at 6 O'clock position appears to be 70% blocked with sediment.  
 Inverts b and c are shown as 120" on basemap but were found to be 36" diameter in field.

1: Lid

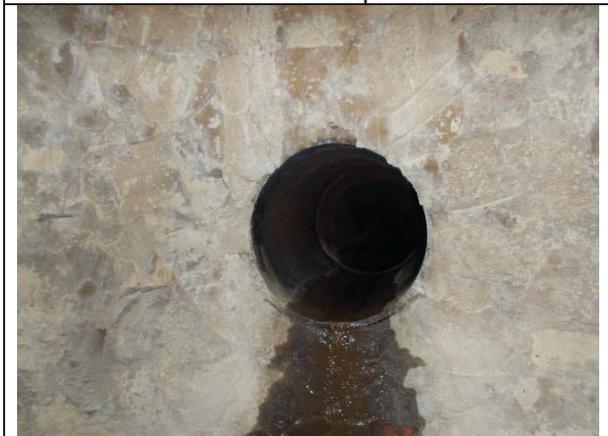
5: 12" CI Pipe

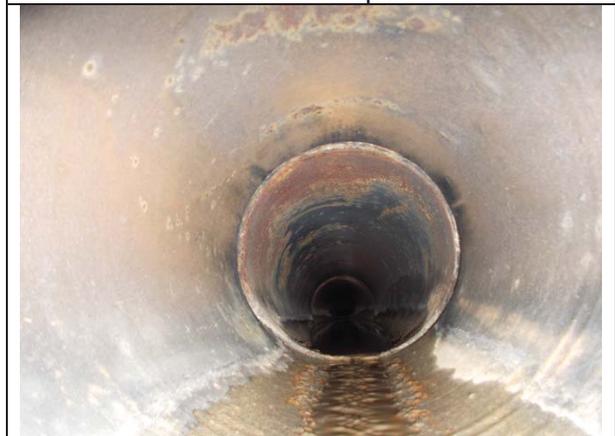
6: 12" CI Pipe

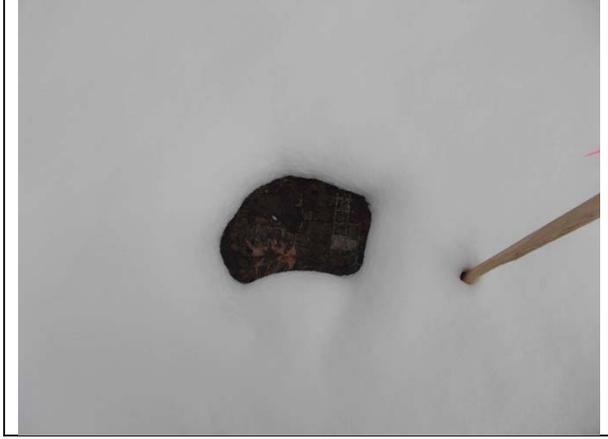
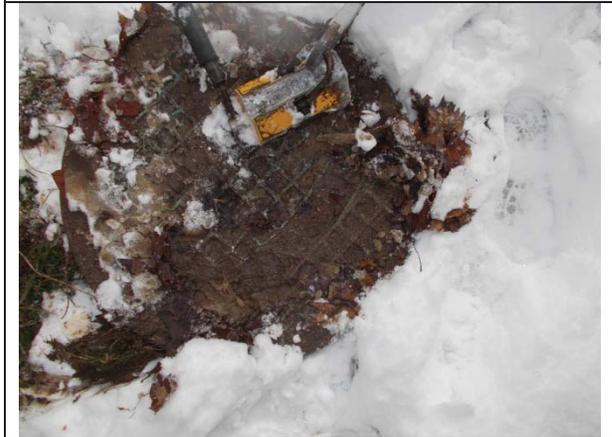
1: Lid

Lid is a solid manhole lid. Lid reads "THE MADISON FDRY CO, CLEVELAND O". Steps are rusted and delaminating. Inverts a and b are shown as 120" on basemap but were found to be 36" diameter in field.

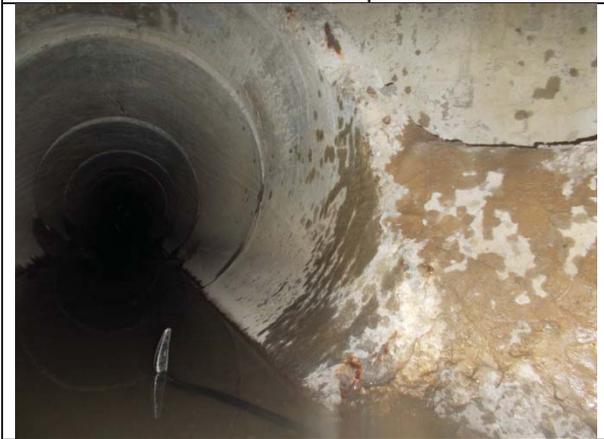
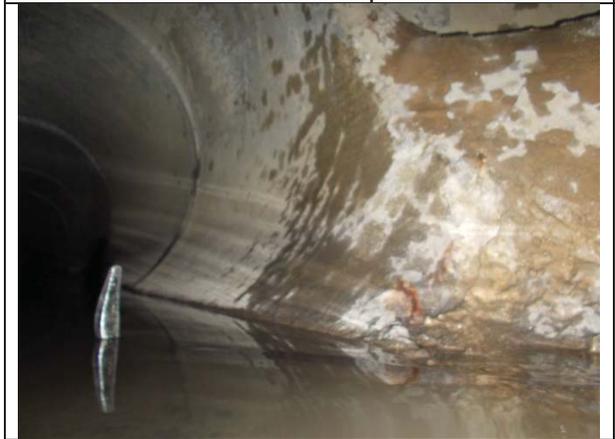
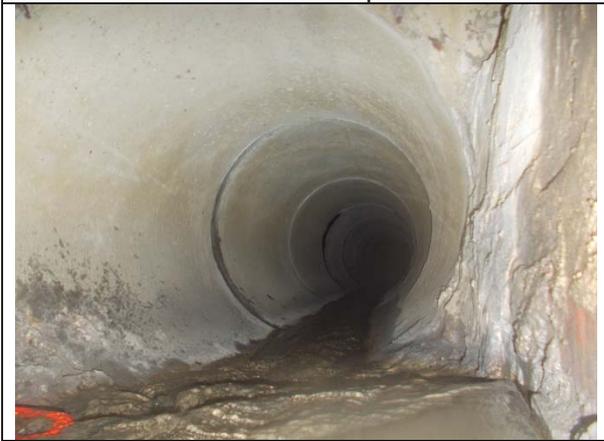
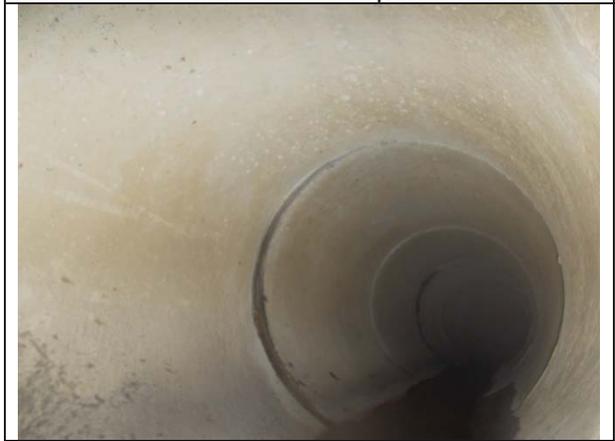
7: 36" RC Pipe

Near wind tunnel networks around BLDG 114  
 Lid is a solid manhole cover.  
 Steps are rusting – metal is delaminating.  
 Invert b is shown as 120" on basemap but was found to be 36" diameter in field.

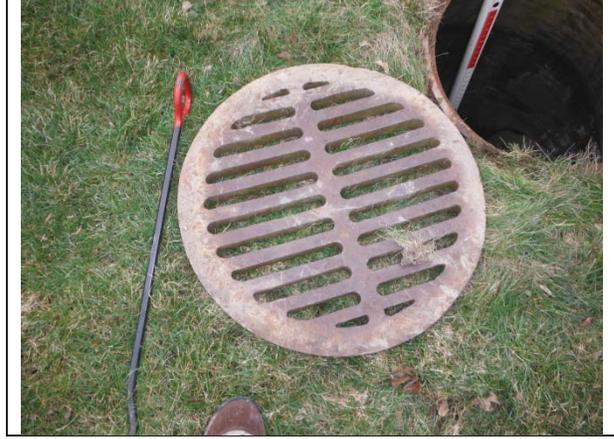
2: Lid

Lid is a concave grate, no text.

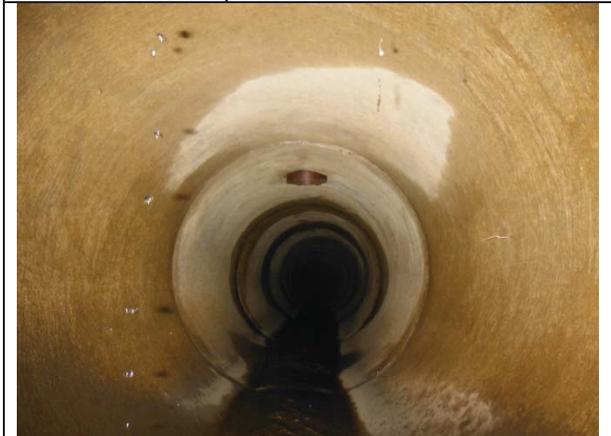
12: 36" RC Pipe, 8.9 Ft. Invert, 9 O'Clock

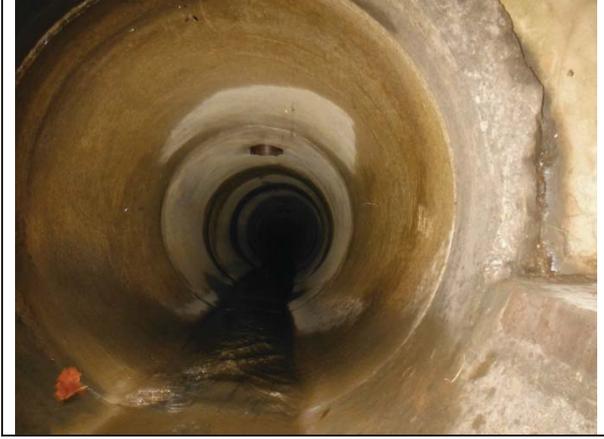
13: 36" RC Pipe, 8.9 Ft. Invert, 9 O'Clock

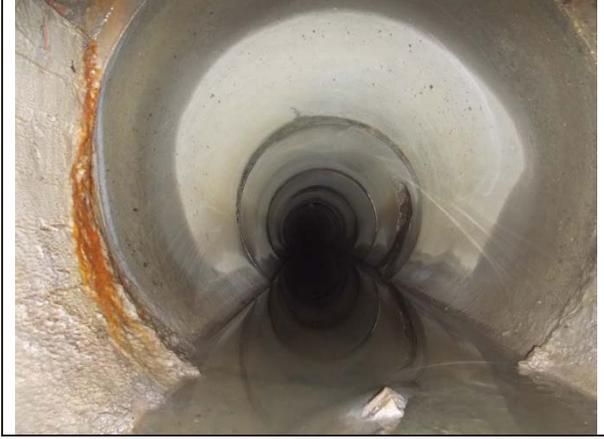
7: 36" RC Pipe

The 34" RC pipe located at an invert of 10.1 feet and at the 3 O'clock position appears to be 90% blocked by sediment.

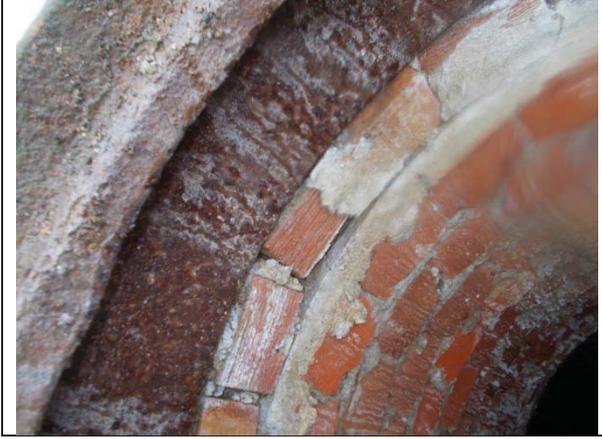
Casting is labeled "THE MADISON FDRY CO CLEVELAND O".  
 Grout is delaminated at all joints on highest ring of brick chimney.

13: Brick Chimney

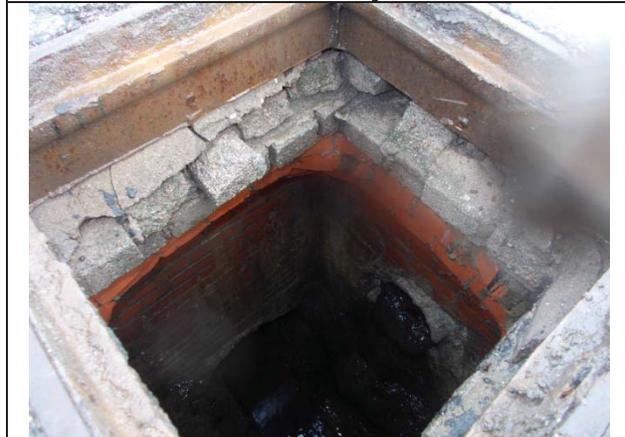
Brick wall is showing section loss on 3 o'clock wall. Approximately 18" X 18" of brick is missing, centered around the 12" pipe. Section loss is approximately 1" deep into the wall.

4: Masonry

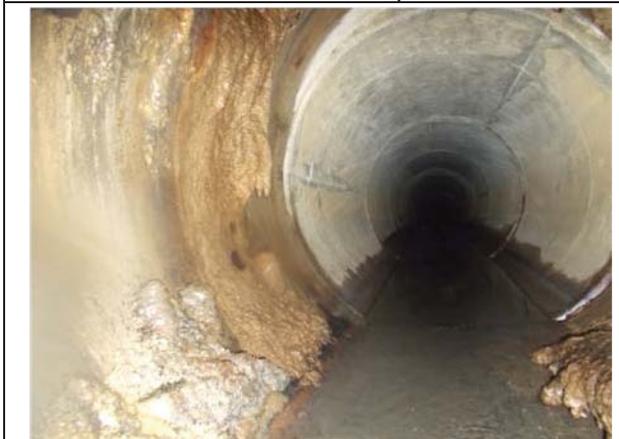
5: 36" RC, 12 o'clock position

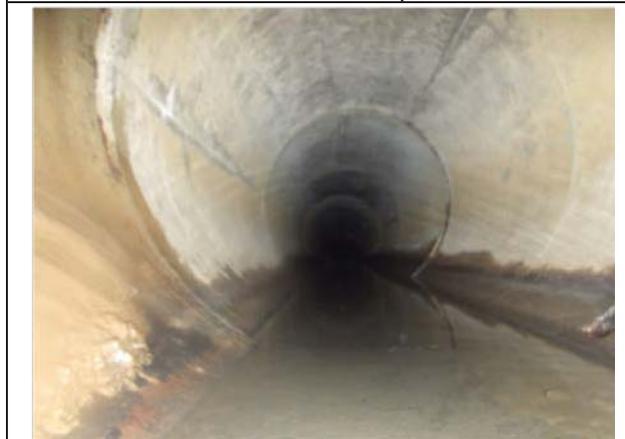
6: 36" RC, 12 o'clock position

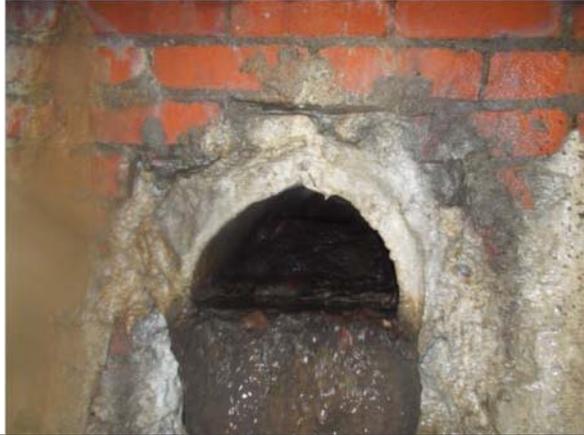
7: 12" RC, 3 o'clock position

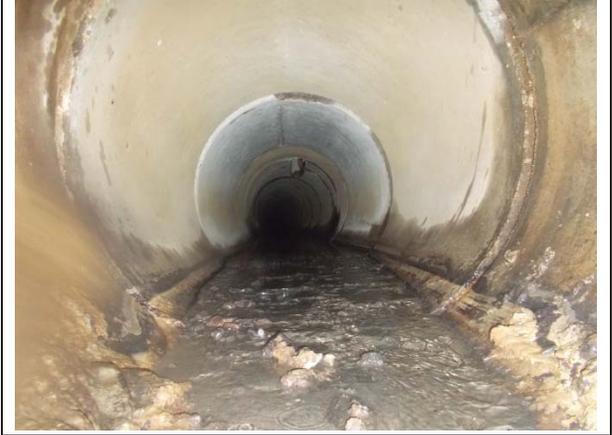
8: 36" RC, 10.5' invert, 6 o'clock position

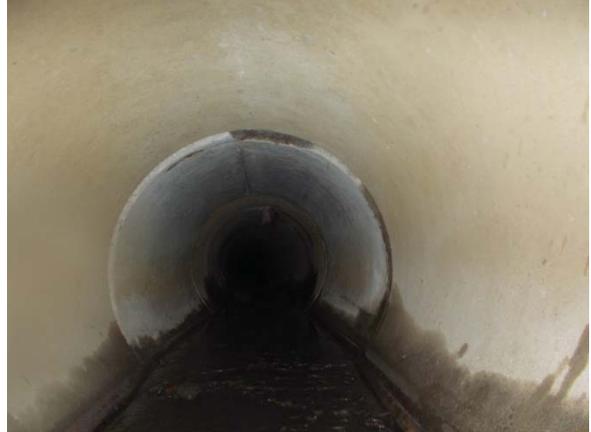
9: 36" RC, 10.5' invert, 6 o'clock position

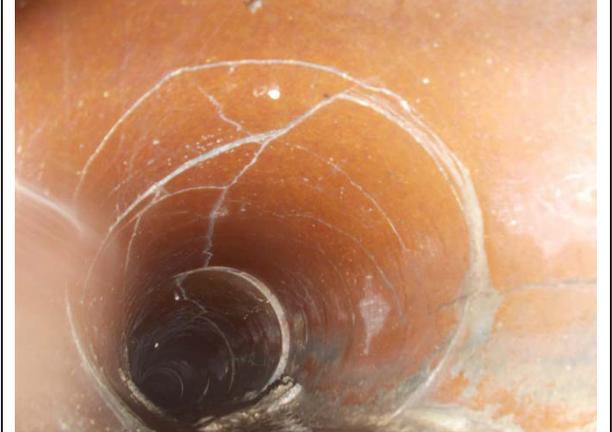
10: 8" RC, 3.6' invert, 9 o'clock position

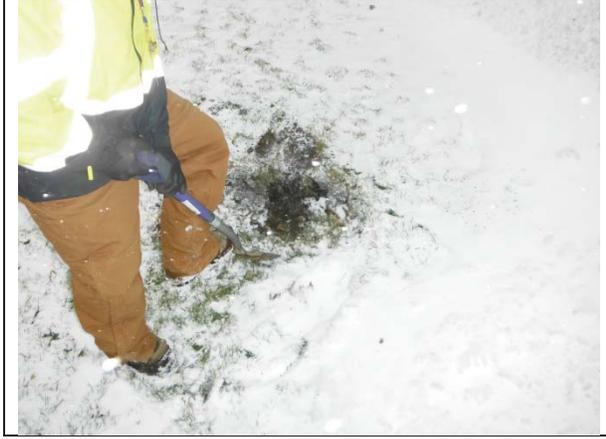
1: Picture at a Distance

Steps: top 3 delamination, bottom 3 90% section loss  
 4" below grade. Was buried, found with metal detector and dug using shovel.  
 Lid says "MADISON FDRY CO, CLEVELAND, O"

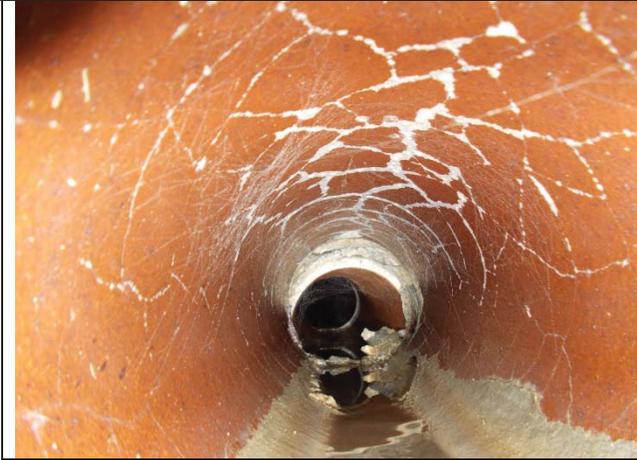
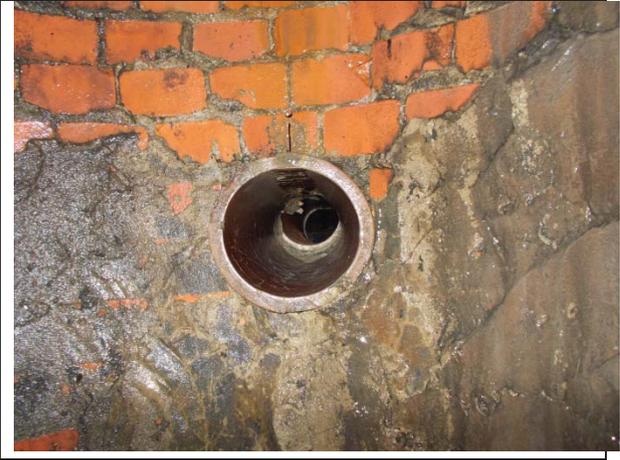
Manhole lid reads: "THE MADISON FDRY CO" "CLEVELAND O"  
 Vertical separation in 6" diameter VC  
 Casting is a flat grate.

9: VC 6" 8 O'clock Position

10: VC 6" 8 O'clock Position

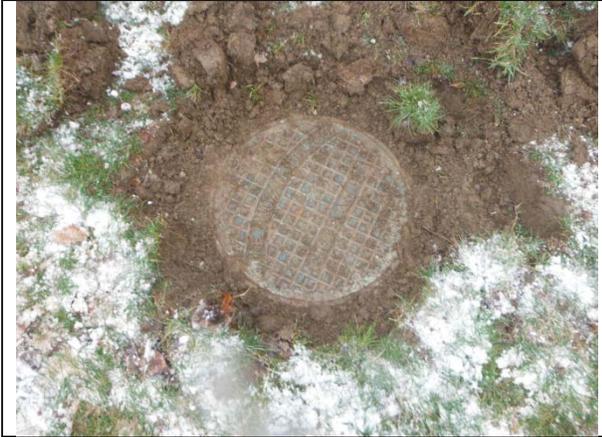
Lid labeled "MADISON FDRY CO, CLEVELAND, O"  
 2" BELOW GRADE, found with metal detector and uncovered using shovel.

3: Structure Uncovered

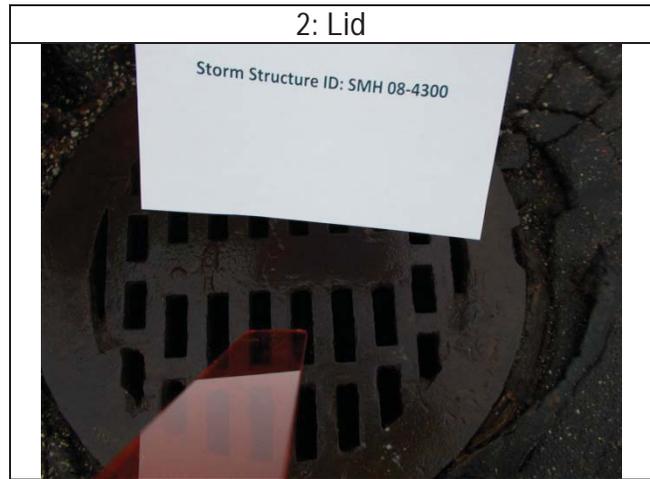
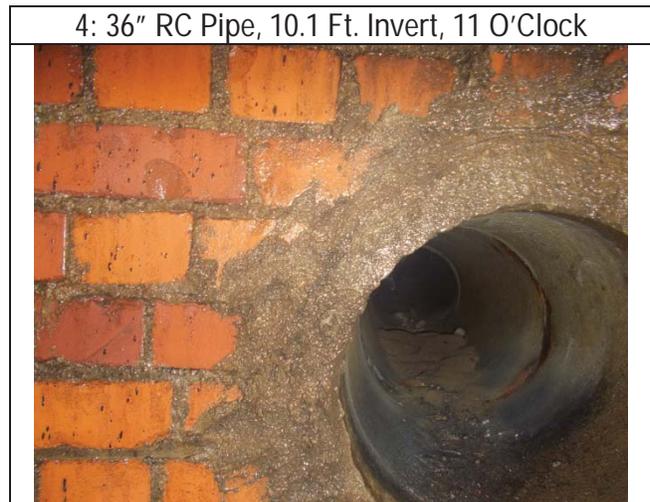
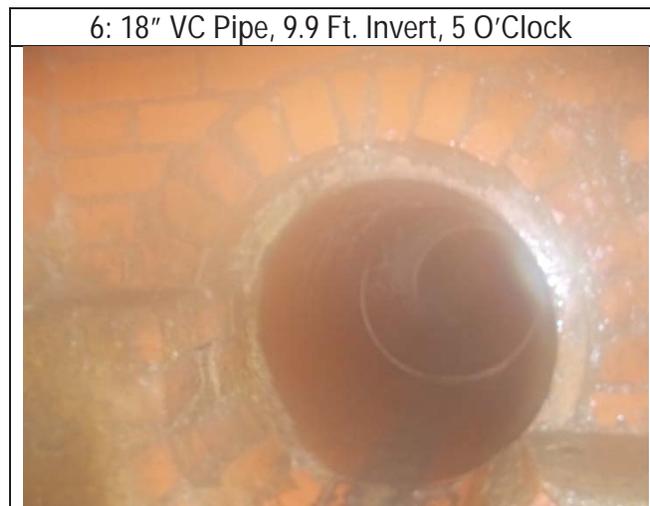
SMH 08-4300

Casting – no major defects, 8. Casting seems to be too small for manhole. Casting is flush at 10:00 position, but 4" off alignment at 4:00 position. Casting is a flat grate.

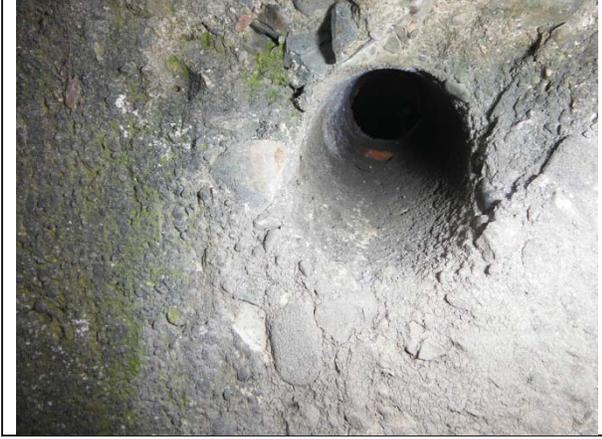
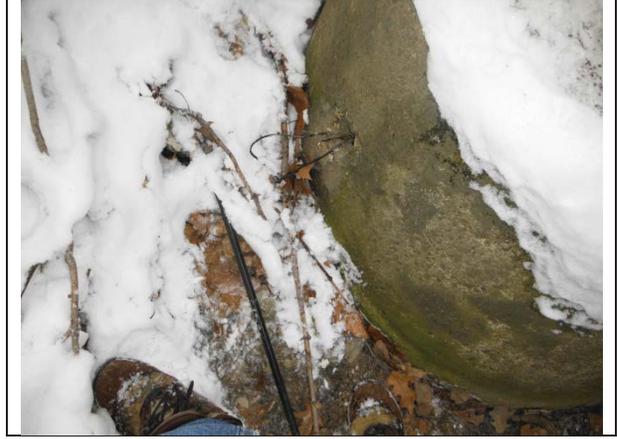
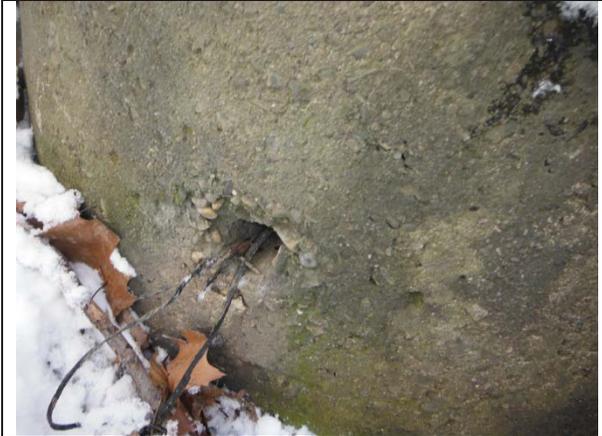
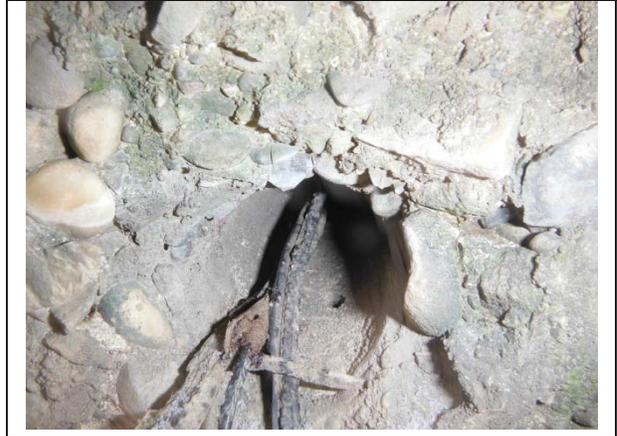
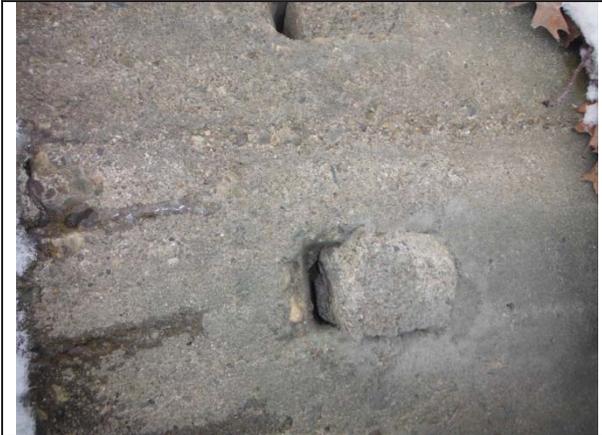
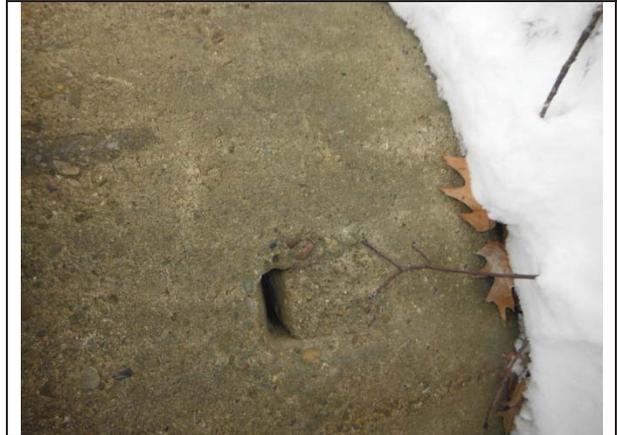
SMH 25-1200

Invert was measured as 5.0'. Manhole protrudes 2.5' above ground. Water is leaking out of structure 1.0' feet above ground through holes drilled through the sides of the manhole. This manhole possibly was plugged with concrete because according to the basemap this structure has a 15 foot invert. See pictures 5 through 10.

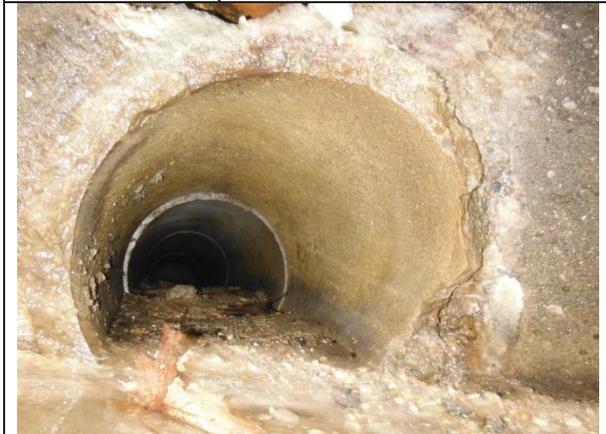
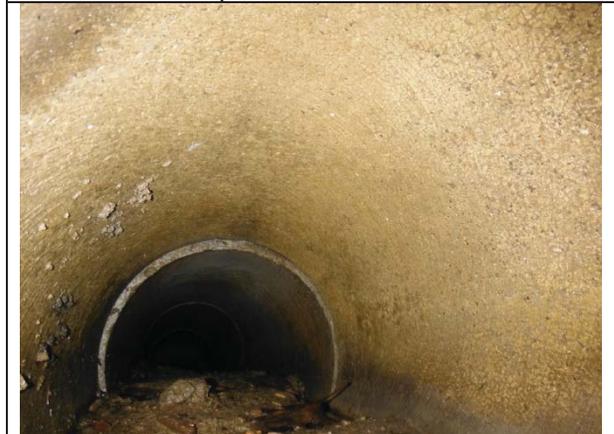
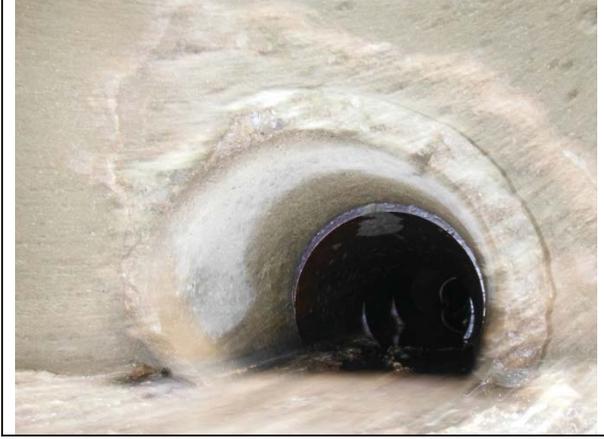
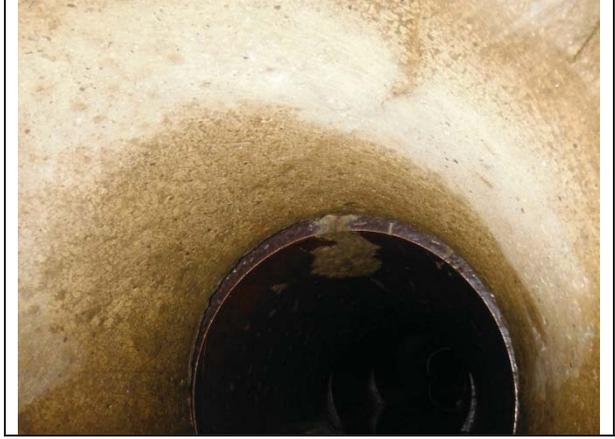
Details of the blockage in these pipes are shown in pictures 5,6,7,and 8 in the photo report.
