Date:	2/11/13	Time:	12:45 PM	Weather:	41F Windy
Outfall System:	06	Structure ID:	4100	Shape:	Round
Structure Type:	SCB	General Appraisal:	8	Diameter:	2.2'
Casting labeled "STORM":	NO	Invert:	10.5'	Water Depth:	1"
Housing Material:	CONC				
Location:	East side of Building 57, in grass.

**Storm Sewer Inspection Reports**

**BARR & PREVOST**

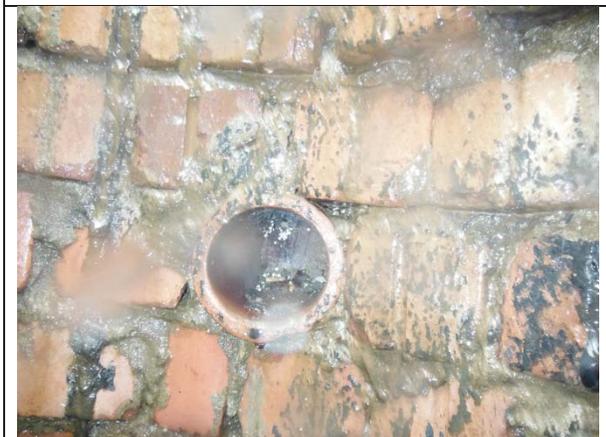
6: 2-6" VC Pipes, 4.2 and 5.6 Ft. Invert, 6 and 7 O'Clock Positions

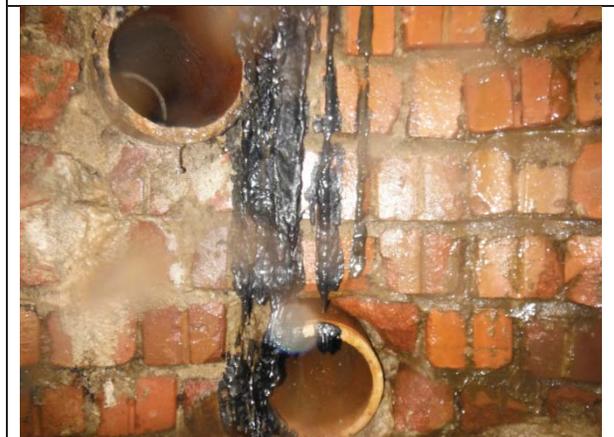
7: 6" VC Pipe, 4.2 Ft. Invert, 6 O'Clock

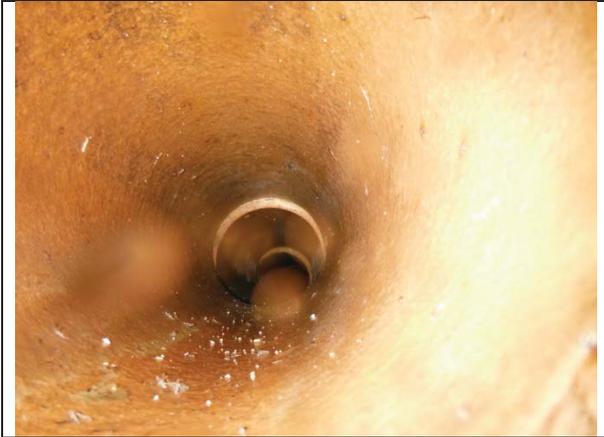
8: 6" VC Pipe, 5.6 Ft. Invert, 7 O'Clock

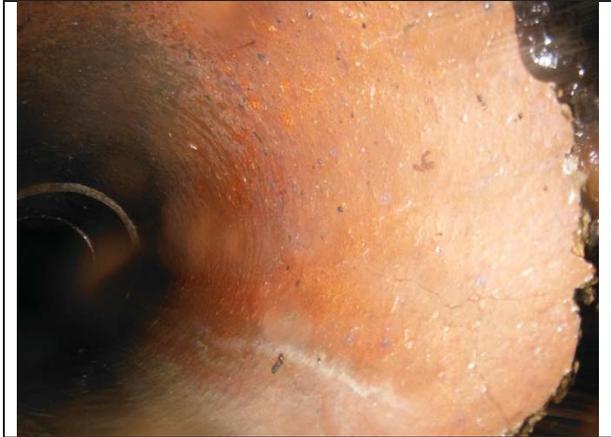
9: 10" VC Pipe, 6.4 Ft. Invert, 3 O'Clock

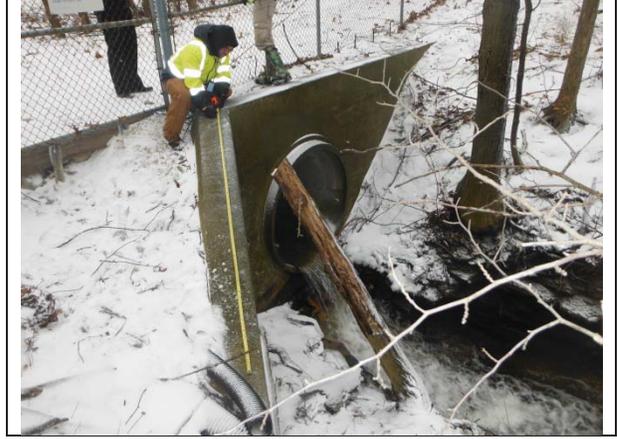
2: Headwall and 60" RC Pipe
